Assessment of safety performance level on simple urban residential building: Case study at Bogor city Indonesia

To cite this article: M Lutfi *et al* 2020 *IOP Conf. Ser.: Mater. Sci. Eng.* **712** 012004

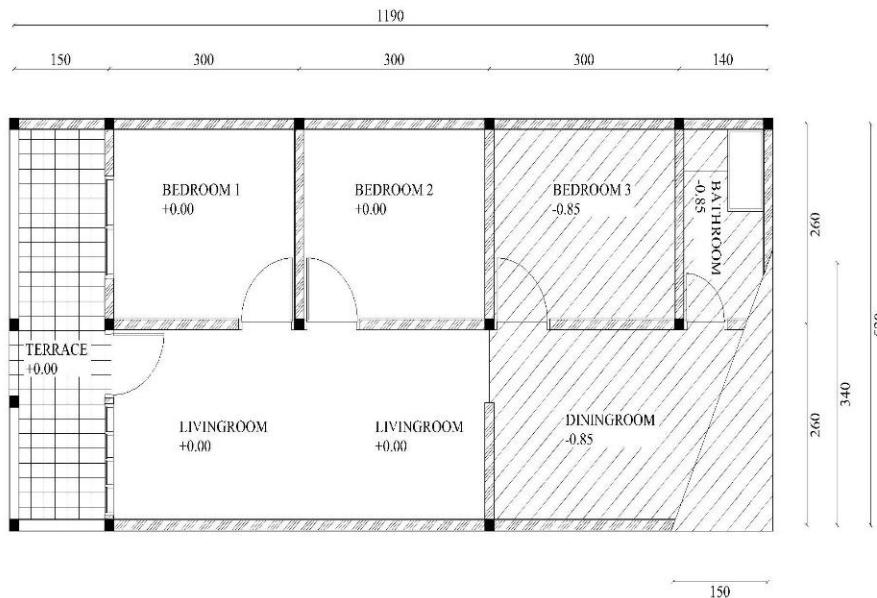
Figure 1. Existing residential building

The specifications of the existing residential buildings are 520 cm X-direction and 1190 cm Y-direction, 300 cm height Z-direction using 15x15 cm column dimension, 15x18 cm dimension beam, 17 MPa concrete (FC), 4D12 BJTP main reinforcement, and shear reinforcement D8-20, is in quake zone 4 with the medium type of soil (Figure 1).

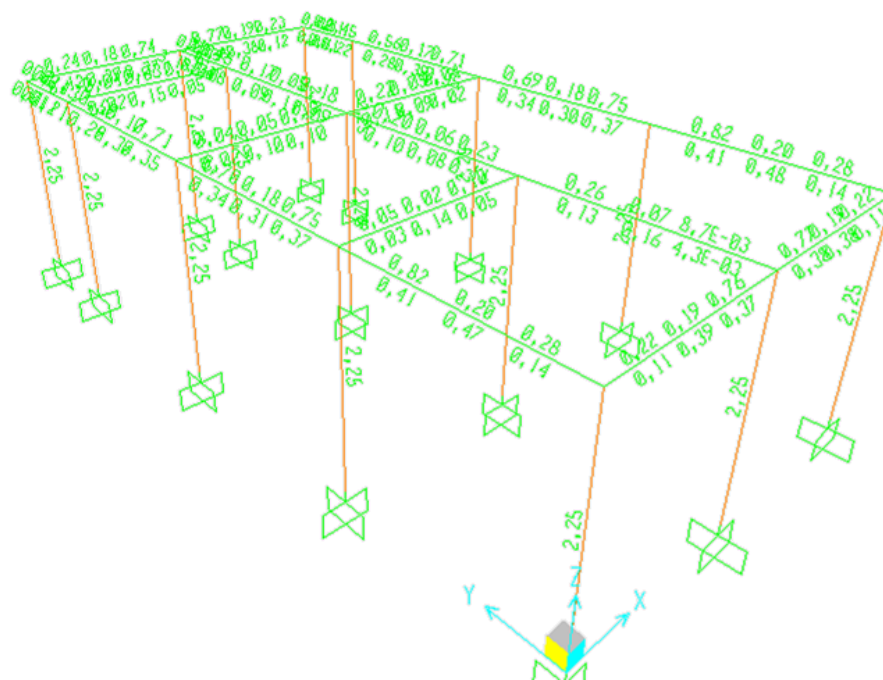
Figure 3. Modeling and analysis results

The result of modeling and structural analysis according to SNI 2847-2013 in a simple residential building is obtained for column structure element almost near the failure which is marked with orange color, while the beam structure element is declared safe marked with green color. Furthermore, the result of evaluation using SAP2000 V10 application refers to the FEMA 356 obtained value of displacement target of 0.02 m, which is categorized at the level of a safety performance of the building is at Life Safety (LS) level.

From the modeling, we performed a structural analysis with a load combination of dead load covering roof $3\text{ m} \times 10.4\text{ m} \times 50\text{ kg/m}^2 = 150\text{ kg/m}^2$, ampig wall $(1.54\text{ m} \times 250\text{ kg/m}^2) / 2 = 192.5\text{ kg/m}^2$, hanging = 11 kg/m^2 . Live load on roof = 100 kg/m^2 . Earthquake loads using spectrum response data based on the Public Works Research and Development Center [10,11,12]. The results of the load combinations analysis obtained for the column structure elements are almost close to failure which is indicated by orange color, while for the beam structure elements expressed which are indicated by the green color shown in Figure 3.

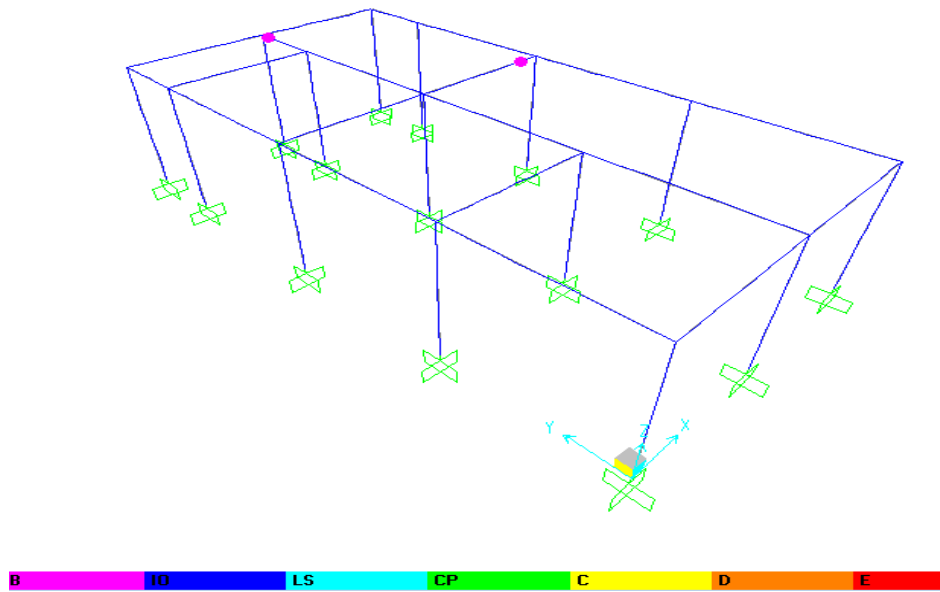
Figure 4. Plastic joints that occurs in step 1

Furthermore, modeling with FEMA 356 was obtained from the pushover method found in SAP2000 V10 to produce plastic joints in the beam and column structure elements. In steps 1 up to step 6 with colorful nodes shown in Figure 4 and Figure 5. Description of pushover color nodes in plastic joints is based on Table 2 which is divided into 7 levels described in Table 3. According Figure 5, the front part of the house is not able to withstand the shear and shattering forces, while the back part is still function. Therefore some reinforcement is necessary to keep the evacuation route through the house front.

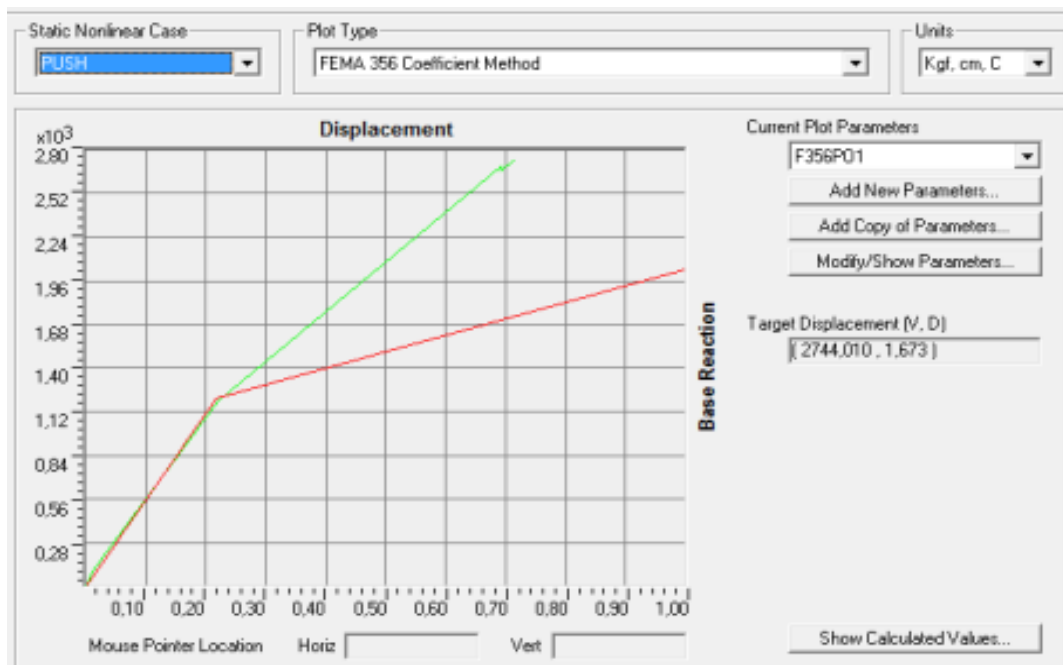
Figure 6. Pushover curve which refers to FEMA 356

Pushover also produces curves referring to FEMA 356 shown in Figure 6 and generates the values required for the displacement target (δT). The values obtained from the FEMA 356 curve are $C_0 = 1.0$; $C_1 = 1.378$; $C_2 = 1.0$; $C_3 = 1.0$; $S_a = 1.011$; and $T_e = 0.221$.

Furthermore, the values are calculated using the equation (1) so that the result of the displacement target value is 0.02 m categorized under table 1 at the Life Safety (LS) performance level. This means

that if there is a movement of land, the structure of the house is stable and has adequate service capacity and damage non-structural part is still controlled.
