Cracks Monitoring and Resistivity Test for a Double-Storey House due to Cavity in the Soil

Abstract This paper presents the feasibility study of structural assessment and monitoring of two-story house due to soil settlement which was not well-compact before construction commenced. Two stages assessments were conducted to monitor and evaluate the structural integrity of existing double-story house which involves preliminary investigation and detailed assessment. Preliminary investigation includes visual inspection of cracks, soil settlement and structural damages. Meanwhile, detailed assessment comprises of crack width measurement, Non-Destructive Test (NDT) and resistivity test. The first detail assessment was carried out on 18th July 2019 which involved crack width measurement, Ultrasonic Pulse Velocity (UPV) test and rebound hammer test. The second inspection was conducted on 19th October 2019 to monitor and identify the integrity of the structure and the main causes of the problem. Visual inspection and non-destructive test indicate that the defects found in the house can be categorized as partial damage due to soil settlement. Resistivity test showed that there were cavities a

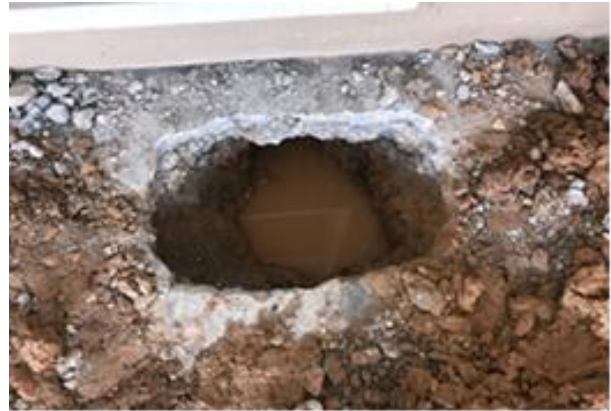
Moreover, high level of groundwater table also can jeopardize the strength of the soil and causing the foundation to constantly be in partial submerged condition with water during its service life. There are several symptoms of foundation and soil failure that were found in this case study which are doors and windows not being closed properly or sticking, diagonal cracks in the interior and exterior wall, cracks and splitting on tiles and ground floor as shown in Figure 12 and 13. This phenomenon will cause the overall structure to settle and has a tendency to be tilted. However, it was found through the non-destructive assessment that the existing structure is in distress condition in which the concrete performance due to quality and compressive strength are poor at most locations of this house. Structural damage of the building

Figure 9. Ground Water Table at 800mm Depth

hole in front of the car porch area based on the resistivity test as shown in Figure 9.

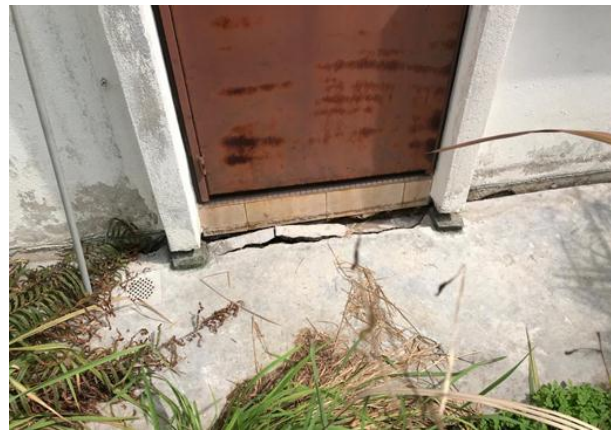
Figure 12. Splitting between ground floor and wall

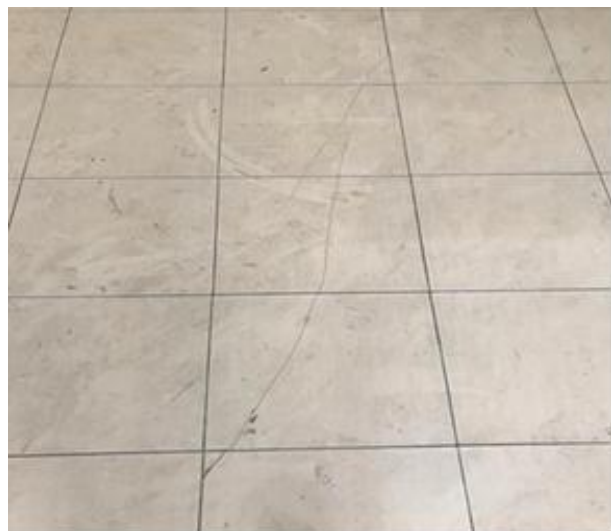
Figure 13. Cracking on the tile and floor

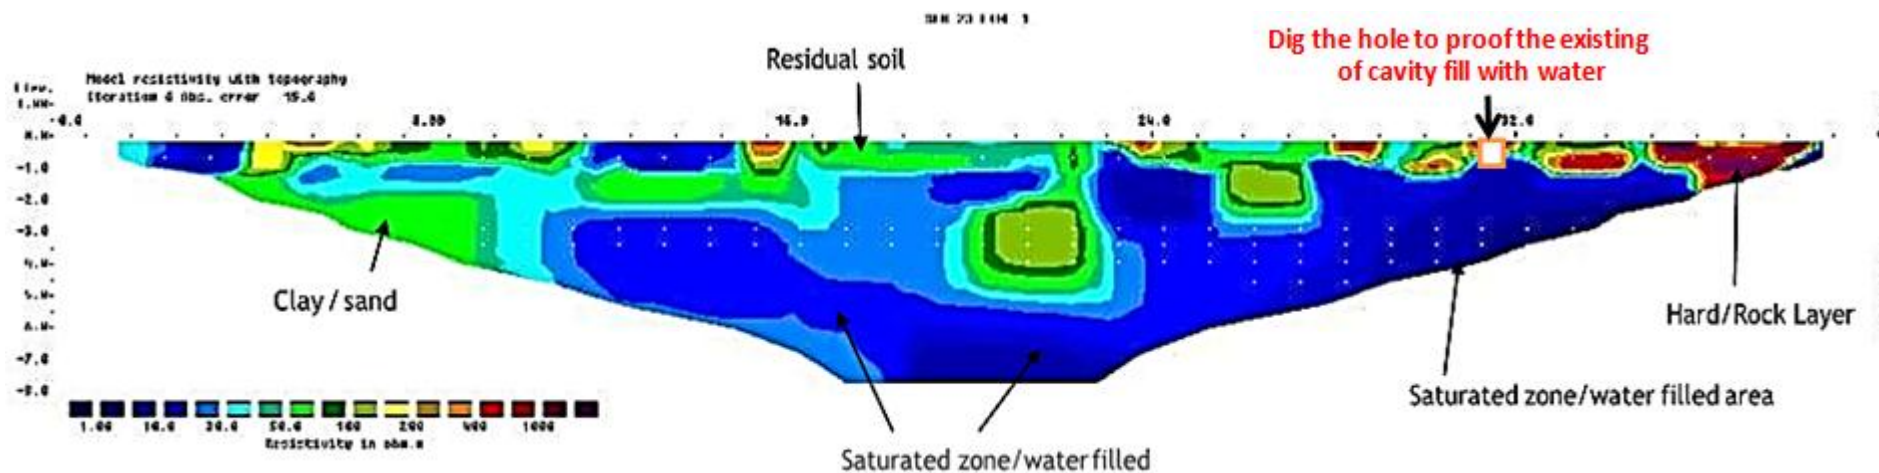
Based on visual inspection and monitored assessment conducted two times within 3 months, there are three main problem encountered to the structural cracks, low quality of concrete and decreasing of compressive strength of concrete. These problems cause soil settlement with low bearing capacity and cavities of soils by changing of ground water table level. The cavities in the soils were notified based on the resistivity test conducted on 23rd of July 2019 using ABEM Terrameter LS2 and 200m cable as shown in Figure 4. Two resistivity tests were conducted with Line 1 of 40m inside the house and Line 2 with 60m in front of the house and these lines are perpendicular to each other. The systematic arrangement of ABEM Terrameter LS2, steel electrode and jumper cable is shown in Figure 5. After analyzing the data from resistivity test using Res2DINV software, the soil profiles were plotted for Line 1 and Line 2. Figure 10 shows the soil profile for Line 1 with 10m depth and 40m length. Meanwhile, Figure 11 shows the soil profile for Line 2 with 20m depth and 60m length. Different colors of contour lines in Figure 10 and 11 show different resistivity and conductivities of igneous metamorphic rocks, sedimentary rocks, soils and water. The interpretation of the contour lines and colors is based on resistivity index and conductivity for materials inside the soil. Table 7 shows the resistivity index and conductivity for some common rocks, minerals and chemicals [20, 21, 22]. Based on Table 7, the predicted subsurface of Line 1 is dominantly underlain by very low resistivity value where the value less than 40 ohm.m with bluish color

which is interpreted as saturated zone or water filled area. For value of resistivity less than 40 ohm.m indicates that this area consists of wet material such as water with conductive solution such as leachate. Similarly, the subsurface of Line 2 is underlain by very low resistivity value with values less than 30 ohm.m (<30 ohm.m) at the center of the line which is interpreted as saturated zone or water filled area. This value indicates that this area filled with water that becomes saturated. Therefore, it is suspected that the underground condition of this line consist of water that filled the voids. In order to validate that there was water and cavity based on the electrical resistivity test and to determine the type of soil underneath the house, a hole was excavated using hoe at the car porch area as marked with dark arrow as shown in Figure 10. After digging the hole at this location until depth of 800mm, groundwater level was discovered at the car porch area as shown in Figure 9. There were several spring water holes coming out from ground beam which located underneath the house. This soil consists of clay, sand and limestone. A layer of clay which is located underneath the house kept the ground water level close to the surface of the soil. Clay has a small particle size less than 2 micrometer which can hold the water above it. Water molecules are strongly attracted to clay mineral surfaces and can distribute itself evenly throughout the water. The predominant clay mineral which has high swelling stress and soil suction can hold the water together [25]. Furthermore, it is believed that this housing area was a dumping site originally from a small stream before constructing this house. Moreover, lacking of proper soil investigation prior to the construction of houses also can lead to failure in selecting a suitable type of foundation which causes the settlement of buildings and houses [17]. Therefore, it is recommended that the cement-based grout to fill the cavities and underpinning with a solid foundation lay below ground level to support or strengthen the house.

Figure 10. Inverse model for resistivity image of Line 1 with 40m length inside the house at ground floor level

- 4) From the electrical resistivity survey, it shows that there are some cavities filled with water underneath the double-storey house and proof by excavating a hole at the marked place as shown in Figure 10.

- 6) It is recommended that the cement-based grout can be used to fill these cavities and underpinning with a solid foundation laid below ground level to support or strengthen the house before repair the cracks using sealant and epoxy resin.
