# Assessment of safety performance level on simple urban residential building: Case study at Bogor city Indonesia

### M Lutfi<sup>1</sup>, H Arien<sup>2</sup>, M Hendrawati<sup>3</sup>, P J Ramadhansyah<sup>4</sup> and N I Ramli<sup>4</sup>

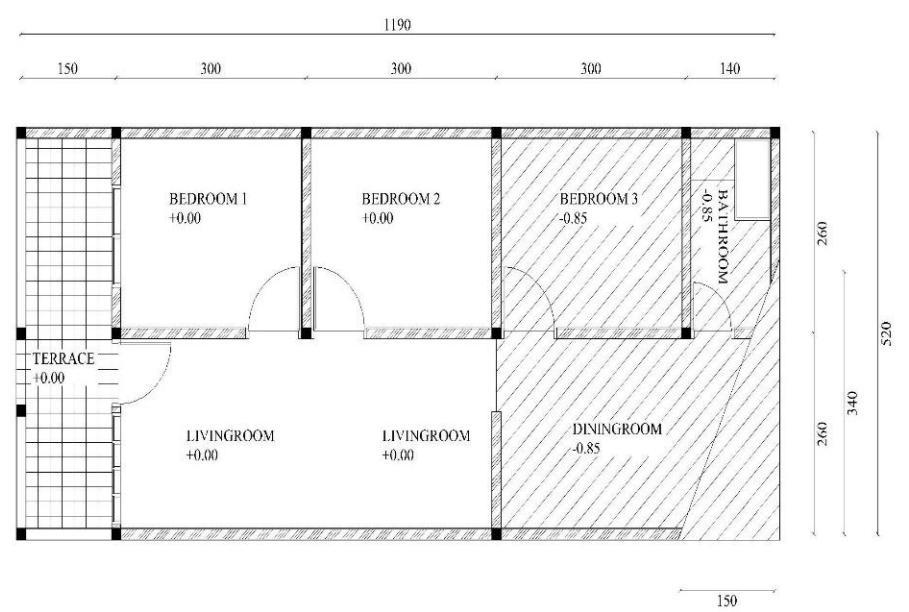
Figure 1. Existing residential building

The specifications of the existing residential buildings are 520 cm X-direction and 1190 cm Ydirection, 300 cm height Z-direction using 15x15 cm column dimension, 15x18 cm dimension beam, 17 MPa concrete (FC), 4D12 BJTP main reinforcement, and shear reinforcement D8-20, is in quake zone 4 with the medium type of soil (Figure 1).

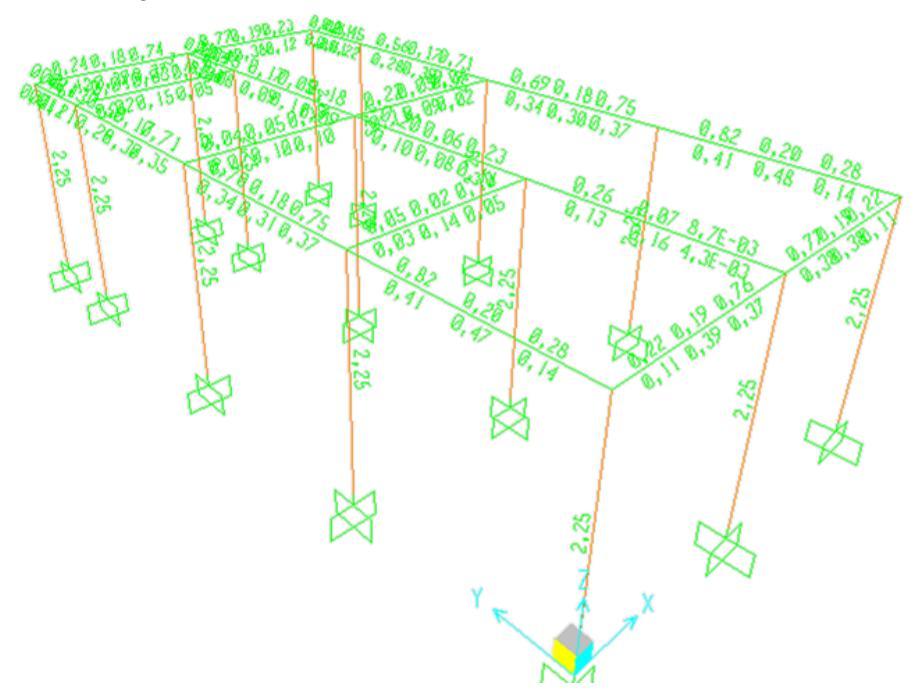
Figure 3. Modeling and analysis results

The result of modeling and structural analysis according to SNI 2847-2013 in a simple residential building is obtained for column structure element almost near the failure which is marked with orange color, while the beam structure element is declared safe marked with green color. Furthermore, the result of evaluation using SAP2000 V10 application refers to the FEMA 356 obtained value of displacement target of 0.02 m, which is categorized at the level of a safety performance of the building is at Life Safety (LS) level.

From the modeling, we performed a structural analysis with a load combination of dead load covering roof 3 m x 10.4 m x 50 kg/m<sup>2</sup>=150 kg/m<sup>2</sup>, ampig wall (1.54 m x 250 kg/m<sup>2</sup>) / 2 = 192.5 kg/m<sup>2</sup>, hanging = 11 kg/m<sup>2</sup>. Live load on roof = 100 kg/m<sup>2</sup>. Earthquake loads using spectrum response data based on the Public Works Research and Development Center [10,11,12]. The results of the load combinations analysis obtained for the column structure elements are almost close to failure which is indicated by orange color, while for the beam structure elements expressed which are indicated by the green color shown in Figure 3.

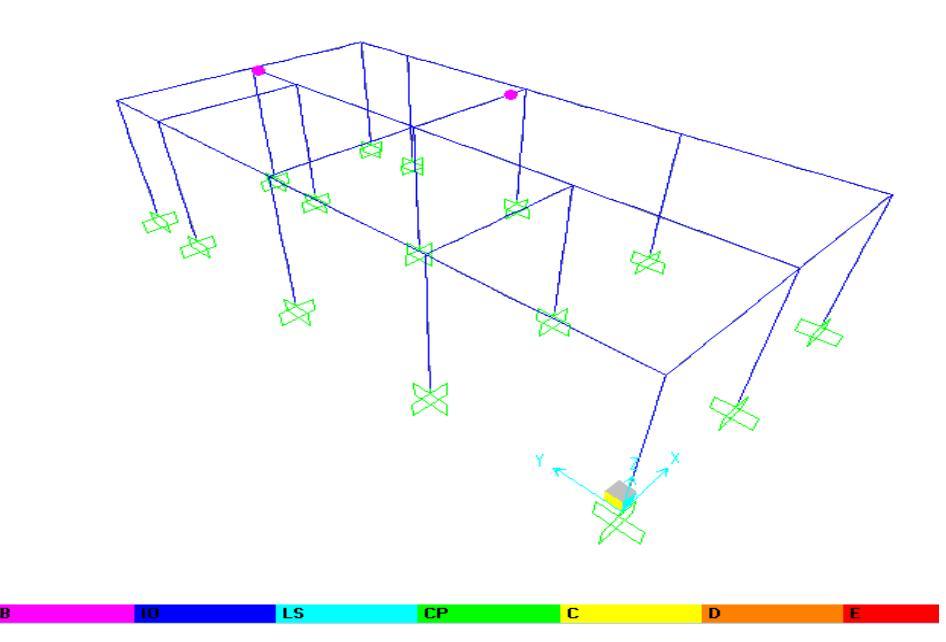
Figure 4. Plastic joints that occurs in step 1

Furthermore, modeling with FEMA 356 was obtained from the pushover method found in SAP2000 V10 to produce plastic joints in the beam and column structure elements. In steps 1 up to step 6 with colorful nodes shown in Figure 4 and Figure 5. Description of pushover color nodes in plastic joints is based on Table 1 which is divided into 7 levels described in Table 2. According Figure 5, the front part of the house is not able to withstand the shear and shattering forces, while the back part is still function. Therefore some reinforcement is necessary to keep the evacuation route through the house front.

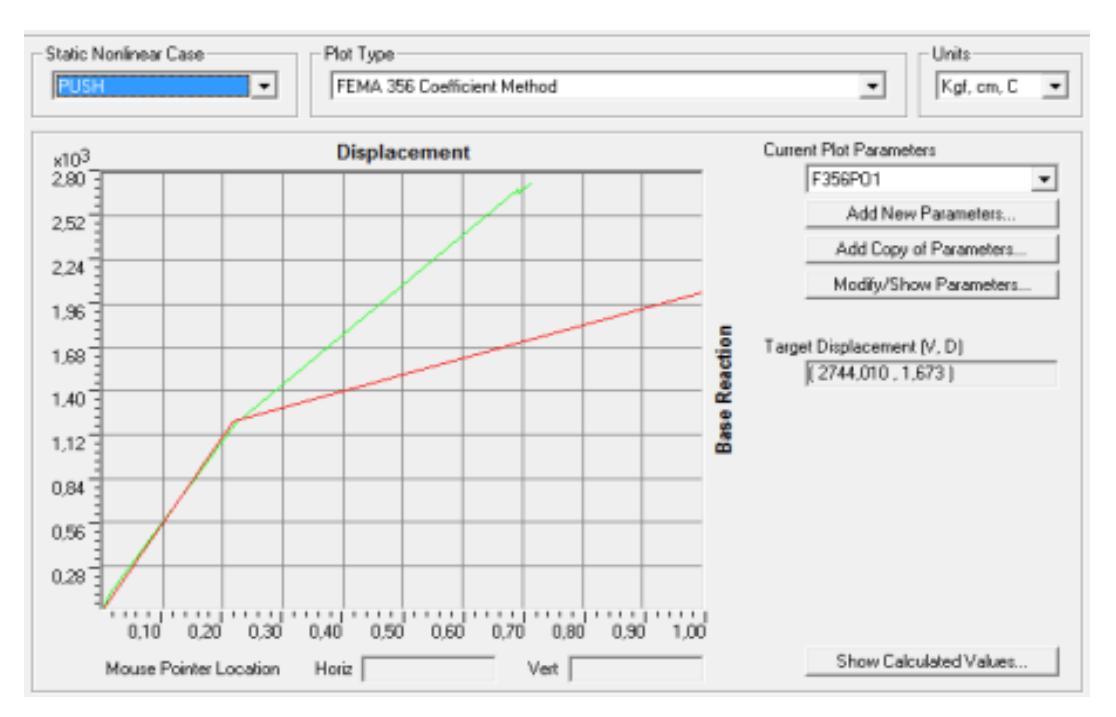
Figure 6. Pushover curve which refers to FEMA 356

Pushover also produces curves referring to FEMA 356 shown in Figure 6 and generates the values required for the displacement target ( $\delta$ T). The values obtained from the FEMA 356 curve are C<sub>0</sub> = 1.0; C<sub>1</sub> = 1.378; C<sub>2</sub> = 1.0; C<sub>3</sub> = 1.0; Sa = 1.011; and Te = 0.221.

Furthermore, the values are calculated using the equation (1) so that the result of the displacement target value is 0.02 m categorized under table 1 at the Life Safety (LS) performance level. This means

that if there is a movement of land, the structure of the house is stable and has adequate service capacity and damage non-structural part is still controlled.
