Tensile Behaviour of MWCNTs-Modified Epoxy Grout for Pipeline Repair

Abstract. Infill material in the pipeline repair system works by filling the gap that is usually caused by corrosion before the fibre wrapper can be applied for pipeline recovery. In this study, nanocomposites were prepared by adding a small amount of Multi-walled carbon nanotubes (MWCNT) to an existing commercial epoxy resin grout aiming to evaluate their behaviour regarding neat epoxy grout as infill material in composite repair for steel pipeline subjected to external metal loss. The dispersion of the nanoparticles in the epoxy resin has been conducted through ultrasonic and calendaring technique. The results of modified epoxy grout were compared to neat epoxy grout to identify if the MWCNTs are advantageous to existing materials. By comparing the results, 0.5% of MWCNT filler has significantly improved the strength by almost 53.3%. In addition, the results also indicate that MWCNT filler has increased the modulus of elasticity of the infill material. Furthermore, the morphologies image displayed that MWCNTs has been well merged into the matrix, and made the fracture cross section rougher through sharing the s

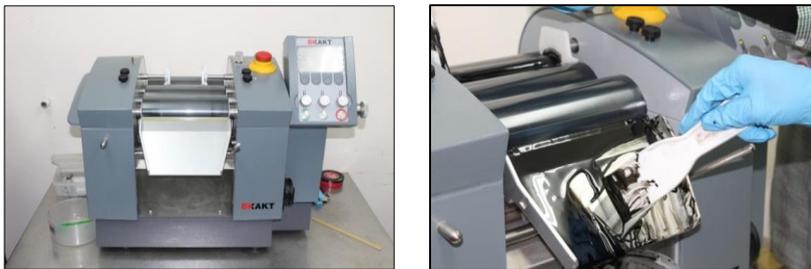
Fig. 1. Dispersion process using three-roll mill machine.

The preparation of MWCNTs-modified epoxy grouts was carried out by using specified weight percentage of carbon nanotubes (0.5%). The appropriate dispersion methods have been used in this study in order to fully utilize the unique features of this special material. Before the mixing process, carbon nanotubes were pre-dispersing in acetone solution using Hielscher Ultrasonic according to prepared weight percentage and were left evaporate for 24 hours at room temperature. It then followed by another dispersion using Three-roll mill (EXAKT 80E) with resin as shown in Figure 1.

The calendaring process was applied at five consecutive times. The mixture of resin and MWCNTs was poured directly into the first roll, sheared in Gap 1 and then in Gap 2. The sheared mixture was then manually poured back into the machine for the next process. The rollers turning at a speed ratio of 9:3:1 and the time taken for each calendaring was approximately 10 minutes. The gap size between the roller and the speed (represent the lowest speed) of three-roll mill process are represented in Table 2.

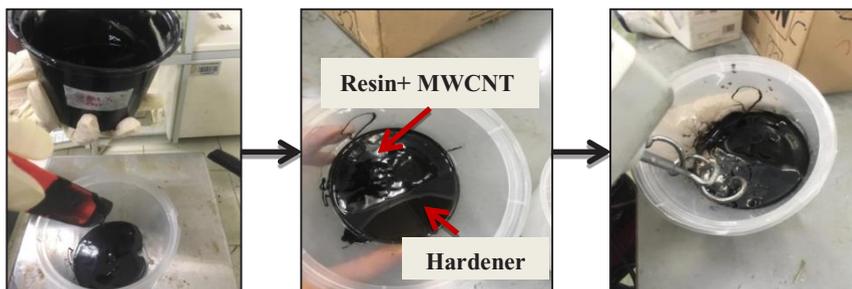
Fig. 2. Preparation of specimens.

Next, an electrical mixer was used to thoroughly mix the epoxy resin with hardener at low speeds in a clean dry container until a smooth consistency specimen was achieved as shown in Figure 2. Then, the mixture was poured into the designated moulds and left for 24 hours at room temperature.

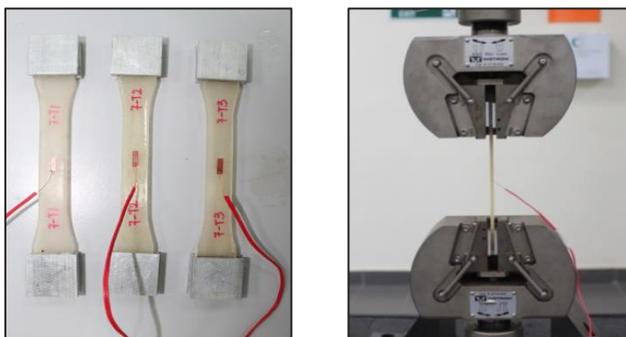
Fig. 3. Tensile testing using Instron machine.

The tensile test was performed by referring to the industry standards accordance with ASTM: D638 where five specimens are needed. Dumbbell or dogbone shaped specimens were used in this testing with a typical dimension of 13.0 mm x 3.2 mm, that is Type I where the failure is anticipated occur at narrow section [8]. The specimen was glued with strain gauges and connected to the data logger before placed in the grips of the universal tester at a specific grip separation. Then, the specimen was pulled until failure at a crosshead speed of 5.0 mm/min at room temperature. In order to minimize the tendency of the failure occurs out of the desired location, the end tab is suggested as an effective method for preventing premature failure at the grip length. The tests were carried out using an INSTRON 5567 Universal Testing Machine with 25KN of capacity. The procedure of tensile test was shown in Figure 3.

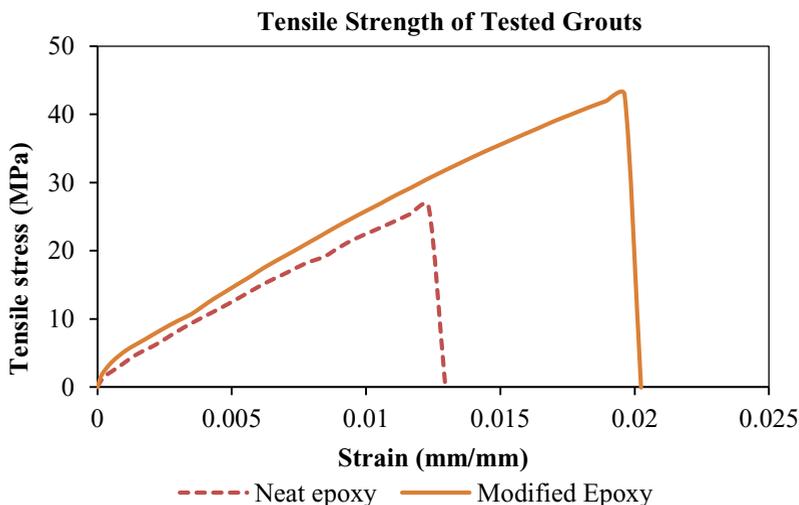
Fig. 4. Stress-strain curve of the tested grouts.

Figure 4 shows the typical stress curve for the tested grouts. These curves are generated from the load recorded on the Instron machine while the strain values are recorded from the data logger. As can be seen from the plotted graph, both tested grouts exhibit linear elastic stress-strain relation in the initial region up to its ultimate strength before failed and there is no plastic deformation detected. The tensile ruptures failure pattern corresponding to each tested grout is presented in Figure 5. All grouts have undergone fracture due to splitting which is perpendicular to the length of the specimen. The failure of tensile specimens occurred without noticeable deformation.

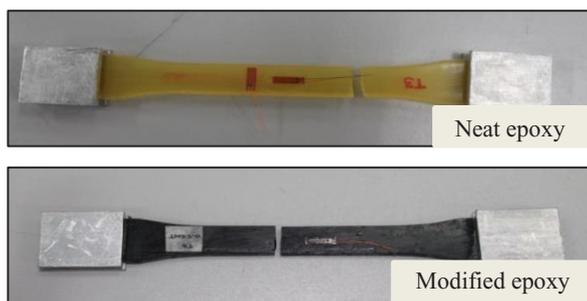
Fig. 5. Failure pattern for the tensile test.

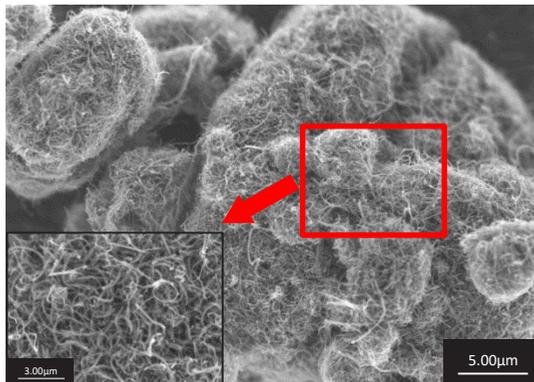
Fig. 6. FESEM imaged of Pristine MWCNTs.

The degree of dispersion of the filler inside the matrix is evaluated by morphological characterization through the Field Emission Scanning Electron Microscopy. It is well known that a uniform dispersion of the filler is a major concern, especially when using nanomaterial. Figure 6 indicates a highly entangled network of pristine MWCNTs before underwent dispersion process. Due to Van der Waals forces acting on the wide exposed surface of the nanostructures, carbon nanotubes particles tend to agglomerate. Figure 7 shows the fracture cross-sectional of FESEM images of the neat epoxy resin and the MWCNTs-modified epoxy grout. As shown in Figure 7, the fracture cross section of the neat epoxy resin shows a very smooth fracture surface but the fracture cross section of the MWCNTs-modified epoxy grout demonstrated a rough profile. From observation, the majority of MWCNTs was dispersing into the small broken segment and ranging out of the epoxy resin. These indicate the strong interfacial strength between MWCNTs and resin matrix, which prevents MWCNTs from being pulled out [11]. Thus, effectually improve the mechanical properties of modified epoxy grout.

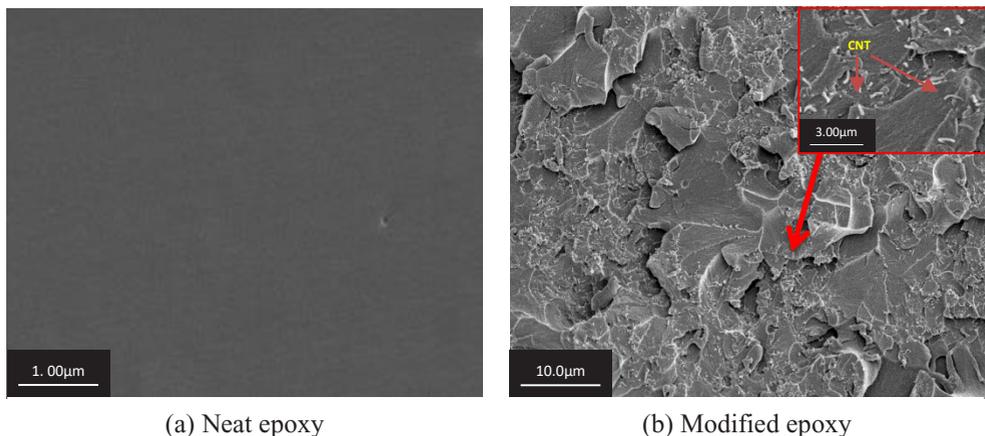
(a) Neat epoxy

(b) Modified epoxy

Fig. 7. FESEM imaged of (a) neat epoxy grout and (b) MWCNTs-modified epoxy grout.
