FAILURE ANALYSIS OF DRIVESHAFT OF TOYOTA SEG

**A report submitted in partial fulfilment
of the requirements for the award of the degree of
Bachelor of Mechanical Engineering**

**Faculty of Mechanical Engineering
Universiti Malaysia Pahang**

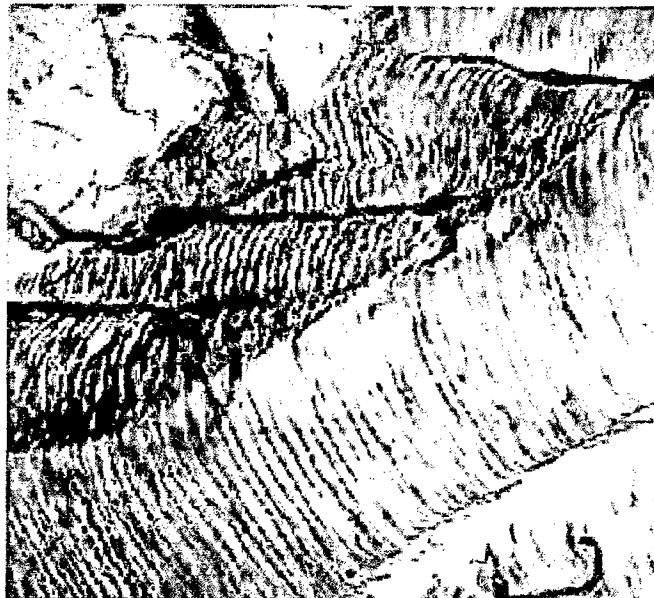
Figure 2.7: An example of the striations found in fatigue fracture.

Other features of a fatigue fracture are Beachmarks and Striations. Beachmarks, or clamshell marks, may be seen in fatigue failures of materials that are used for a period of time, allowed to rest for an equivalent time period and then loaded again as in factory usage. Striations are thought to be steps in crack propagation, where the distance depends on the stress range. Beachmarks may contain thousands of striations. Visual Examples of Beachmarks and Striations are seen below in Figure 2.6 and 2.7.
