Mechanical Properties of Graphene-Modified Epoxy Grout for Pipeline Composite Repair

Abstract: In general, when the pipeline experiences metal loss on the external surface, epoxy grout has always be used to fill the gap before fibre reinforced composite can be applied to recover the pipeline strength. In this research, the existing commercially available epoxy grout has been strengthened using graphene nanoplatelets (GNPs) at the amount of 0.1wt% to enhance its mechanical properties. Various mechanical tests were conducted on this modified epoxy grout to identify the compression, tensile, flexural and shear properties and were compared to the neat epoxy grout to observe its potential improvement. GNPs were dispersed using a sonication process followed by three-roll milling technique to ensure a uniform and homogeneous dispersion within the epoxy matrix can be well achieved. The experimental results clearly show an improvement in the strength and Young's modulus especially for tensile, flexural and lap shear test by incorporating GNPs as additives. The presence of GNPs has a significant reinforcement effect and has succeeded in increasing the ductility of the grout, thus reducing i

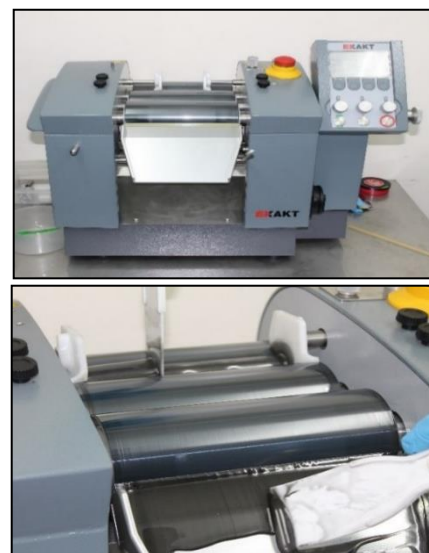
Fig. 1 Dispersion using three-roll mill machine.

A weighted amount of GNPs was prepared at the desired concentrations. First, the GNPs were pre-dispersed in an acetone solution for 45 minutes using Hielscher ultrasound sonicator and were left to evaporate for 24 hours at room temperature. Then, GNPs was mixed with resin until it was homogeneously distributed. The epoxy/GnP mixture was further dispersed using a three-roll mill machine (EXAKT 80E Advanced Technologies GmbH) to achieve homogeneous dispersion as shown in Fig. 1. The epoxy/GnP mixture was poured into the gap between the feed roller and centre roller and transported to the third roller as shown in Fig. 2. The dwell time of graphene suspension on the roll was approximately 1 minute while graphene was dispersed in the resin by enormous shear forces resulting from the rollers turning at a speed ratio of 9:3:1.

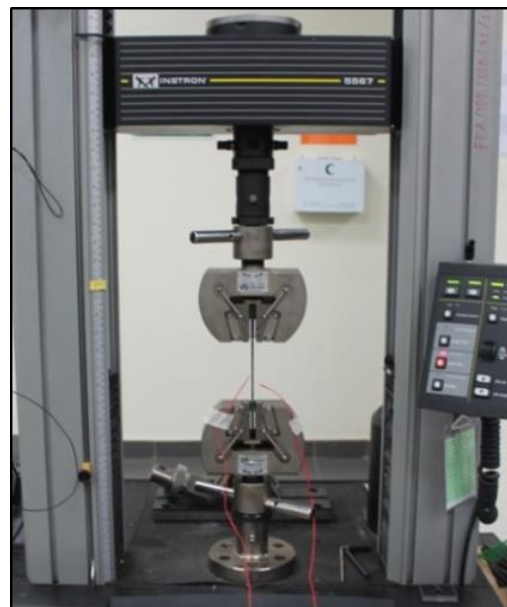
Fig. 5 Universal Testing Machine (INSTRON 5567)

Mechanical tests need to be carried out to determine the properties of modified epoxy grout and to investigate the contribution of graphene as nanofiller. INSTRON 5567 Universal Testing Machine with 25KN of capacity is used to test the specimens until failed as shown in Fig. 5.

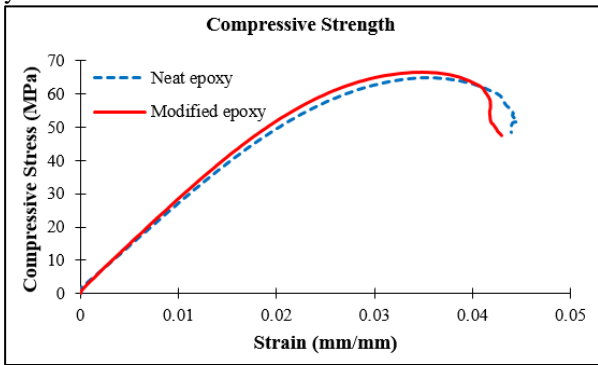
Fig. 6 Stress-strain curve for compression test

The stress-strain curve under a unidirectional compression load was depicted in Fig. 6. All grouts showed comparable strain value with similar behaviour to one another starting with linear elastic behaviour during the initial loading stage until it reaches ultimate compressive strength, followed by a strain softening and plastic deformation. Based on the graph, both grouts demonstrated ductile behaviour and no sudden failure occurs. Fig. 7 presents the failure patterns of the tested grouts. After the initial elastic behaviour, both grouts exhibit ductile behaviour with visible deformation. The specimen exhibit buckling and initial crack when the maximum stress occurred, and then the stress is gradually reduced prior to failure. This failure pattern can be seen at the top and bottom of the specimens for both grouts.

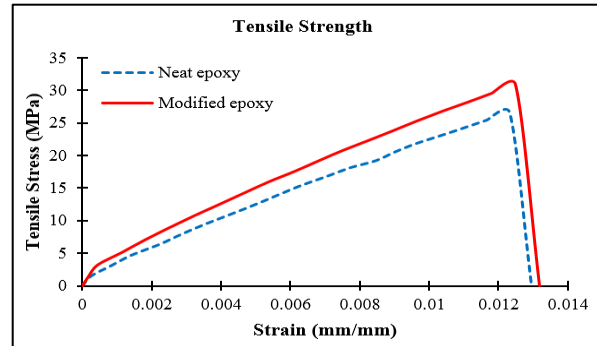
Fig. 8 Stress-strain curve for tensile test

Tensile properties of the test are summarized in Table 4 and Figure 8 illustrates the stress-strain curve under tensile loading conditions. Based on the results, the tensile strength of the modified epoxy grout is found to increase with the inclusion of 0.1wt% graphene nanoplatelets. A maximum increment of 24% in the tensile strength of modified epoxy grout is observed with 32.64 MPa as compared to neat epoxy grout with 26.42 MPa. It can also be noticed that graphene nanoplatelets has improved the tensile modulus of the neat epoxy grout. A gain of 14% in the tensile modulus is observed in the modified epoxy grout from 2.21 GPa to 2.52 GPa. As depicted in Fig. 8, the stress-strain curve for all grouts demonstrated comparable behaviour where linear elastic behaviour was observed from the beginning of the testing until the specimens reach ultimate tensile strength up to failure, indicating the brittleness of the grouts.

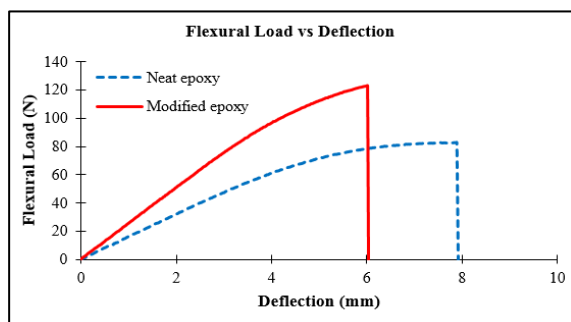
Fig. 10 Load-deflection curve for flexural test

Fig. 10 presents a comparison of the load-displacement curve for flexural specimens. Both tested grouts show linear elastic behaviour prior to failure. The modified epoxy grout exhibited higher flexural load but slightly lower in deflection and this behaviour is contrary to the neat epoxy grout with lower flexural load but has higher deflection value. Under flexural load, the incorporation of GNPs into the epoxy grout increases the surface area to volume ratio. GNPs has the capability of high endurance to deform during loading, thus enhances more loading ability and increasing the stiffness of the epoxy grout while decreased its deflection. The failure pattern of the neat and modified epoxy grout was presented in Fig. 11. It is observed that all grouts show similar failure pattern under flexural test with relatively prolonged deformation. The specimens were observed from the beginning of the test until the failure occurred and based on the observation, it showed that the crack formation was initiated at the middle of the specimen and forms a visible wedge.

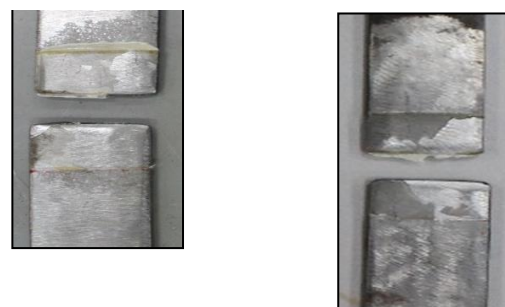
(a) Neat epoxy grout

(b) Modified epoxy

grout

Fig. 12 Failure pattern of shear test

It shows that the inclusion of graphene nanofiller gives a higher shear bonding compared to grout without nanofiller. In addition, the modified epoxy grout shows the highest load during failure recorded at 2.06 kN while the neat epoxy grout failed at load 1.86 kN. Figure 12 presents the failure pattern of the tested grouts. As depicted in the figure below, both grouts show similar failure pattern as some parts of the matrix remains attached to both surfaces of the steel coupons, indicating cohesive shear failure. This behaviour implies that the bonding between the matrix and the steel coupon is much stronger than the strength of the matrix itself [35].
