PEDESTRIAN FACILITIES FOR
WHEELCHAIR USERS AT UTC AREA
KUANTAN

Bachelor in Engineering Technology
Infrastructure Management (Hons)

UNIVERSITI MALAYSIA PAHANG

Thesis submitted in partial fulfillment of the requirements
for the award of the degree of
Bachelor in Engineering Technology Infrastructure Management (Hons)

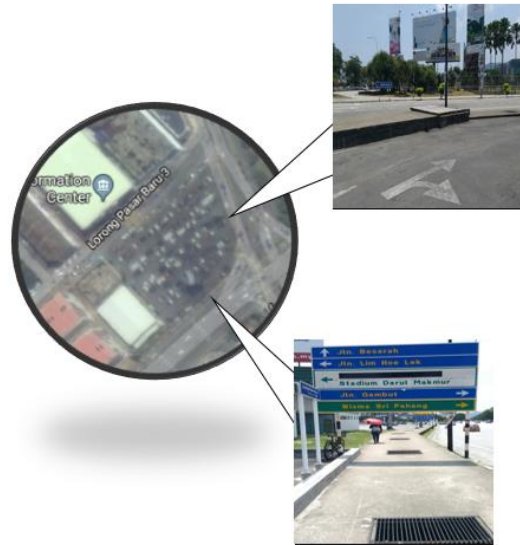
Figure 4.5.3: Zone 3

Zone 3 is a walkway surrounding the parking space area and this walkway is very long. This walkway is located right off the main road. Actually at the beginning it is a drain cover which have multi-function that became the walkway and can be used by the public.

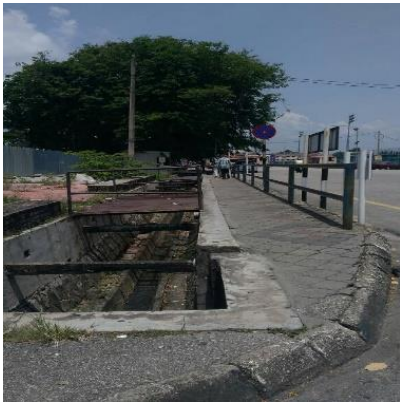
Figure 4.6.1.a: Block type

There is 2 type of the pavement at zone 1 which are the block type is at the private land walkway and the second type which is the tile at the rapid terminal walkway. The pavement of the walkway at the zone 1 is very poor and unsafe. First of all, the pavement type at the private land walkway is a block pavement where it is non-slip pavement and suit for the wheelchair users to use it. However, there is lack of the safety factor and it will harm the wheelchair users and others. There are many holes and obstacle at the middle of the road. The condition of the walkway are very poor where there is the holes, poles and the width of the walkway also not follow the standard. The surface of the walkway is uneven and some part of the road is very sloppy and it can cause the wheelchair users slip into the drain that just beside the walkway.

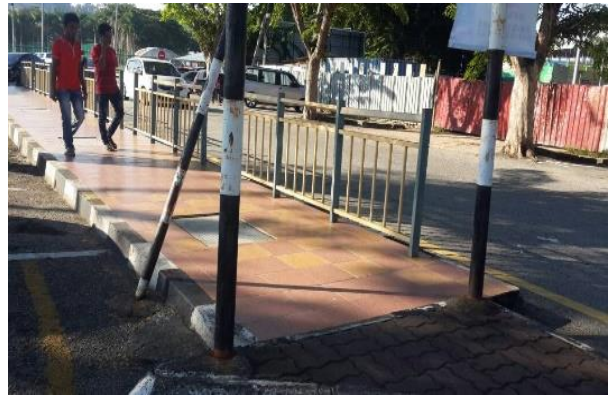
Figure 4.6.1.b: Tile type pavement

Secondly, the pavement type at the rapid terminal is tile pavement. The tile pavement is very slippery and can cause the public to skew when rainy day. Besides that, it also danger for the wheelchair users because the possibility for them to slip is very high when the pavement is to smooth. Along the walkway there's is the obstacle at the middle such as the pipe and hole. All the obstacle will not allow the wheelchair users to use the walkway

and even danger for the normal people itself. The safety factor at this walkway is very poor and dangerous.

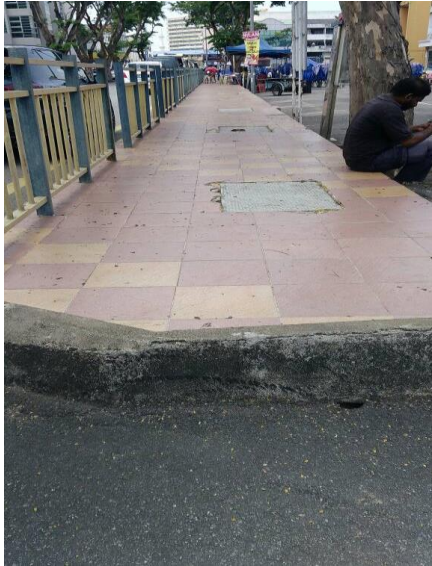
Figure 4.6.2.a: Walkway A

Walkway A is one of the main walkway and usually used by the public because there is beside the market. User will coming from the market walking through the walkway A to go to the parking lot. The pavement type at walkway A is a tile pavement. Tile pavement is not suitable to use for the uncover walkway because when rainy days the rain water will cause the pavement become slippery and its will harm the people that are coming out from the market because market is a very wet place. Other than that, it is not desirable for the wheelchair users to use the tile pavement. Besides that, along besides of walkway A there is the night market and “Pasar Pagi” in every weekend. The seller usually will put their stuff at the edge of the walkway. Their action will effected and trouble to the wheelchair users to use the walkway because of the limited space. There is no barriers along the walkway A other than weekend. However the safety factor at walkway A is low where there is no divider from falling and not even kerb at the side of walkway since the walkway is quite high. It will danger the wheelchair users because they need all the item as precaution for them if fall or slip.

The standard measurement for walkway A should be 1800 mm for the constant two-way traffic and 1500 mm for the frequent two-way traffic. The result of measurement for

walkway is 2000mm which is pass because it is more than 1800 mm. Nevertheless, walkway A still not suitable for wheelchair users because lack of safety factor. In addition the standard measurement for walkway B should be 1500 mm x 1500mm to 1600 mm x 2150 mm. The real measurement on the site is 1900 mm more than the standard so its pass and suitable for wheelchair users.

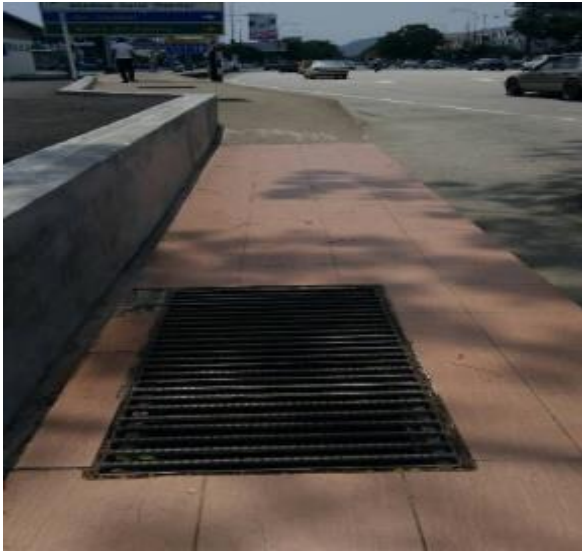
Figure 4.6.3.a: Walkway that connecting Zone 2 and Zone 3

Walkway at zone 3 is the longest walkway and there are a lot of the obstacle and barriers along the walkway. The walkway have an even surface that is good for wheelchair users. However along the walkway there is the barriers of 2 signboard, 2 litter bin and the grading. All the barriers are located at the middle of the road which this can block the route of the wheelchair users. The presence of this barrier will limit the space. On the other hand, wheelchair users need an enough space to ease them to move around. Grading will become a barriers when the direction is wrong because it will cause the wheel of the wheelchair stuck at the grading. So, the direction must be correct to avoid any incident happen.

The measurement of the walkway must be correct by following the standard. The standard measurement for the walkway are 1800 mm for the constant two-way traffic and 1500 mm for the frequent two-way traffic. The actual measurement at the site are 2900 mm which more than the standard so the measurement part is pass. However, the standard of the walkway must be barriers free and can be access by everyone. This walkway not applying the concept of barrier free and it also lack of the safety factor where there is no kerb at the edge of the walkway since the walkway is quite high too. The function of the kerb at the edge of the walkway is to avoid the wheelchair users from fall aside the walkway. The material of the walkway is pass because it suit the wheelchair users where it is not slippery.

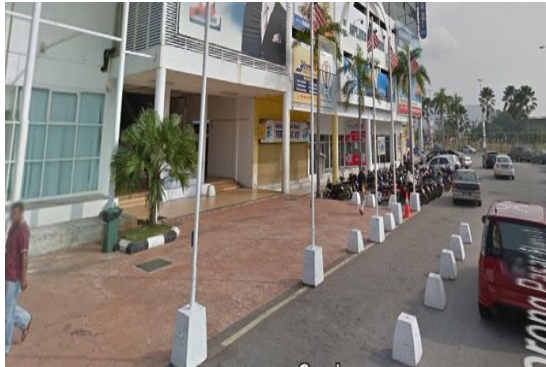
Figure 4.6.4.a: Walkway A

ramp provided by the wheelchair users and the only facilities provided is only the stairs. However the pavement at the UTC area is suitable which the tile pavement and it is the non-slip type of tile. So the possibility to fall or skew is low.

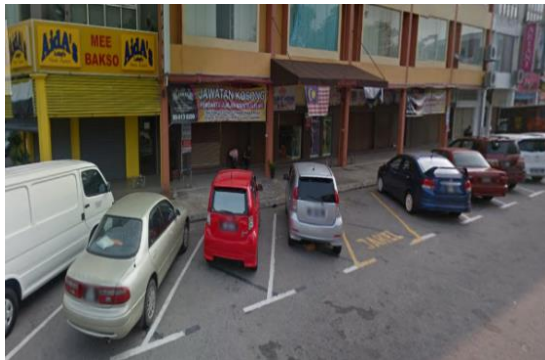
Figure 4.6.4.d: Walkway C

Walkway C will be cover on the shop lot where there are located of Aida restaurant, Jakel Kuantan and 7 eleven. The pavement use for this walkway is mixture pavement half is a concrete pavement and another half is a tile pavement. The walkway in front of the Aida restaurant is concrete pavement and it is uncover walkway. So the material of this pavement is suitable where is non-slip and not slippery for wheelchair users. Next the other half is a tile pavement where this type of pavement is under the roof and covered from the weather.

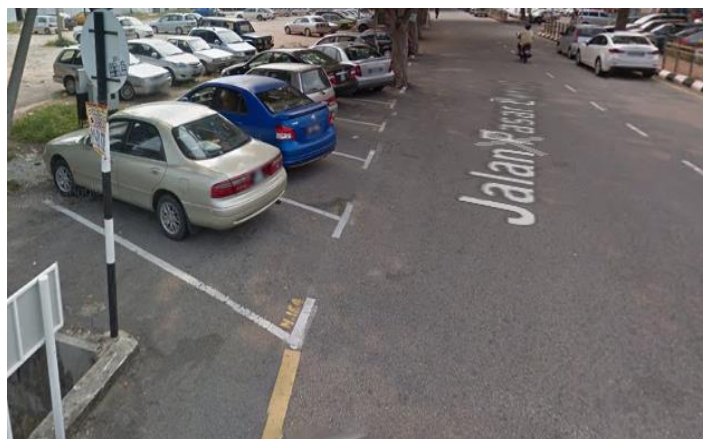
Figure 4.7.1. a: Parking space at zone 1

At zone 1, there is the location of the private land and still have the new building that is under construction. The nearest facilities is a rapid terminal and also the food stall. The parking lot also provided at the private land. The problem is the parking lot provided far from the terminal and the food stall. Besides, the wheelchair users need to cross the road to go to the nearest facilities. It is very dangerous because at that location the traffic is busy and near to the junction. The driver might not see if the wheelchair users cross the road because their move movement is limited and slow. However, at zone 1 there is no people with disabilities (PWD's) parking provided.

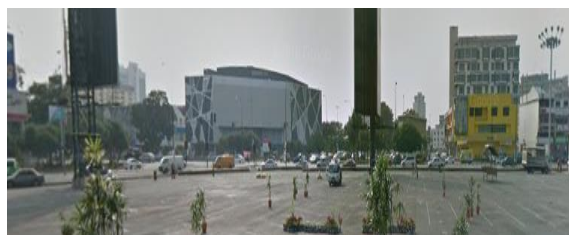
Figure 4.7.3.a: Parking space at Zone 3

The location of zone 3 is the parking lot area in front of the UTC Kuantan. This parking is a paying parking lot so there's is provided the payment counter for the customer. Besides that, at the entrance there is provided the automatic parking ticket machine. Even thought, this parking space areas are very spacious the only problem at this zone 3 is a no parking lot provided for PWD's. The standard for the height of automatic parking ticket machine is between 800 mm to 1100 mm.

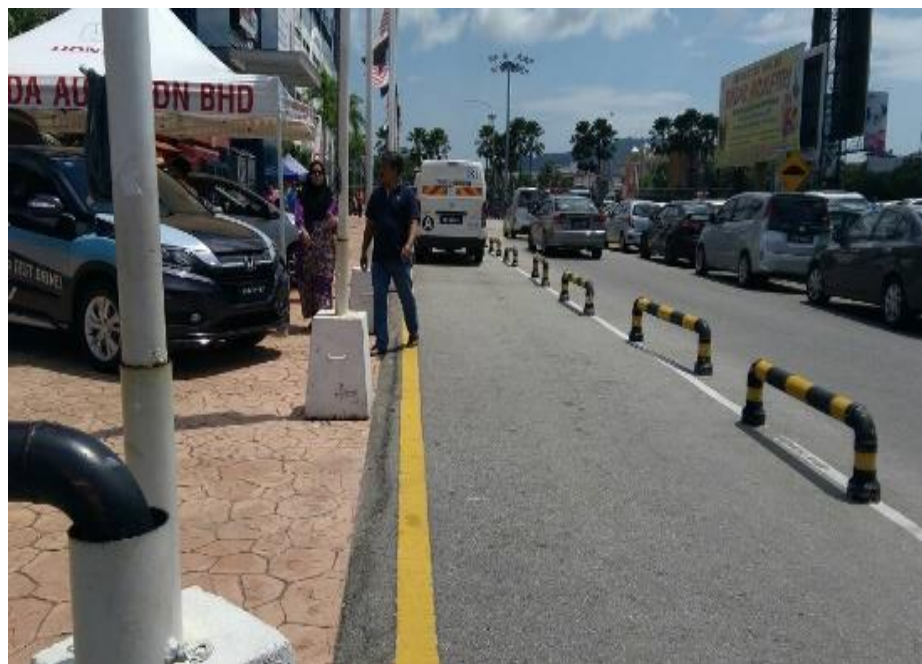
Figure 4.7.4.a: Parking space is block

Zone 4 is at the UTC building, Complex Teruntum and the shop lot where location of the Jakel, Aida's restaurant and any other shop. The area include in zone 4 is huge so the parking space is separate. In front of the UTC Kuantan building there is provided one parking lot for PWD's.

The measurement for the PWD's parking in front of the UTC Kuantan building is 4900 mm x 3000 mm and transfer space is 1100 mm. The signboard for PWD's parking is provided and complete with the PWD's parking symbol. The parking space also have been block and it will not allow the wheelchair users' car to park at the PWD's parking space. So the amount of the parking space is pass but the measurement is failed because it not follow the standard. Next, at the other building such as at the Hotel Makmur, back of the UTC Kuantan and at the shop lot there are no PWD's parking provided.

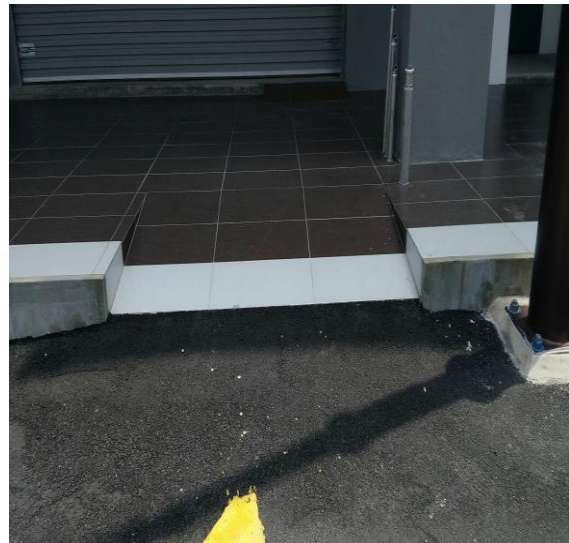
Figure 4.8.2. b: Kerb ramp

Next are the kerb ramp at the shop lot, since this shop lot is a new building and have 2 building so the kerb ramp that is provided is 6 in total. The kerb ramp position also correct at the near with the parking and connected to the entrance of the building, the corner of the walkway and at the end of the walkway. Besides, at the shop lot there is the zebra crossing and the kerp ramp provided is connected to the zebra crossing. This facilities is very useful for wheelchair users to cross the road safely.

The kerb ramp at the shop lot is connected with the entrance of the building. The measurement of the kerb ramp is 700 mm height, 2200 width and slope is 2920 mm. The standard that has highlighted by the MPK when the rise is more than 500 mm the maximum length between landings should be 6000 mm with the maximum slope 5.0% and the width is minimum 1000 mm. So the ramp at shop lot is fail because the slope is not reach the slope percentage.

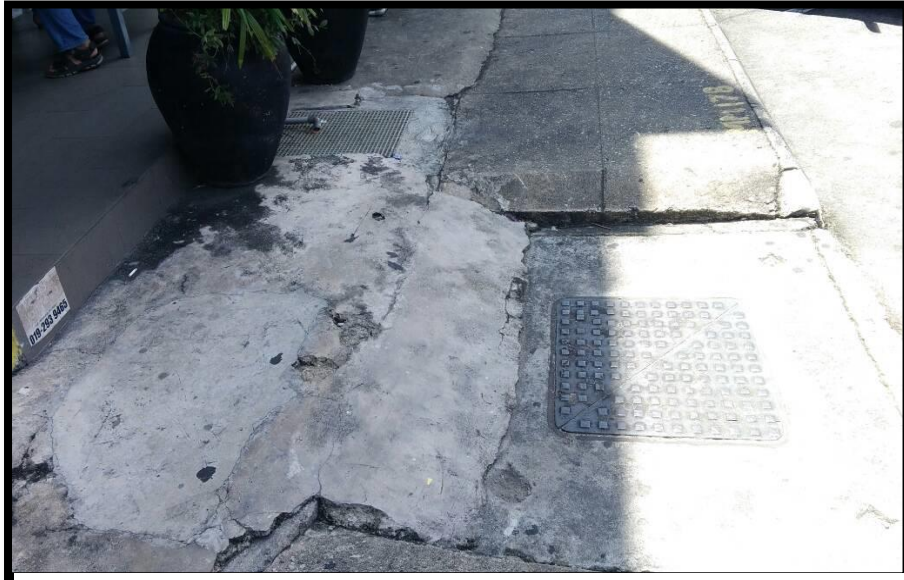
Figure 4.8.4.b : No kerb ramp provided

In addition, UTC Kuantan and Complex Makmur walkway is connected but it have a different level of walkway the only facilities provided is a stairs. The wheelchair users can't even go through the walkway because no ramp provided. Next the walkway is stop at the Complex Makmur so there is no connectivity. The walkway is continue at Hotel Makmur and at the beginning of the walkway there is no kerb ramp provided until at the middle of the walkway there is a kerb ramp provided. The measurement of the kerb ramp is 900 mm width, 50 mm height and 320 mm slope. Besides that, at the shop lot where there is the location of Aida's restaurant and other more there is no ramp provided. So wheelchair users can't even access to the walkway and very hard for them to go at this location alone without any assistant. This is the main problem face by the wheelchair users because lack of the facilities for them and sometimes the existing facilities provided is not follow the standard, so they can even use it.

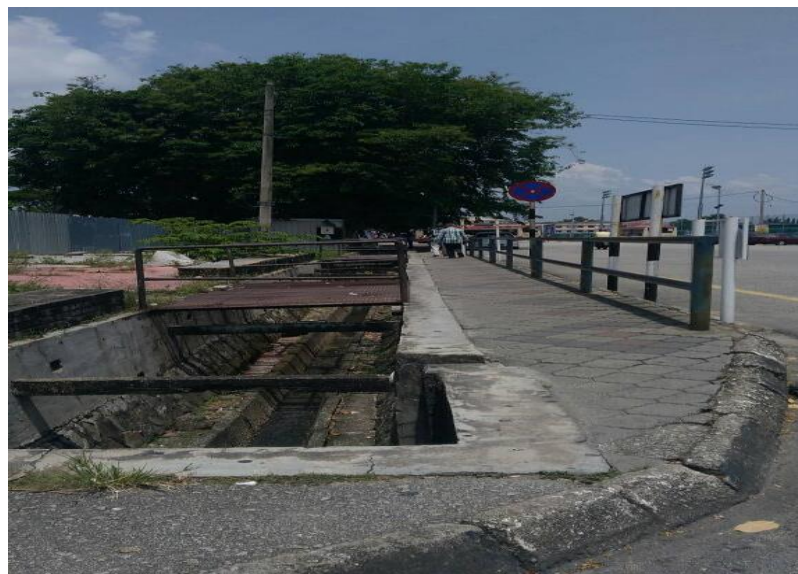
Figure 4.9.1a: Handrail only provided at one side and no passing space and improper drain cover

Zone 1 is the walkway that cover from private land to the rapid terminal. First of all, walkway at the private land have a drain beside the walkway. The drain is big and not maintain well because there is no drain cover at that drain. Besides that, the handrail are available only next to the side of the main road but not available in the separator drain and walkway. The handrail must be provided at both side of the walkway because the level of the walkway is uneven and it may cause the wheelchair use falling down to the drain. This situation is very dangerous for wheelchair users. The drain cover must be provided and the existing handrail must be replace because the old one already rusty and damage.

So, the handrail need to replace with the new one and must follow the standard. The walkway at zone one is quite long so the passing space must be provided. The actual situation at this zone is no passing space for wheelchair users and the walkway width also not follow the standard.

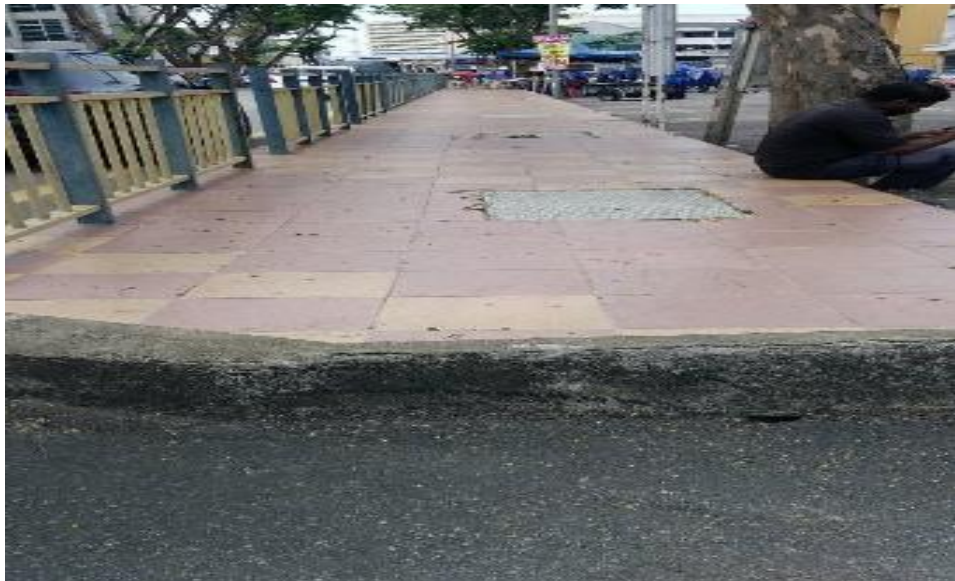
Figure 4.9.2.a: Handrail only provided at the side of the walkway

Zone 2 is the location at the side of the market and the shop lot. The walkway at the market have the gap between the walkway and the ground level. The walkway have the handrail at the side of the walkway which is the separate between the walkway and the road. Next the walkway must have a kerb at the edge of the walkway because it is to prevent the wheelchair users from fall. The existing handrail at this zone is not follow the standard because the shape is rectangle hard for wheelchair users to hold it and it already damage. Next at this zone there is no drain cover so that will not cause the problem for wheelchair users. Besides that, there is also no passing space for wheelchair users since the walkway is long so the passing space should be required.

The other location of zone 2 is at the shop lot where at this area there have many kerb ramp. Shop lot usually is an open space so no handrail needed at this area. Next the drain cover use at this area also follow the standard which is not harm the wheelchair users.

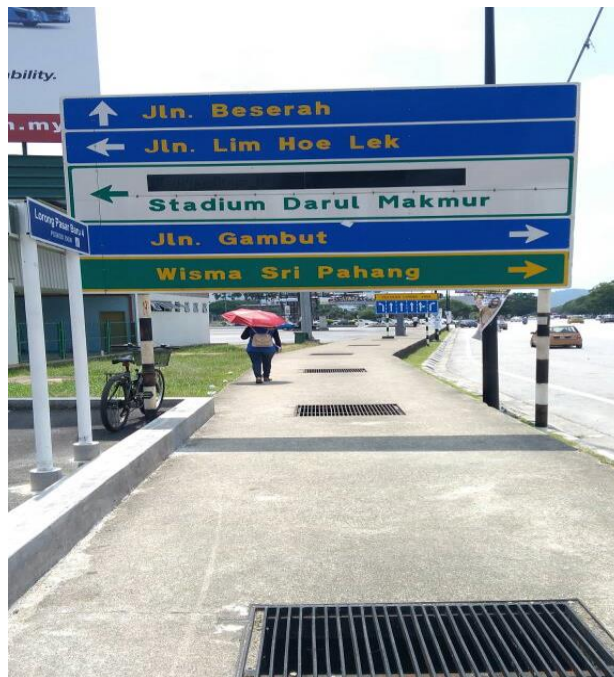
Figure 4.9.3.a: No handrail provided, no passing space and drain cover is wrong direction

Zone 3 is the longest walkway and have a ramp at the beginning of the walkway. The handrail must be provided at the ramp because the length of the ramps more than 800 mm that is already stated in The Universal Design, Town and Regional Planning of Peninsular Malaysia, 2012. There is no handrail provided at this zone and it will cause a problem for wheelchair users because they may fall if no safety precaution provided. The ramp without handrail will cause difficult for wheelchair users up on the walkway because they need the support when they want to go to the high level.

Next is the drain cover at zone 3. There are man of drain cover at this zone and type of drain cover use is the grading type. The problem occur when the direction of the drain cover is incorrect which will cause disruption of the smooth movement especially wheelchair users. There is also no passing space provided at this zone because the width of the walkway is already enough for wheelchair users.

Zone 3 walkway is improper because the handrail need to be provided at the ramp, the kerb need to be provided at the edge of the walkway and the drain cover but be at the correct direction to avoid any trouble for wheelchair users.

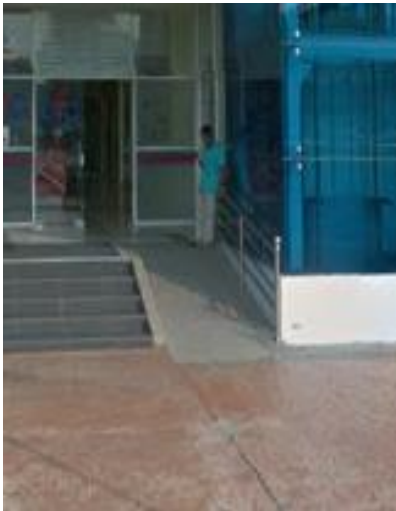
Figure 4.9.4. a: Handrail provided

Zone 4 is the location where there is the building and the building is connected to each other. The handrail is provided at the ramp and the handrail have two size and the measurement is 200 mm diameter for the big size and 130 mm for the small size. The size is too big because the standard diameter for handrail is 40 mm-60 mm only. There is no problem on drain cover at this area because mostly the drain is cover with a concrete because it is part of the walkway of the building. The passing space also no need because the width of the walkway is big enough.

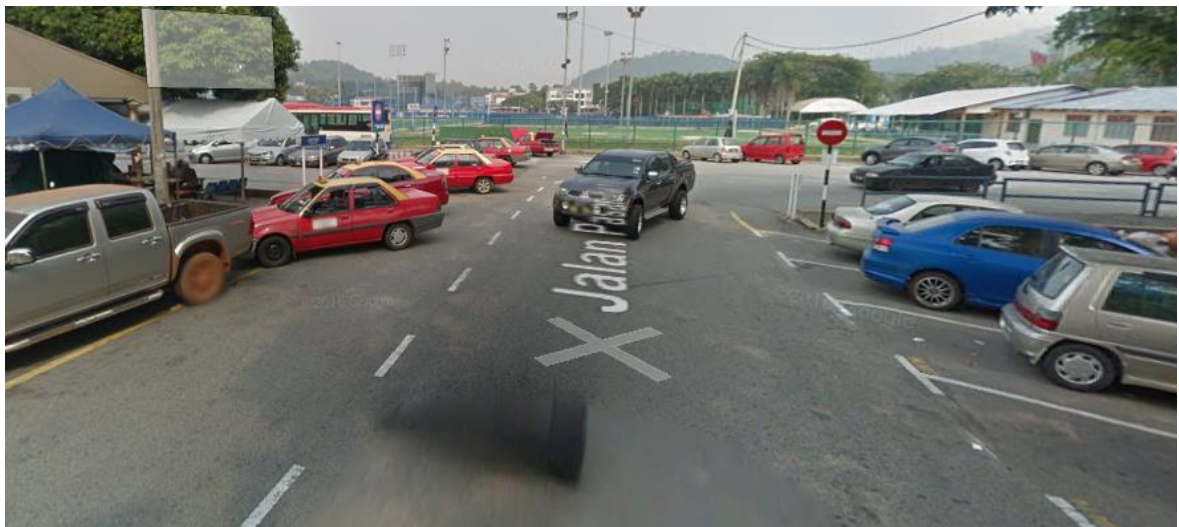
Figure 4.10.1 a: Zebra crossing should be provided at this Zone 1

Zone 1 have two walkway which are at the private land and rapid terminal but the walkway is not connected to each other. There is connectivity problem between the walkway and problem occur when the wheelchair users itself will face the problem when they want to cross the road. They zebra crossing need to be provided because it will ease the journey of wheelchair users and to keep them save.

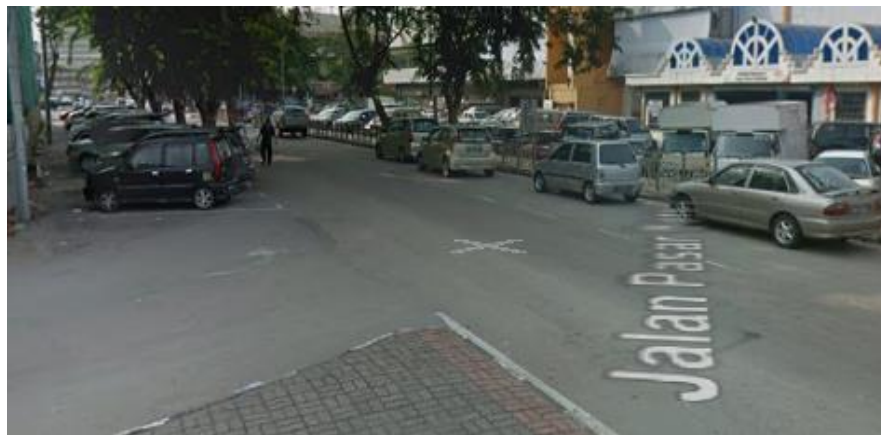
Figure 4.10.2.a: Zebra crossing should be provided at zone 2

Zone 2 also have two walkway are at the side of the market and at the shop lot. The walkway is not connected because there is no zebra crossing provided. So, this mean that there is no connectivity at this walkway. The real situation at this zone is no zebra crossing provided and the walkway is not connected because separated by the road the zebra crossing is required. However, at the road in front of the shop lot there is zebra crossing provided which it is connecting with the walkway 3.

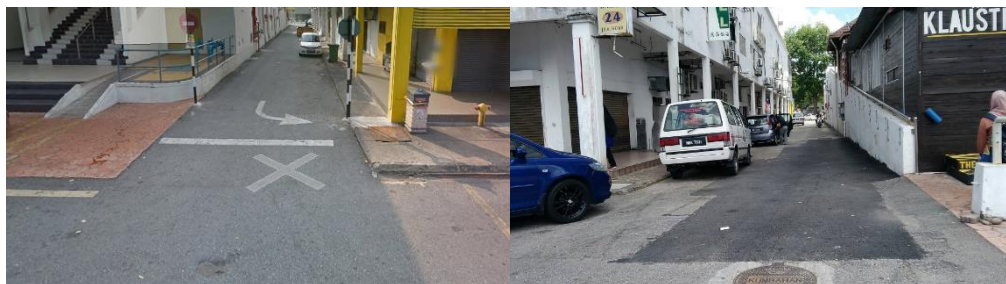
4.10.4.a : Zebra crossing should provide at the Zone 4.

Zone 4 is there are the building such as UTC Kuantan, Complex Makmur, Hotel Makmur and shop lot. At this zone the only zebra crossing provided is only in front of the UTC Kuantan which is connecting between zone 3 and zone 4. Besides that, the walkway between the buildings is very improper because there is no connectivity and walkway is intermittent. The zebra crossing need to provide between the gap of the building for example between UTC Kuantan and shop lot. So that, it will encourage wheelchair users to use the walkway because it is more safe.
