CHAPTER 1

INTRODUCTION

1.1 BACKGROUND

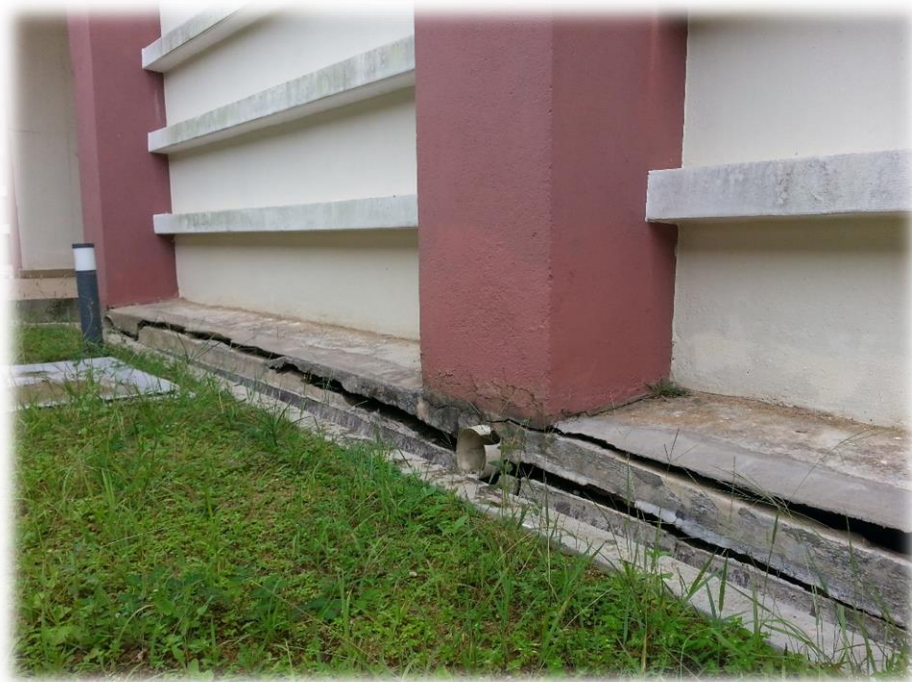
Figure 1.2: Cracked formed on the building structural

The problem at this study area were issuing the seriously cracked occurred on building which induced by the slope failure. This building was made up of two levels with a total built up area of 5,555 m². The pretentious of the slope stability was mainly caused by improper compaction of slope before the building construction which made in an initially investigation from Kumpulan IKRAM Sdn. Bhd. (geotechnical department). This issue had also affected the education environment of students near IIUM, Indera Mahkota, Kuantan Campus. The building which are loading directly on the slope has resulted of the cracked formation inside and outside the building structure.
