ASSESSMENT OF BEACH  
MORPHOLOGICAL CHANGES AT PANTAI  
SEPAT

B. ENG (HONS.) CIVIL ENGINEERING

UNIVERSITI MALAYSIA PAHANG

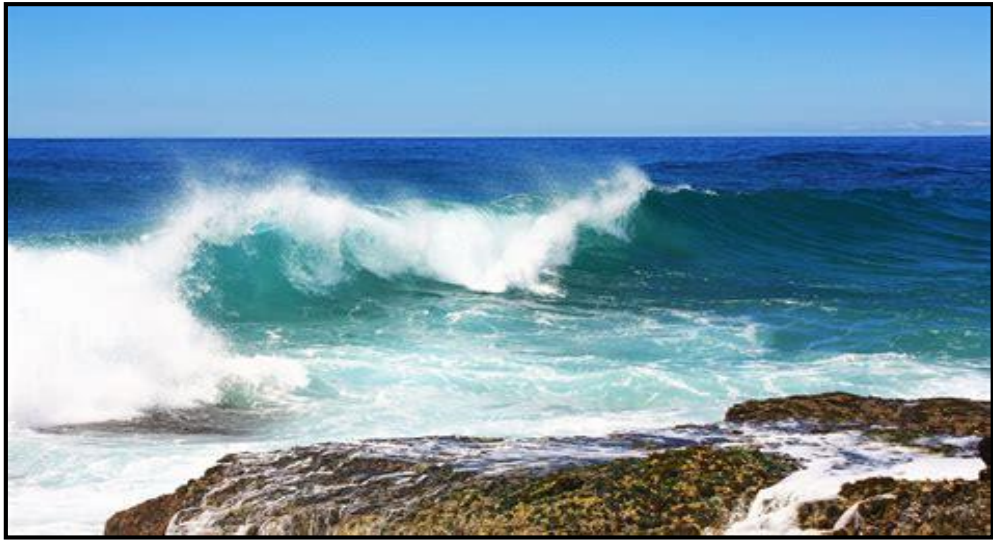
Figure 2.3 Wave

Wave crest is the highest part of the wave. That part of the wave above still water level. It develop short crested wave which is of the same order of magnitude as the wave length. A system of short-crested waves has the appearance of hills being separated by troughs as shown in Figure 2.3.

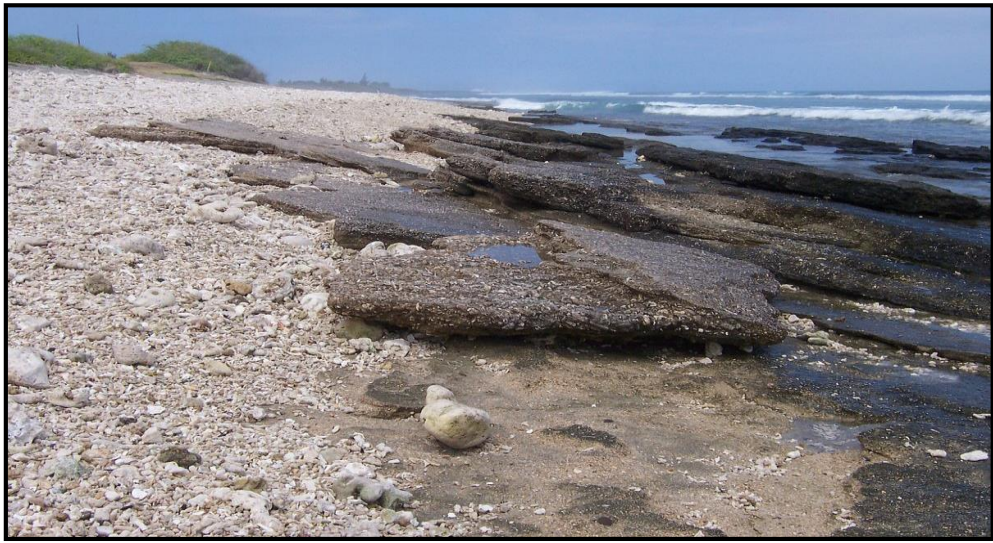
Figure 2.6 Beach rock

Beach rock is a friable to well-cemented sedimentary rock that consists of a variable mixture of gravel-, sand-, and silt-sized sediment that is cemented with carbonate minerals and has formed along a shoreline as shown in Figure 2.6. Depending on location, the sediment that is cemented to form beach rock can consist of a variable mixture of shells, coral fragments, rock fragments of different types, and other materials. Beach rock typically forms within the intertidal zone within tropical or semi tropical regions (Vousdoukas, 2012).

Beach rocks are located along the coastline in a parallel term and they are usually a few meters offshore. They are generally separated in several levels which may correspond to different generations of beach rock cementation. Thus, the older zones are

located in the outer part of the formation when the younger ones are on the side of the beach, possibly under the unconsolidated sand.

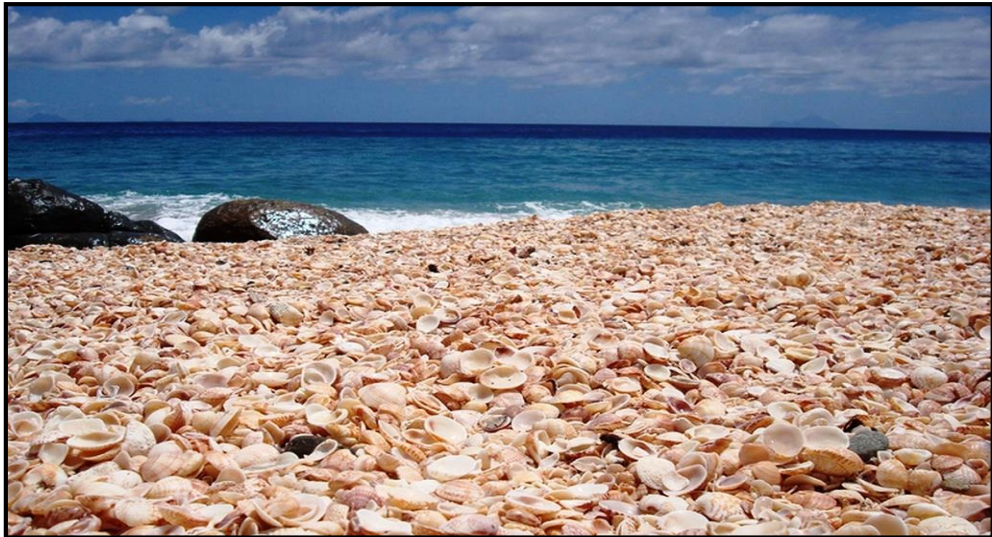
Figure 2.8 Shell beach

A "shell beach" is a sea beach that routinely has an unusually large accumulation of seashells washed up on it as shown in Figure 2.8. Seashells are most often the dead empty shells of marine mollusks, but may also include tests or shells of other kinds of marine animals. The majority of beaches in the world are primarily composed of rock particles such as sand, grit, gravel and pebbles but in rare cases a beach can be composed entirely of seashells, both broken and whole valves.

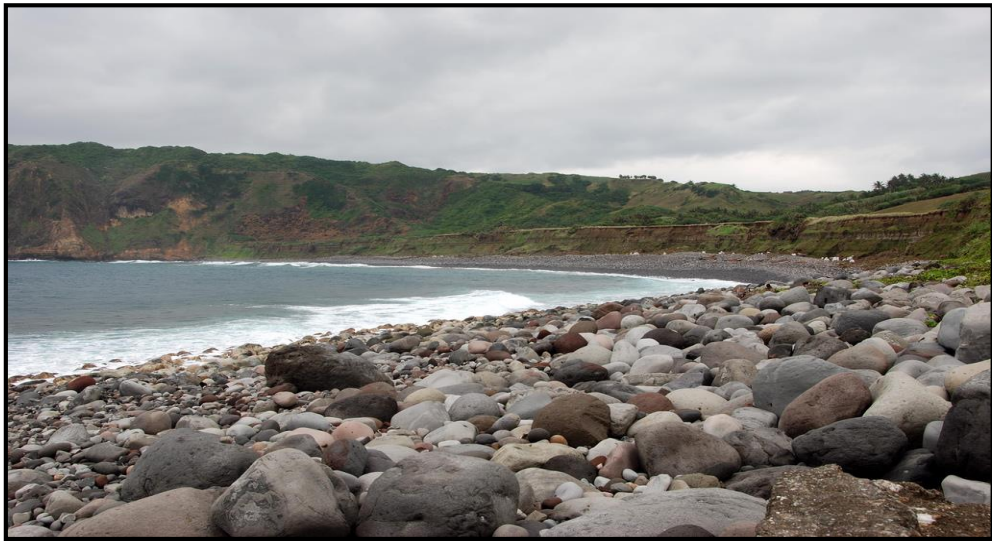
Figure 2.9 Shingle beach

Shingle is coarse beach material that is on the whole more common in previously glaciated areas, where many of the stones are derived from glacial and fluvioglacial deposits as referred to Figure 2.9. Marine shingle becomes well rounded, and usually consists of resistant rocks, such as flint, quartzite, granite, and sandstone (Arnott, 2009). On a beach, shingle tends to be moved to the top of the beach, where it occurs mixed with sand, forming a steep bank near the high water level. A typical shingle beach has a ridge at the level of the level of the extreme storm wave action and minor ridges at lower elevations marking the levels of lesser storms or lower tides. A terrace commonly occurs at the low tide level. A shingle beach is a beach which is armoured with pebbles or small- to medium sized cobbles (as opposed to fine sand).

Typically, the stone composition may grade from characteristic sizes ranging from 2 to 200 mm (0.1 to 7.9 in) diameter. While this beach landform is most commonly found in Europe, examples are found in Bahrain, North America and in a number of other world regions, such as the shingle beach in Batanes, Philippine, where they are associated with the shingle fans of braided rivers. Though created at shorelines, post-glacial rebound can raise shingle beaches as high as 200 m (660 ft) above sea level, at the High Coast in

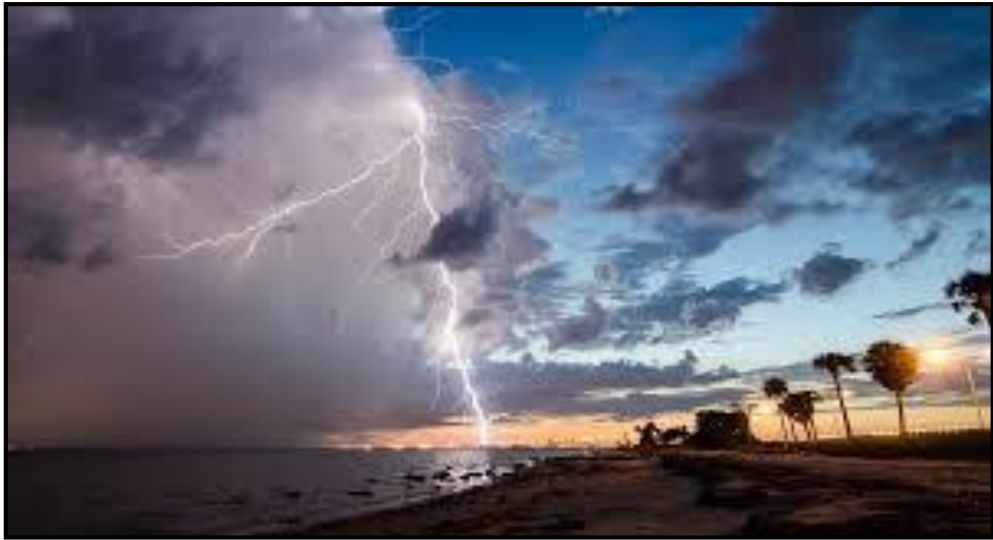
Figure 2.10 Storm beach

These are associated with large spring tides, where, due to the time of greatest gravitational pull tides are highest. Some material is thrown up and beyond the usual high water mark because of the large waves. The material remains at the top of the beach if it is not pulled back down the beach by 'swash'. Storm beaches are more common on steep shingle beaches that are affected by destructive waves (Arnott, 2016). A storm beach is a beach affected by particularly fierce waves, usually with a very long fetch as refer to Figure 2.10. The resultant landform is often a very steep beach (up to 45°C) composed of rounded cobbles, shingle and occasionally sand. The stones usually have an obvious grading of pebbles, from large to small, with the larger diameter stones typically arrayed at the highest beach elevations. It may also contain many small parts of shipwrecked boats.

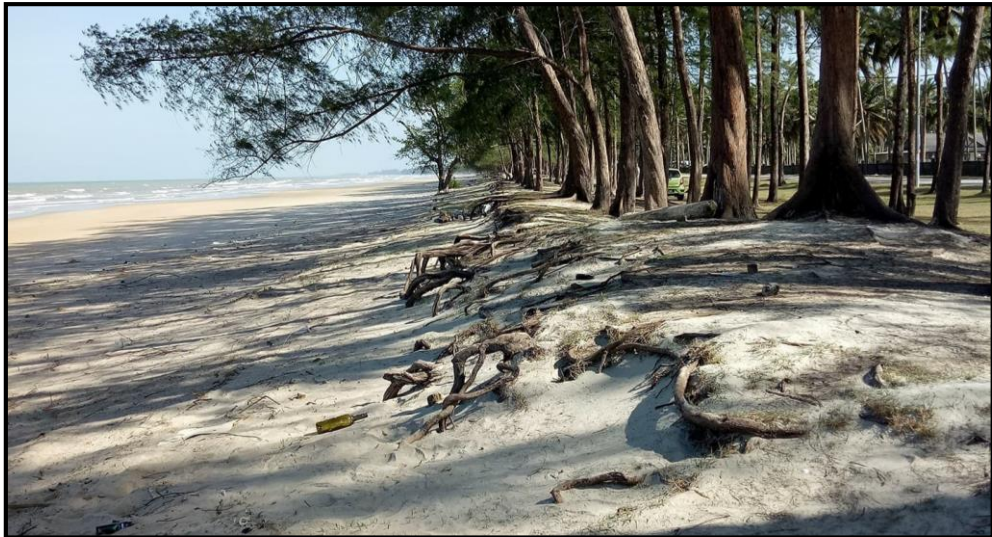
Coastal erosion is the wearing away of land and the removal of beach or dune sediments by wave action, tidal currents, wave currents, drainage or high winds (see also beach evolution) as shown to Figure 2.11. Waves, generated by storms, wind, or fast moving motor craft, cause coastal erosion, which may take the form of long-term losses of sediment and rocks, or merely the temporary redistribution of coastal sediments; erosion in one location may result in accretion nearby. The study of erosion and sediment redistribution is called 'beach morphodynamics' (Loureiro et al., 2013). It may be caused by hydraulic action, abrasion, impact and corrosion.

Figure 2.11 Beach erosion at Pantai Sepat

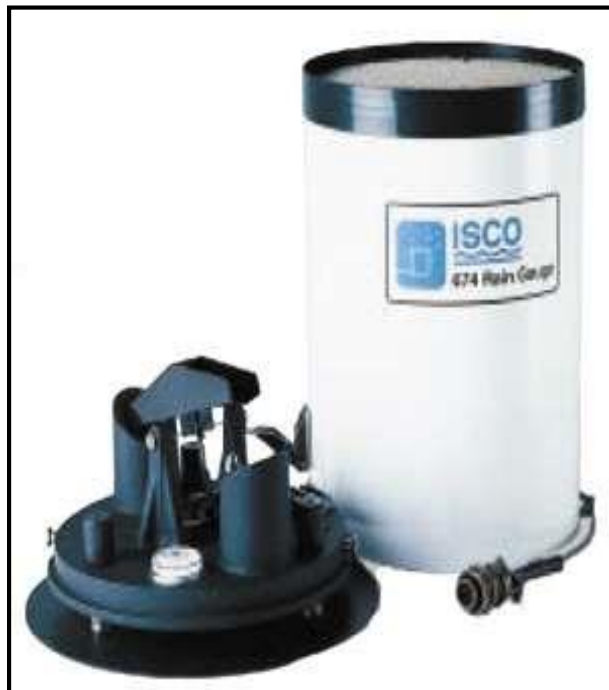
The equipment that is placed at the study area is Rainfall Logger ISCO 674 as shown in Figure 3.3. The data logger is well placed at UMP Pekan. The rainfall Logger is free from obstacle to ensure the accuracy of the data. This rain gauge was set up on to get the complete data. The data was taken every month at least for the analysis to determine the wet and dry period within 5 minutes interval. Rainfall data collected was linked to beach profile to get the conclusion of this study.

Figure 3.3 Rainfall Logger ISCO 674

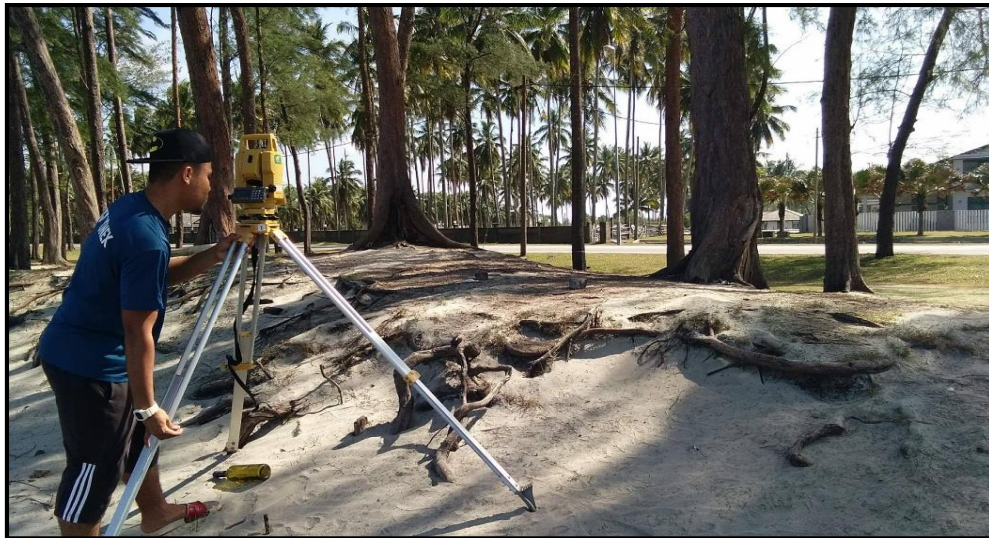
Figure 3.4 Surveying work at Pantai Sepat

Beach profile data is taken by using total station Topcon GTS-250 (referred Figure 3.6) and prism (referred Figure 3.7) by collecting horizontal distance, vertical distances of the beach as shown in Figure 3.5. Benchmark was placed before the surveying started to reduce the error during the study as shown in Figure 3.4. Beach profile data was taken during the low tide by refers to sea tidal near site area.

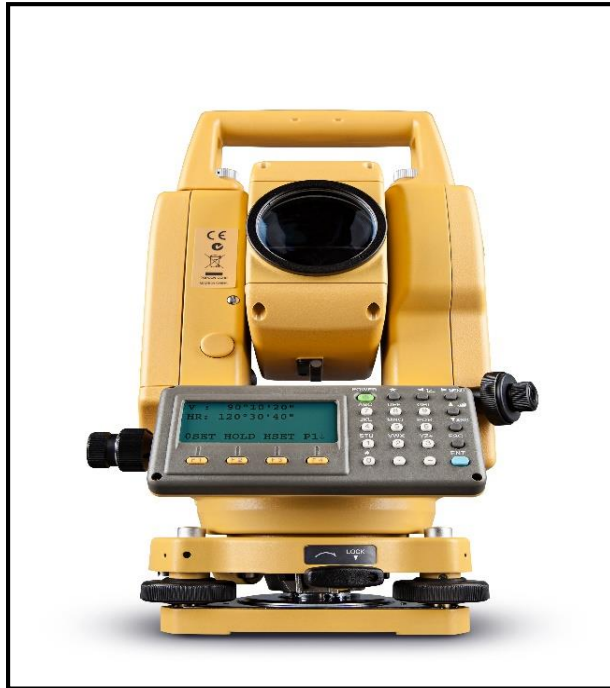
Figure 3.6 Total station Topcon GTS-250

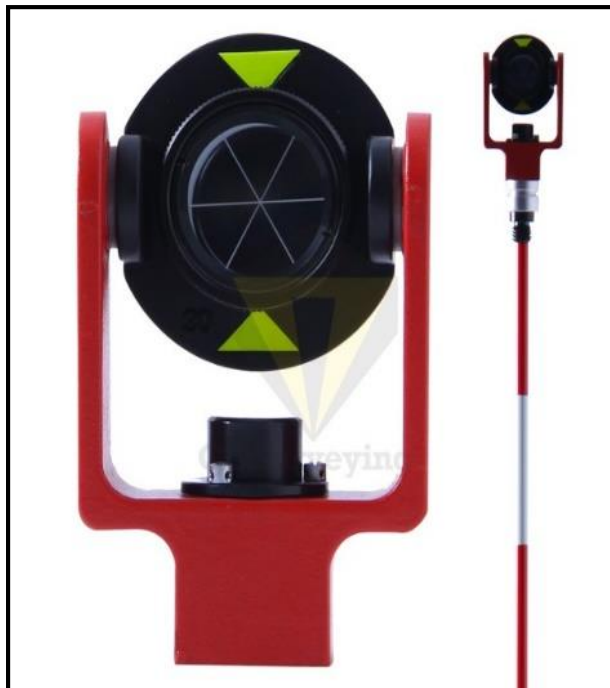
Figure 3.7 Prism

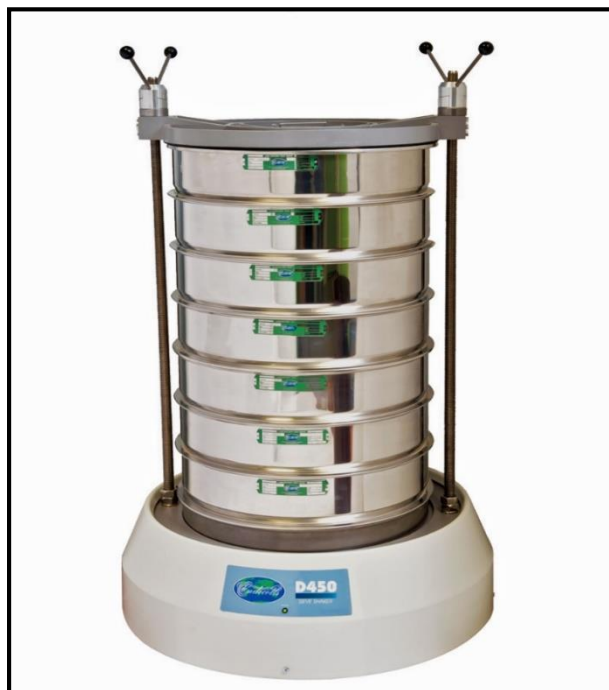
A sieve analysis or gradation test is a practice or procedure used commonly used in civil engineering to assess the particle size distribution also called gradation of a granular material by using the sieve shaker as shown in Figure 3.8. The samples were collected at Pantai Sepat as shown in Figure 3.9. After that, sieve analysis was conducted at Geotechnical Laboratory (UMP Gombang) to classify the particle distribution size of the samples as shown in Figure 3.10. Besides, the sieve analysis test procedures are based on the manual of soil laboratory testing in accordance with the British Standard (BS) and American Standard Testing Methods (ASTM). The size distribution is often of critical importance to the way the material performs in use such as 1.18 mm, 0.6 mm, 0.425 mm, 0.3 mm, 0.212 mm, 0.15 mm and 0.063 mm. It can be performed on any type of non-organic or organic granular materials including sands, crushed rock, clays, granite, feldspars, coal, soil a wide range of manufactured powders, grain and seeds, down to a minimum size depending on the exact method. Being such a simple technique of particle sizing, it is probably the most common.

Figure 3.8 Sieve shaker
