Properties of Concrete Containing Crushed Palm Oil Clinker as Partial Fine Aggregate Replacement

Abstract. The growing demand for sand supply for construction industry use especially in concrete production drives the sand mining industry to flourish. However, excessive sand mining would affect the river environment, aquatic life and water quality. At the same time, the increasing quantity of palm oil clinker, which is a by-product at palm oil mill disposed at landfill, poses negative impact to the environment. The use of palm oil clinker waste as sand replacement in concrete production would be able to reduce the use of natural sand from the river and dumping of clinker waste at landfill. The current research investigates the fresh and mechanical properties of concrete containing palm oil clinker as partial fine aggregate replacement. A total five concrete mixes were produced. The control specimen was prepared by using 100% natural sand. Other mixes were formed by integrating crushed palm oil clinker as partial fine aggregate replacement ranging from 10%, 20%, 30% and 40%. All specimens were water cured up to 28 days. The specimens were subjected to slump test, compressive strengt

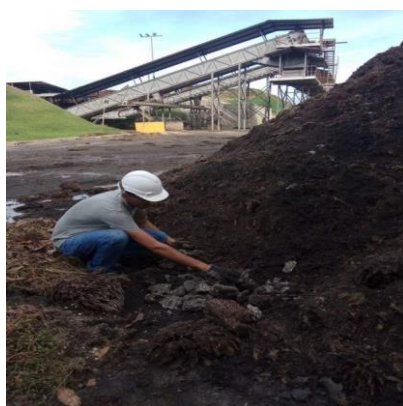
Figure 1: Palm oil clinker waste collection

Among the materials used to prepare concrete specimens in this research are cement, water, coarse aggregate, fine aggregate and palm oil clinker. Ordinary Portland cement (OPC) from a single source was used throughout the experimental work. Both coarse and fine aggregate were supplied from the local sources. Tap water was used for mixing and curing purposes. Palm oil clinker (POC) was obtained from a palm oil mill located in East Coast of Peninsula Malaysia. POC was collected from an open dumping area at mill as illustrated in Figure 1. POC were cleaned to remove the debris sticking on it and oven dried for 24 hours. After that, the clinkers were crushed and sieved passing sieve 2 mm. Only clinker passing 2mm were packed and stored for concrete mixing work. Figure 2 illustrates the palm oil clinker before and after crushing process.

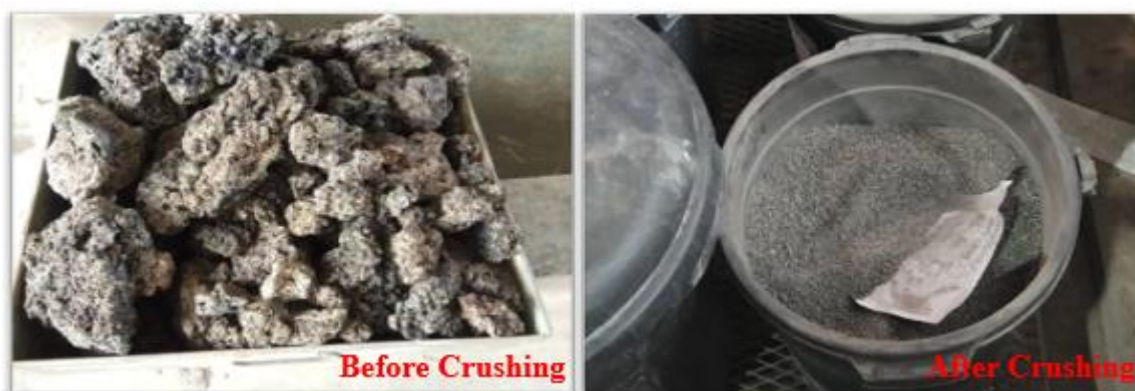
Figure 2: Palm oil clinker before and after crushing process

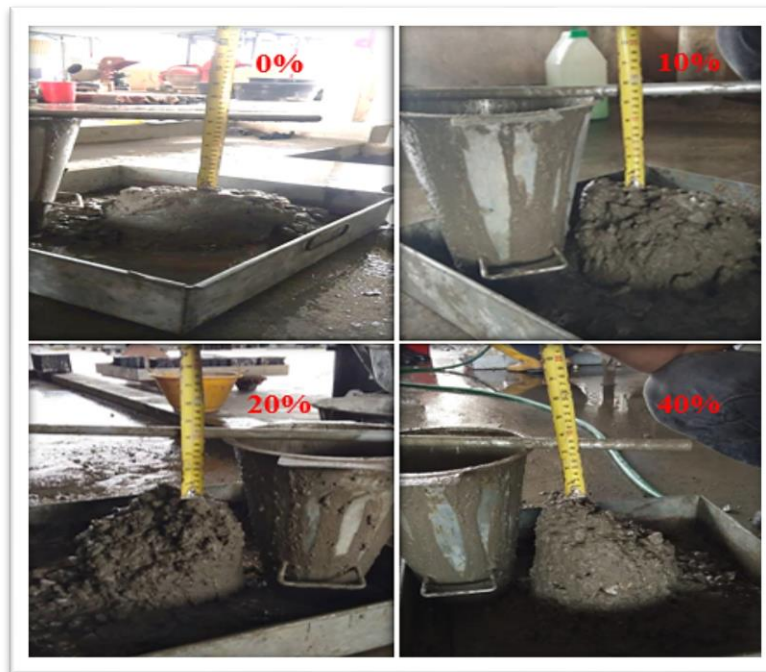
Figure 4: Effect of clinker on slump of concrete mix

Figure 3 and 4 shows that the slump decreases as the percentage of palm oil clinker content replaced becomes higher. The result indicates that concrete become less workable as the amount of palm oil clinker added increases. This implies the need for larger amount of water required to make the mixes more workable. The reduction of workability is due to the porous clinker particle unlike the solid sand particles. Past researcher, Neville [12] has pointed out that physical properties of the aggregate used have influence on the workability of concrete. Similar trend has been reported by Nazrin et al. [13] and Abutaha et al. [14] when clinker is used as partial fine aggregate replacement in lightweight concrete mix.

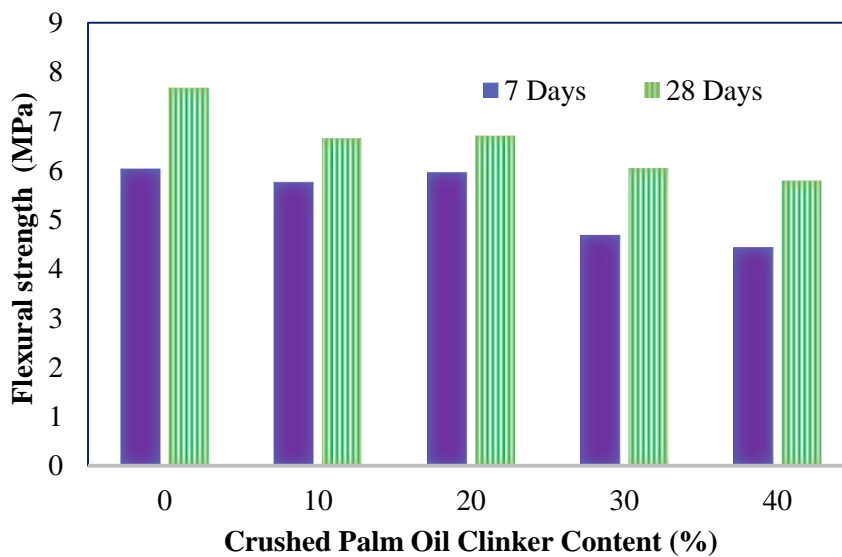
Figure 6: Flexural strength results

Figure 5 and 6 illustrate the compressive strength and flexural strength results of the concrete specimens containing various percentage of crushed palm oil clinker. Generally, the strength of all specimens increases as the curing age become longer due to continuous presence of water promoting undisturbed hydration process. As a result, larger quantity of CSH gel was formed in concrete internal structure thus creating a more compact concrete with higher load sustaining capacity. One of the researchers, Neville [12] has highlighted the importance of continuous water supply during curing in enhancing the concrete strength. As for the effect of clinker on concrete strength, it is evident that the use of porous type of clinker as fine aggregate somehow affects the concrete strength. Inclusion of clinker, which absorbs water owing to its porous physical appearance, reduces the concrete mix

workability. This cause difficulty during compaction works and also results in loss of adhesion due insufficient water for hydration process resulting in concrete with lower strength. As larger amount of clinker is added, the mix stiffer and hard to be compacted thus creates more voids that reduce concrete strength.
