EFFECTIVE DISPERSION OF GRAPHENE  
NANOPLATELETS IN EPOXY GROUT FOR  
STRUCTURAL REHABILITATION

B. ENG(HONS.) CIVIL ENGINEERING

UNIVERSITI MALAYSIA PAHANG

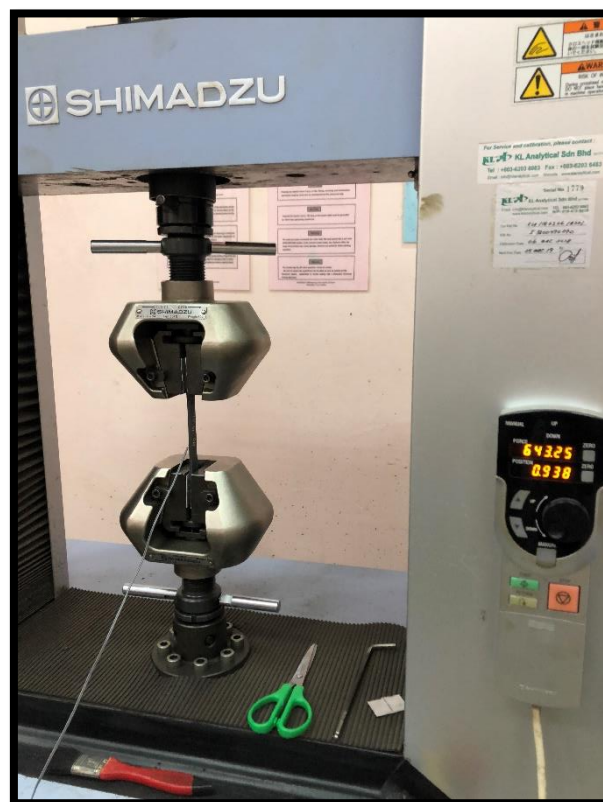
**Figure 3.6:** Universal Testing Machine

After completing Stage 1, each compressive sample (prism shape) was glued using cyanoacrylate (CN) glue and connected to data logger where the strain readings were recorded. The specimen was placed at the Shimadzu Universal Testing Machine (UTM) and a loading rate of 1.3 ( $\pm 0.3$ ) mm/min was applied to the sample until failures occur. The reading of the load and strain were recorded by the computer data logger.

The steps of tensile test are similar with compression test. Tensile test has been conducted based on ASTM D638 standards. Every sample was connected with strain gauge and data logger where the readings were collected by the computer system. Next, the specimen (dog-bone shape) was gripped by the jig of the UTM while the crosshead movement was applied at 3.75mm/min's rate. The dimension of specimens was provided as input by the user into the UTM in order to obtain stress and strain reading. After the testing is completed, the failed sample was kept for further testing. The specimen considered fail when the failures occur at the weak point of the dog-bone shape. If the failures happen outside of the weak point of the specimen, the specimen will be rejected and the data of the specimen will deem as invalid, as specific by the standard. Figure 3.6 shows the UTM machine used for the mechanical properties test.

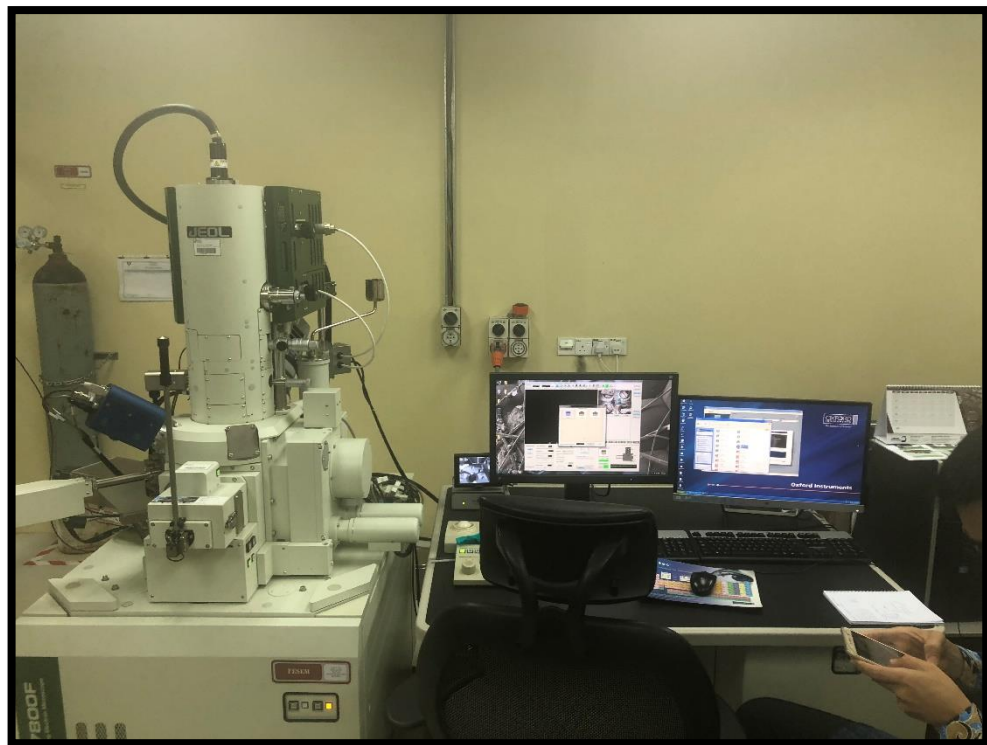
**Figure 3.7:** FESEM machine

After the tests for mechanical properties are done, the failure part of the selected specimen of tensile test undergo FESEM test as shown as Figure 3.7. The nature of failure part of the specimen was studied and the small structure failure was visualized. The failure surface of the specimen was enlarged in nanometre scale under the microscope to have a better understanding and provide additional information of the failure surface of epoxy grout. To get the better visualization under the FESEM, a layer of Platinum coating was coated to the whole surface of the failure surface.

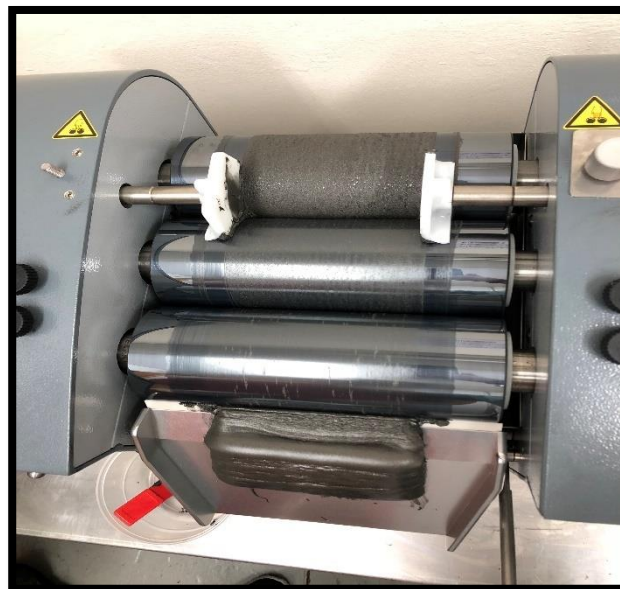
There is a problem encountered during the calendaring process where the phase separation occurred. This is the reason why the result of the milled down sample is different as compared to control sample. Phase separation is a phenomenon where the existing reinforcement in epoxy grout separated from the epoxy grout by three-roll mill as shown in the Figure 4.7. The size of the existing reinforcement in the epoxy grout may be too big to go through the designated gap of the three-roll mill. The existing reinforcement in epoxy grout might be the main tensile strength contributor in the original epoxy grout. Hence, with the steel reinforcement which is the tensile strength contributor in the matrix separated from the epoxy grout in the milled down sample, the tensile strength drops dramatically from the control sample to the milled down sample. On the other hand, with the tensile strength contributor separated, the compressive strength of the matrix shows marginal increment because the matrix will be denser without any reinforcement.

**Figure 4.7:** Phase separation of the existing reinforcement on the three-roll mill
