IMPACT OF MINERALS FREIGHT AND
LOGISTIC OPERATION TOWARDS
TRAFFIC SAFETY IN KUANTAN ROAD
NETWORK

B. ENG (HONS.) CIVIL ENGINEERING

UNIVERSITI MALAYSIA PAHANG

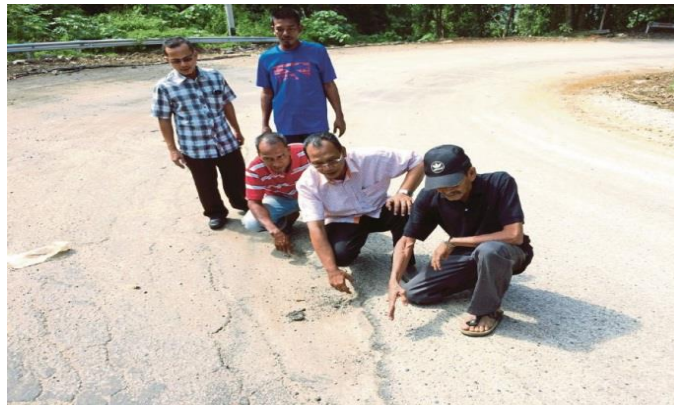
Figure 1.1: Road damage by bauxite lorries.

Bauxite freight and logistic operations are one of the reasons why the crash rate increases at Kuantan. Tones of bauxite transported from mine sites to Kuantan port daily, resulting the roads to be jam-packed with heavy vehicles, harmed by potholes and covered by red residues from ores. Most bauxite lorries are carrying bauxite more than the permissible weight because the driver are racing for “trips” which can cause damage to road structures and danger to other road users (New Straits Times, 2015). Otherwise, the crash might occur because of cracks and potholes when the drive tends to lose control of the vehicle while driving especially to motorcyclist. Potholes can worsen the condition practically when driving at night because the road users might not notice the sudden change of roadway and possibly injuries to anyone who involved.
