PAVEMENT SURFACE CONDITION  
ATTRIBUTED TO TRAFFIC OPERATIONS ON  
FEDERAL ROADWAYS IN KUANTAN

B. ENG(HONS.) CIVIL ENGINEERING

UNIVERSITI MALAYSIA PAHANG

Thesis submitted in partial fulfillment of the requirements  
for the award of the  
B.Eng (Hons) Civil Engineering

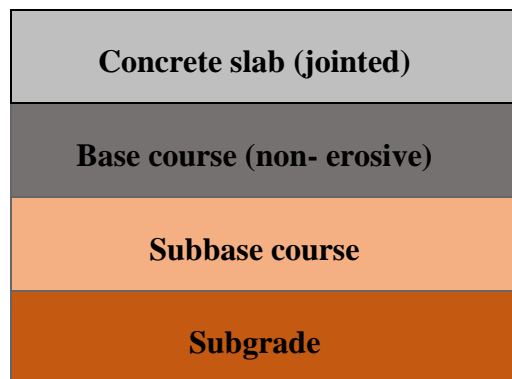
A rigid pavement was constructed from cement concrete or reinforced concrete slabs. Grouted concrete roads are in the category of semi-rigid pavements. The design of rigid pavement was based on providing a structural cement concrete slab of sufficient strength to resist the loads from traffic. The rigid pavement has rigidity and high modulus of elasticity to distribute the load over a relatively wide area of soil. The concrete slab was capable of distributing the traffic load into a large area with small depth which minimizes the need for a number of layers to help reduce the stress (Chandra, Flexible Pavement versus Rigid Pavement, 2017). The most common type of rigid pavement consists of dowel bars and tie bars. Dowel bars were short steel bars that provided a mechanical connection between slabs without restricting horizontal jointed movement. Tie bars on the other hand, are either deformed steel bars or connectors used to hold the faces of abutting slabs in contact. Although they may provide some minimal amount of load transfer, they are not designed to act as load transfer devices and were simply used to tie the two concrete slabs together.

Figure 2 : Rigid Pavement Cross-section

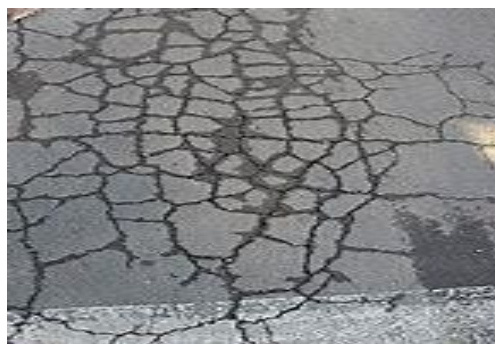
A series of interconnected cracks creating small, irregular shaped pieces of pavement. It is caused by failure of the surface layer or base due to repeated traffic loading (fatigue).

Figure 3 : Fatigue Cracking

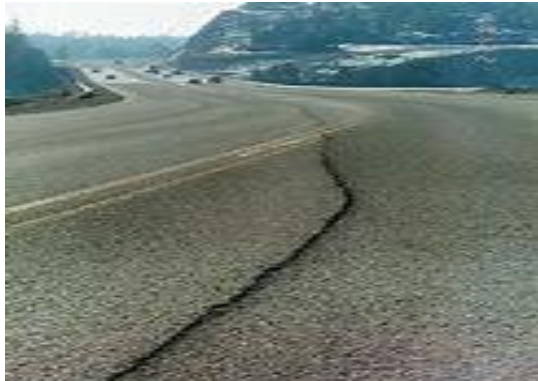
A long crack that run parallel to the center line of the roadway. These may be caused by frost heaving or joint failures, or they may be load induced.

Figure 4 : Longitudinal Cracking

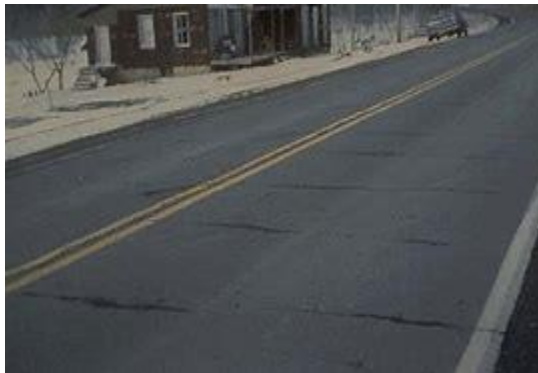
Transverse cracks form at approximately right angles to the centerline of the roadway. They are regularly spaced and have some of the same causes as longitudinal cracks.

Figure 5 : Transverse Cracking

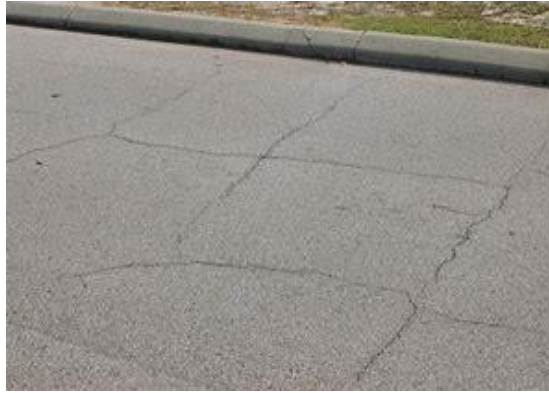
Block cracking was an interconnected series of cracks that divides the pavement into irregular pieces.

Figure 6 : Block Cracking

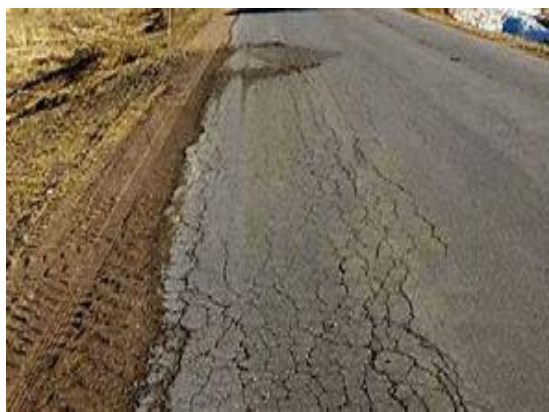
Edge cracks typically start as crescent shapes at the edge of the pavement. They will expand from the edge until they begin to resemble alligator cracking. This type of cracking results from lack of support of the shoulder due to weak material or excess moisture.

Figure 7 : Edge Cracking

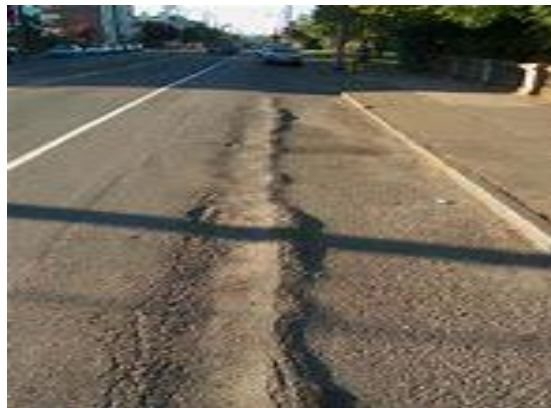
Rutting was the displacement of pavement material that creates channels in the wheel path. Very severe rutting will actually hold water in the rut. Rutting was usually a failure in one or more layers in the pavement. The width of the rut was a sign of which layer has failed.

Figure 8 : Rutting

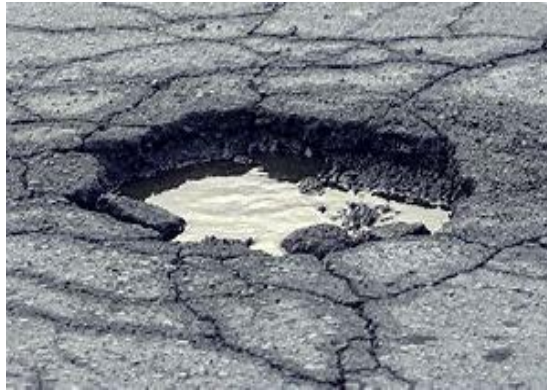
Potholes were formed when the pavement disintegrates under traffic loading, due to inadequate strength in one or more layers of the pavement, usually accompanied by the presence of water. Most potholes would not occur if the root cause was repaired before development of the pothole (Sharad.S.Adlinge).

Figure 9 : Potholes

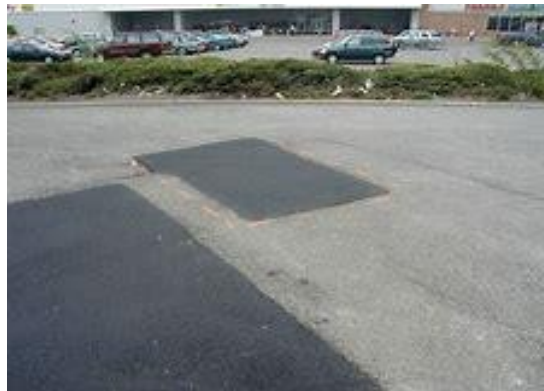
A patch was defined as a portion of the pavement that has been removed and replaced. Patches are usually used to repair defects in a pavement or to cover a utility trench. Patch failure can lead to a more widespread failure of the surrounding pavement.

Figure 10 : Patching

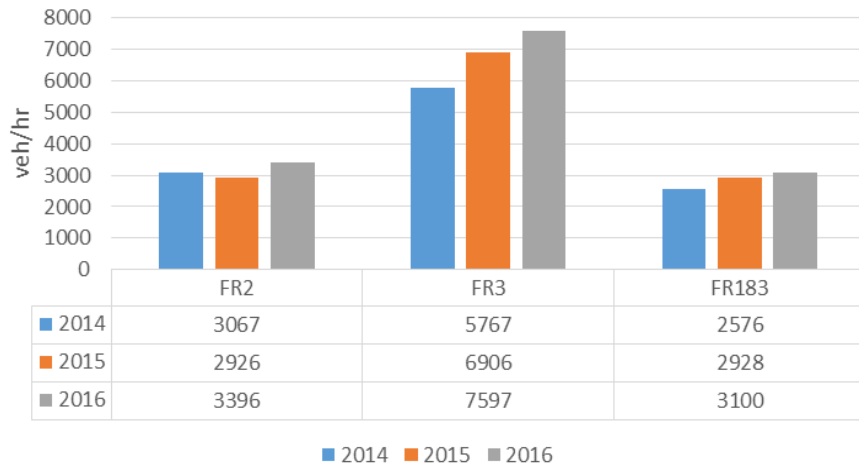
Figure 19: Traffic Volume on Kuantan Federal Roadways

As the result obtained in the Figure 19, the data was collected from RTVM for the three consecutive years started 2014 until 2016 on the three selected roadways in Kuantan. Based on the Figure 19, it shows that the highest traffic volume was on Federal Route 3 because of the most strategic area and as the main road for East Bound Kuantan Bypass. According to the data obtained, it was shows that there are moderately increased of the total traffic volume for FR3 and FR 183. But, difference to FR2 have a slightly decreased started from 2014 to 2015 and becoming increased from 2015 to 2016 like others roadways. The data shows there was not a large difference of total traffic volume for these three types of road and time of analysing.

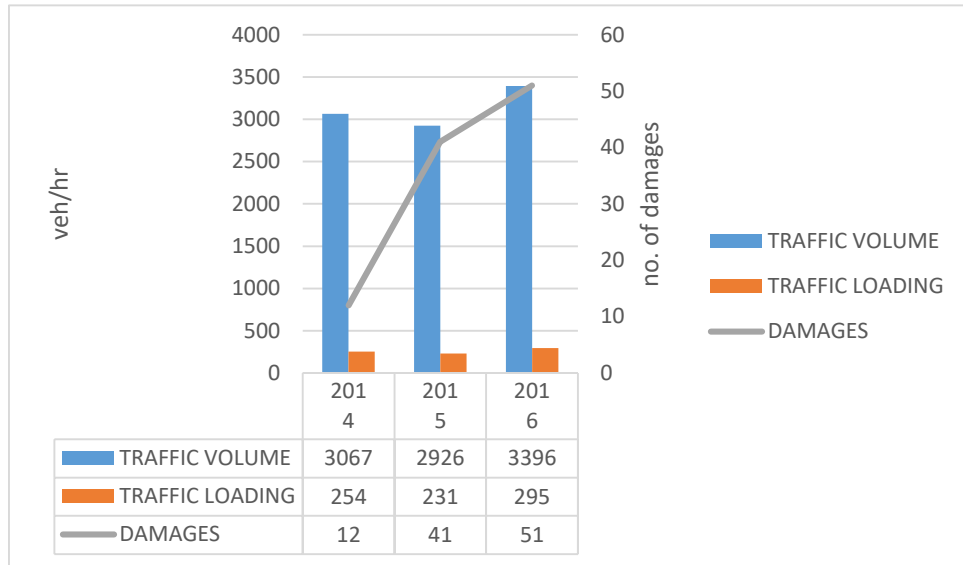
Figure 21: Traffic volume and Traffic loading towards Pavement Damages on FR 2.

As the result obtained based on the Figure 21. There was a linearity association between traffic operations in terms of traffic volume and traffic loading for all the types of parameter measured. Based on the Figure 21, it was proved that according to the data was analyzed on the FR 2, when the total of traffic volume increased the number of pavement damages also increased. It was clearly shows that there was a linearity association between traffic volume and pavement on the FR2 especially in years 2014 and 2016. A large value of total volume give a huge number of pavement damages as we can see in the Figure 21 in year 2014, the value of the traffic volume is 3067 veh/hr and followed to the number of pavement damages was 12 and then for 2016 the value traffic volume is 3396 veh/hr and the number of pavement damages was 51, this value clearly shows that the high traffic volume value gave a high value of pavement damages.

Other than that, there were same case for the traffic loading parameter in result of evaluation the association between traffic loading and pavement damages. According to the result was obtained in the Figure 21 for FR 2 in years 2015 and 2016, the traffic loading in 2015 was 231 veh/hr then slightly increased in the year 2016 with the total traffic loading 295 veh/hr. Meanwhile, the number of pavement damages also shown the similarity with 41 total of damages in 2015 then slightly increased to 51 total of damages in 2016. It is clearly shows there was as a similar increment trend for traffic loading and number of pavement damages for FR 2.

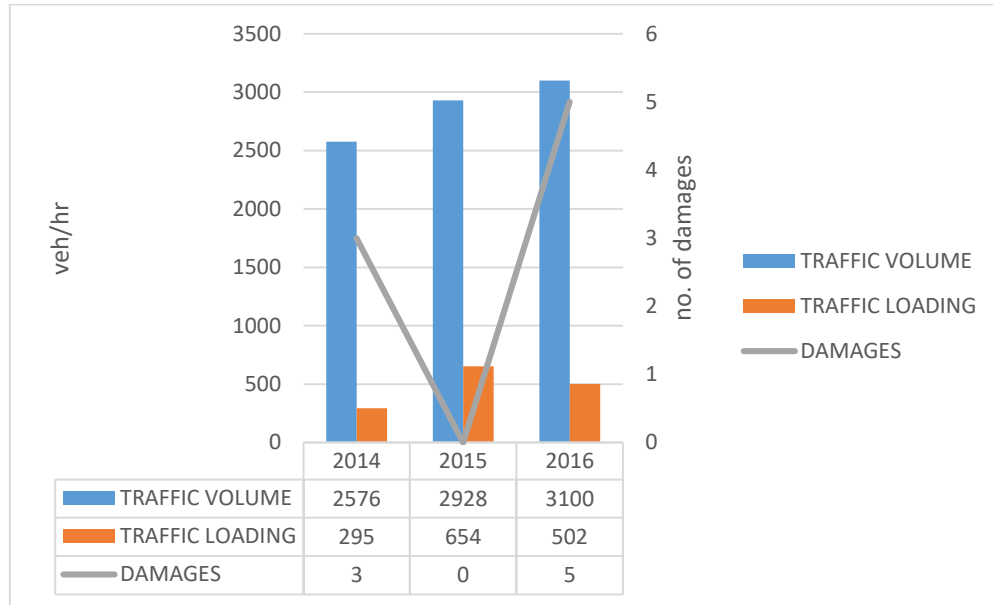
Figure 23: Traffic volume and Traffic loading towards Pavement Damages on FR183.

Based on the result obtained, Figure 23 interpret that FR183 have a slightly differences result obtained for association of traffic volume and pavement damages compared to FR 2 and FR 3 based on the line graph and histogram chart created. The line trend for number of damages shows that there was no association between traffic operations in terms of traffic volume with number of pavement damage for FR 3. According to the result obtained, in years 2014 and 2015 when the total of traffic volume increased the number of pavement damages was decreased unlike the result for 2015 and 2016, when the total of traffic volume increased the number of pavement damages was increased dramatically. Here, it was proved there no association between traffic volume and pavement on the FR 183 especially in years 2014 until 2016, there was a hit trend of graph as presented in the Figure 23. The result shows the value of the total traffic volume in 2015 was 2928 veh/hr then moderately increased in the year 2016 with the total traffic

loading 3100 veh/hr. Meanwhile, the number of pavement damages was slightly decreased with number of damages with zero damage in 2015 then slightly increased to 5 in 2016. It was shows there was not a smooth increment trend for traffic loading and number of pavement damages for FR 183.

Then, there were a same case for the traffic loading parameter in result of evaluation the association between traffic loading and pavement damages. According to the result obtained in the Figure 23 as data analyses for FR 183 in years 2015 and 2016, the total traffic loading in 2015 was 654 veh/hr then slightly decreased in the year 2016 with the total traffic loading 502 veh/hr. Meanwhile, the number of pavement damages also shown there was no similarity trend increment number of pavement damages and traffic loading. It would can be cause of the location of the roadways area and the lowest of traffic loading occurred on FR183.

As a result, obtained from the analyses of FR 183, there were no association between traffic operations (traffic volume and traffic loading) towards pavement damages on FR 183 because of the trend for all parameters (traffic volume, traffic loading and pavement damages was difference for FR 183.
