DEGRADATION MODELLING ON
TEMPERATURE UPON BURST CAPACITY
OF COMPOSITE REPAIRED PIPELINE

Thesis submitted in partial fulfillment of the requirements
for the award of the
B.Eng (Hons.) Civil Engineering

Faculty of Civil Engineering & Earth Resources
UNIVERSITI MALAYSIA PAHANG

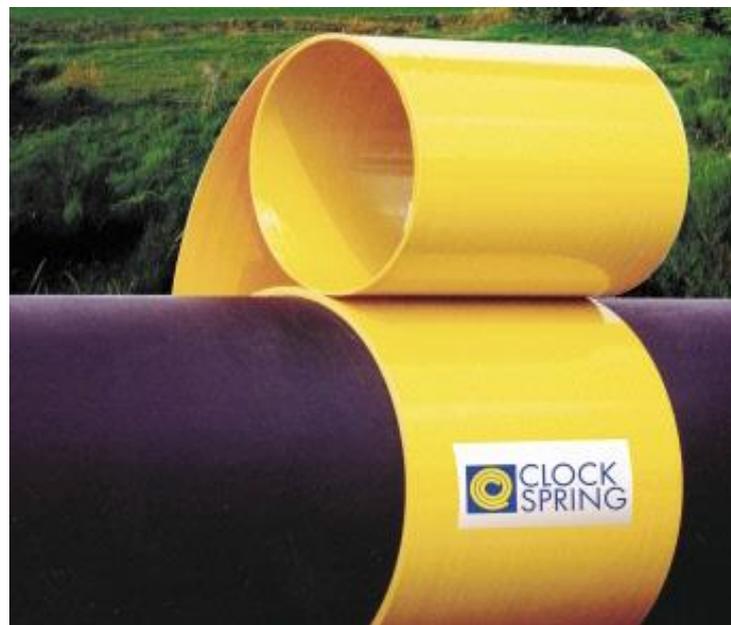
Figure 2.4 Clock Spring[®]

Bonding of pre-manufactured fiber-reinforced composite materials that bonded to defective pipeline and held together by using an adhesive is known as pre-cured layered system. Clock Spring Company, the company who is the pioneer in the development of composite repair system designed a product by using pre-cured layered system which is Clock Spring®. Clock Spring® utilises E-glass/Polyester material with a methacrylate adhesive to bond the pre-cured composite layer (Clock Spring Company, 2017). Figure 2.5 shows the component of pre-cured layered repair system used in Clock Spring® where (1) is composite sleeve, (2) is interlayer adhesive, and (3) is infill material. In this system, the pre-manufactured composite layer which is a coil of high strength composite materials. Thus, the composite layer is able to wrap securely around the pipeline. Then, the composite layer is bond to the pipeline by interlayer bonding adhesive. Meanwhile,

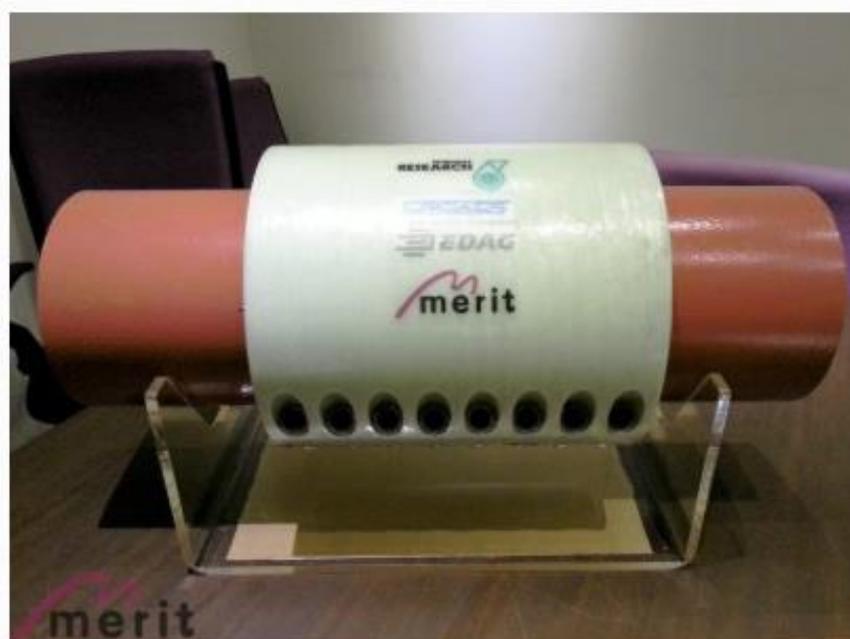
Figure 2.6 ProAssure™ Clamp
Source: Merit Technologies Sdn Bhd

Split composite sleeve system is the repair system that provide higher structural integrity than the other repair system such as pre-cured layered, wet lay-up, and pre-impregnation. This system is able to permanently restore the original strength, contains leaks, and support axial load of the pipeline (Shamsuddoha, 2014; Lim, 2017). There is a product that using this system which is ProAssure™ Clamp (Figure 2.6) that made of advanced composite material (Merit Technologies Sdn Bhd). In this system, infill material is used to give a smooth surface to the damaged area of pipeline. Hence, a continuous support is provided by the introduced infill layer which minimizes the radial deformation and transfers the load from the pipeline to the outer shell. The principle of this system is largely depending on the performance of infill. At the same time, split composite sleeve system has some drawbacks or disadvantages such as limitation on straight section defective pipeline. Moreover, the joining of the split sleeves is very challenging in this repair system, especially underwater and restricted area.
