Stability of weathered cut slope by using kinematic analysis

H Awang^{1*}, A F Salmanfarsi², M S Aminudin³ and M I Ali¹

¹College of Engineering, Universiti Malaysia Pahang, 26300 Gambang, Pahang, Malaysia

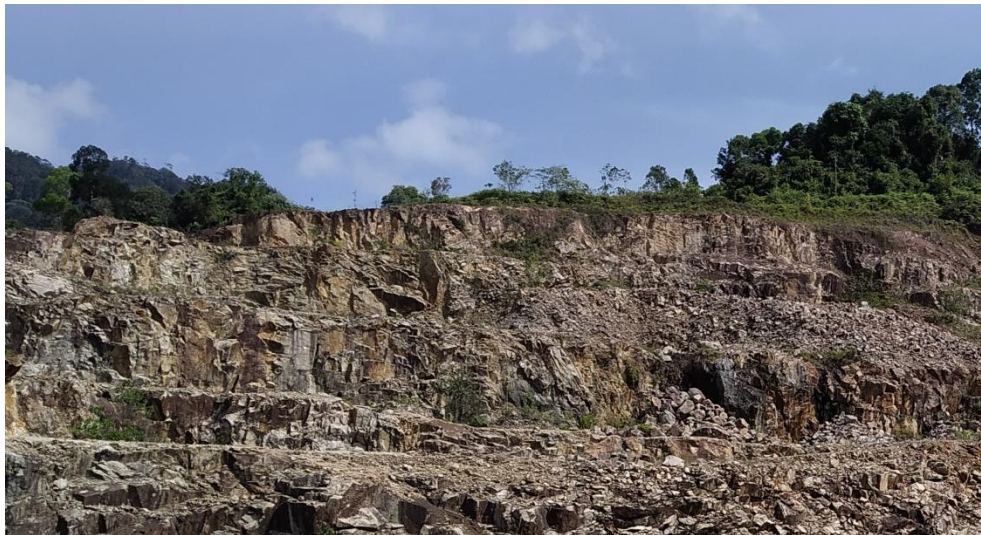
Figure 1. View of the exposed cut slope at Sri Jaya

In this study, the main objective is on finding the stability of weathered rock cut slope by using kinematic analysis. The data needed for the analysis would include the Schmidt rebound hammer test readings and discontinuity mapping (scanline mapping) of the rock slope. Fieldwork was carried out in order to determine the extent of the weathered rock, and ultimately to study its effect to the potential failure of the slope. The study area takes place in Sri Jaya, Pahang, where large exposed cut slope is found (Figure 1). The weathering condition of the slopes means that there are potential for the weakening of the slope, which could lead to failures. The rock mass along the slope consist of granitic rocks.

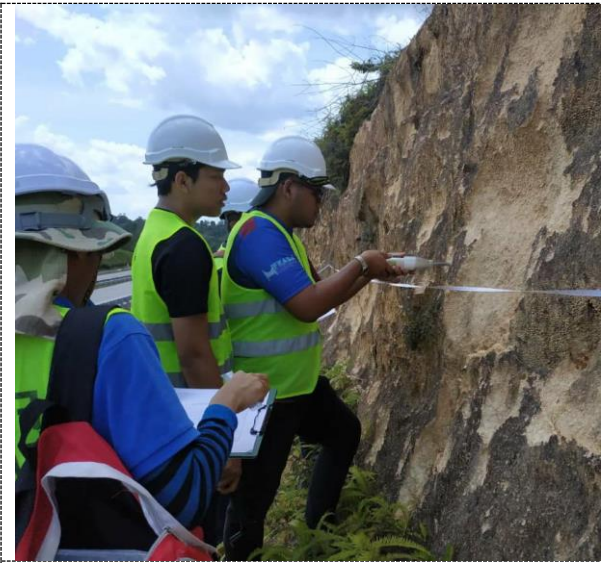
Figure 2. The Schmidt rebound hammer used to identify weathering grade *along the scanline* of the slope

Schmidt rebound hammer test is a simple test used in determining the surface hardness of the weathered material of the rock slope (Figure 2 – Figure 3). The test was carried out an interval of 5m along scanline of the slope face. For every interval, the test was repeated 10 times in order to get the average value of the rebound number. This is following the suggested method by [7]. The values can be used to determine the weathering grade of the rock.

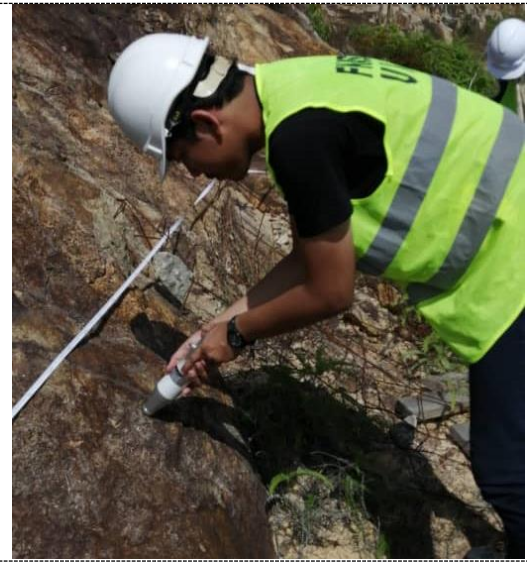
Figure 3. Close up of measurement using the Schmidt rebound hammer

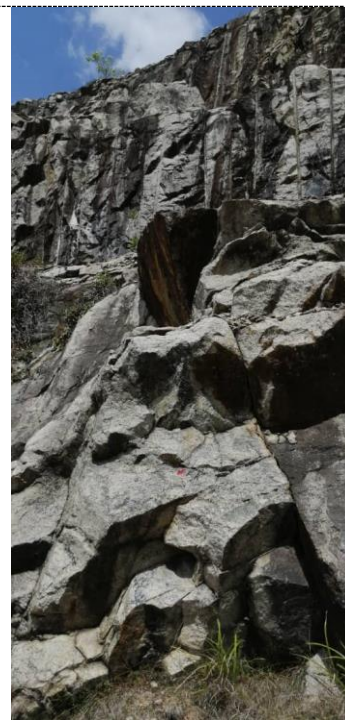
Figure 6. View of potential wedge failure on the slope (Panel 4)

Due to the orientation of the joints to the way the slope surface was excavated, the potential of plane failure is low, as the joint are not oriented in a way that would facilitate the occurrence of planar sliding. However, with the orientation of the joint that dips towards the slope direction, together with the excavation of the slope to form high level berms, there is significant potential for toppling failure to occur. In addition, intersection of two or more sets of the joints in the rock slope could also lead to potential wedge failure, where there is weakening of the rock strength along more than one joint sets. However, kinematic analysis only provides the potential of slope failure based on discontinuity mapping of the slope. In order to further predict the stability of slope based on the weathered material, more detailed wider in-situ and laboratory testing of the weathered material is required [10]. This is to ensure proper protection measures could be undertaken for the slope.
