Effect of Multi-Walled Carbon Nanotubes on Infill Material for Pipeline Composite Repair

DOI: <https://doi.org/10.30880/ijie.2022.14.01.029>

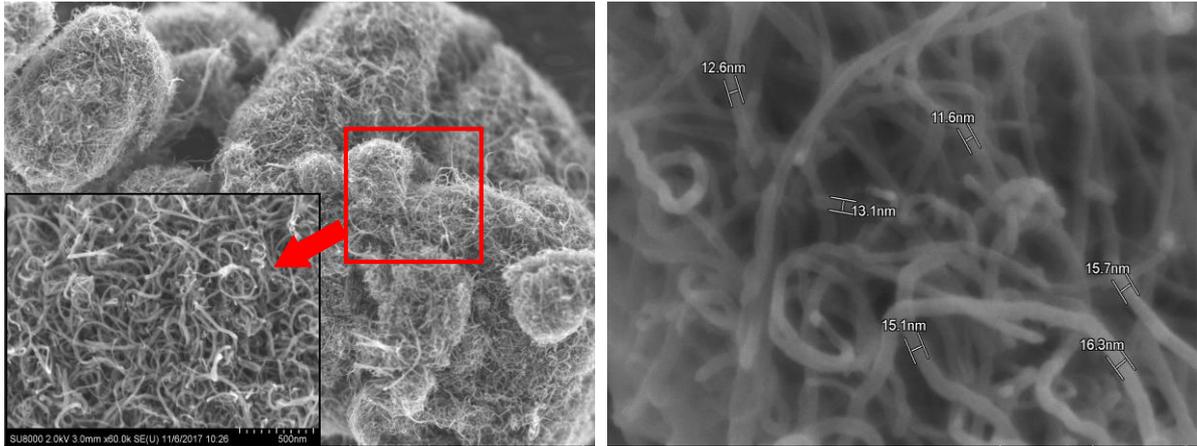
Fig. 1 - Entangled network of pristine MWCNTs

Fig. 1 shows the pristine MWCNTs with strongly entangled networks prior to the dispersion process. An appropriate dispersion technique was applied to detangle the agglomeration using mechanical and chemical approaches. The MWCNTs were pre-dispersed first using the acetone-ultrasonication method for 15 minutes according to the prepared weight percentage as shown in Fig. 2. The MWCNTs/acetone suspension was then left at room temperature for 24 hours until it had fully evaporated. It is then followed by the calendaring process of pre-dispersed MWCNTs/acetone with resin as shown in Fig. 3 using a three-roll mill (EXAKT 80E) machine. The mixture was fed into the first gap between feed roll and centre roll before being moved into the second gap between centre roll and the apron roll linked by a 9:3:1 speed roller. The process was applied at four consecutive cycles for 0.1 wt% and five cycles for 0.5 wt% of MWCNTs. The time required is about 10-15 minutes for each calendar cycle.

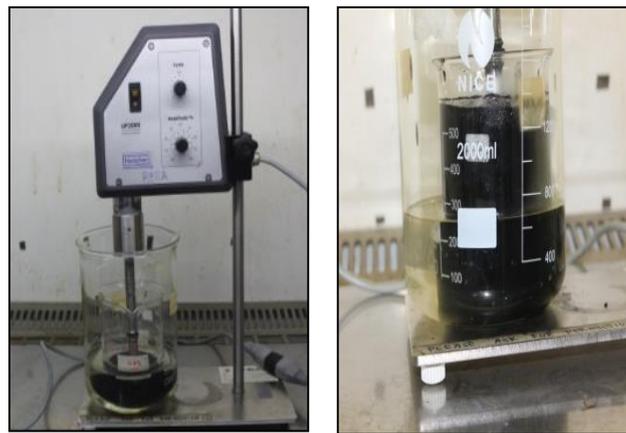
Fig. 2 - Pre-dispersion process using Hielscher Ultrasonic Homogenisers UP200s

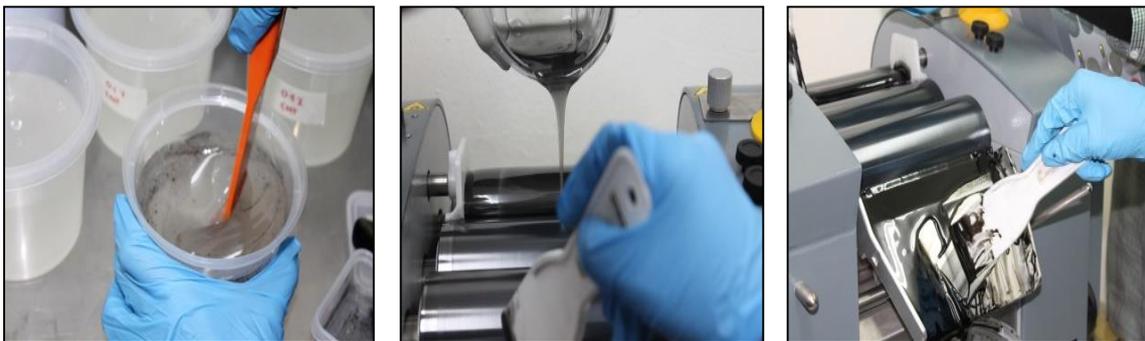
Fig. 3 - Process of dispersion using the calendaring method

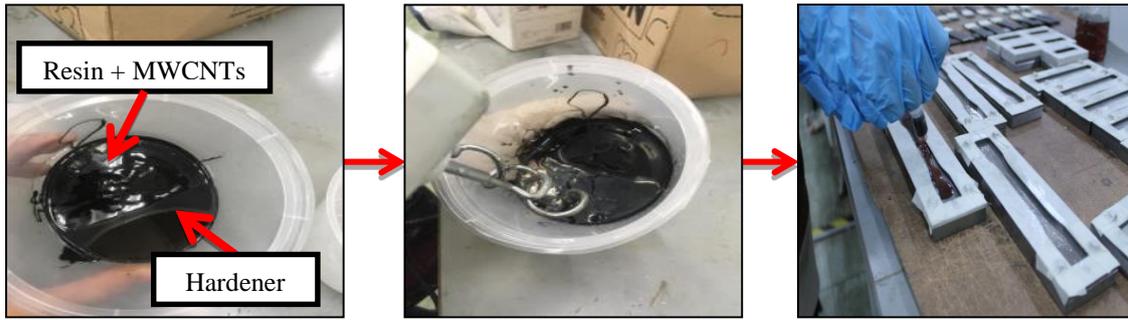
Fig. 4 - Preparation of modified epoxy grout

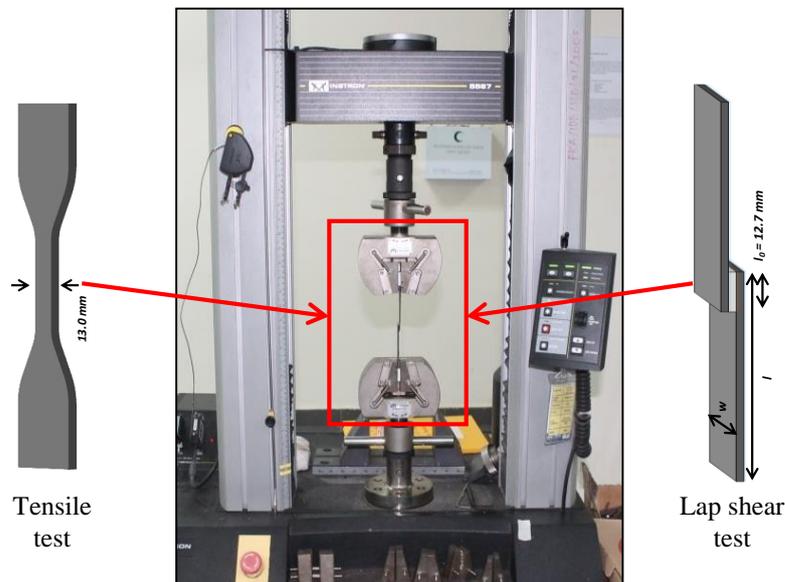
Fig. 5 - Universal testing machine-INSTRON 5567

Five specimens were prepared for tension and lap shear tests referring to appropriate industry standards. The 25kN INSTRON 5567 universal test machine, as seen in Fig. 5, was used to conduct both tests. Dumbbell or dogbone specimens with the size of 13.0 mm x 3.2 mm were used for tensile testing, i.e., Type I of the ASTM: D638. The crosshead speed used for the traction specimens was 5.0 mm/min. The specimens were marked and clamped at the top and bottom using the end tab to prevent premature failure of the grip length. All specimens are equipped with strain gauges and attached to a data logger at a specific INSTRON 5567 grip separation before being pulled up until failure.

A single lap joint test was conducted in accordance with ASTM D1002. ASTM D1002 determines the shear strength of adhesives for bonding metals by applying tension loads to the specimens. Two pieces of carbon steel coupons measuring 25.4 mm x 100 mm (width x length) were bonded together with a sample at each end where the two coupons overlapped. The specimen was pulled in opposite directions to produce shear stress at the specified load rate of 1.27 mm/min.

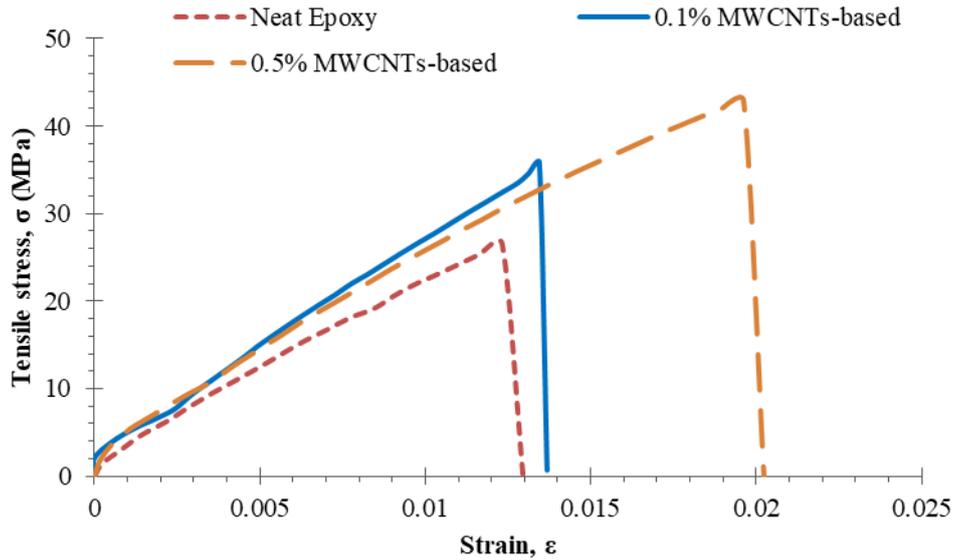
Fig. 6 - Specimens' stress-strain curves

The pressurised pipeline will experience three stresses under circumferential (hoop), longitudinal (axial) and radial directions [26], [27]. However, hoop stress is the most critical stress for the pipe under internal pressure. This stress will cause the failure of the pipe in tension. Therefore, the tensile properties of repair material are considered as the most important properties to be understood. The representative tensile stress-strain curves for each specimen are shown in Fig. 6. As can be seen, both control and modified epoxy grout displayed a linear stress-strain relationship in the initial elastic region, and no plastic deformation has occurred before fail. Fig. 7 shows the fractured specimen for modified epoxy grouts in the tensile test. All specimens failed due to splitting into two parts perpendicular to the direction of loading during peak stress. No significant lateral dimensional differences were found in all specimens before failure.

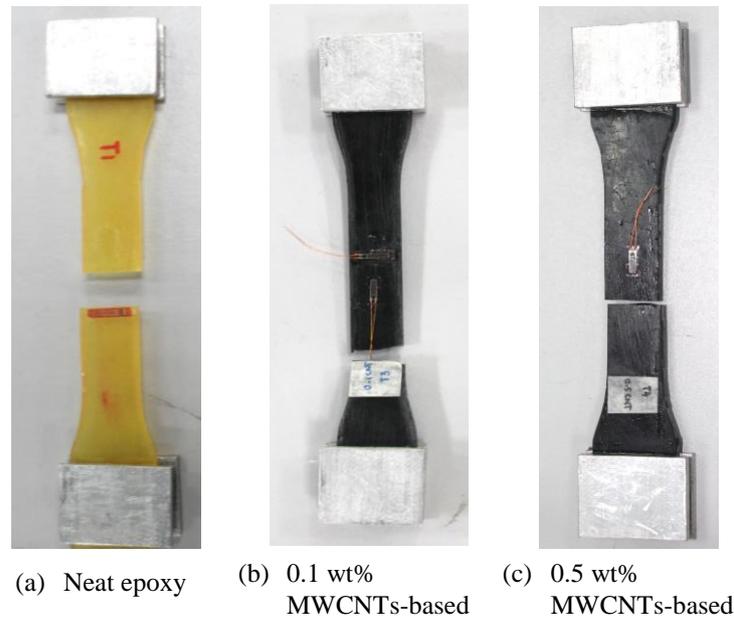
Fig. 7 - The failure of tension specimens

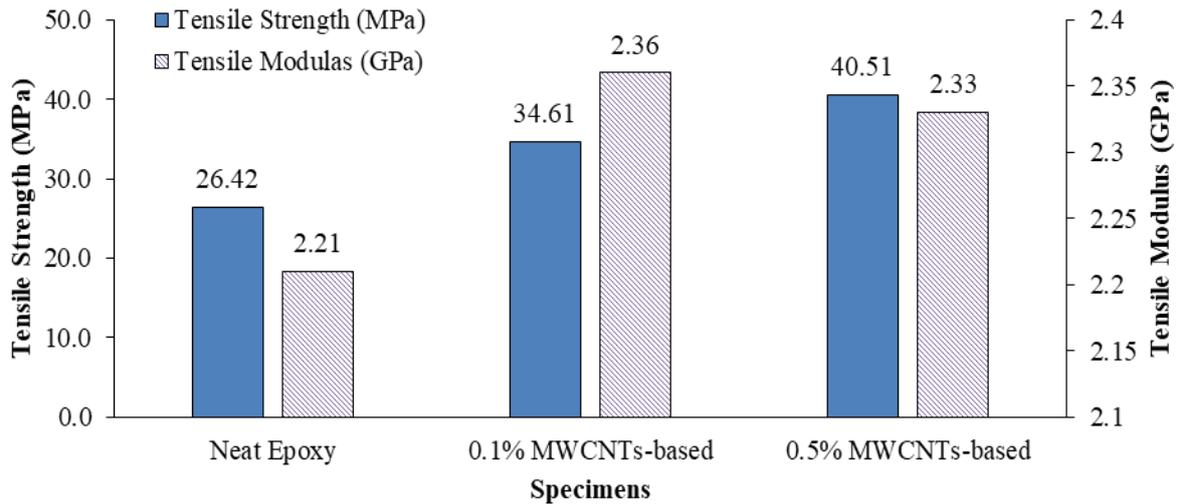
Fig. 8 - Specimen tensile strength and tensile modulus

Fig. 8 shows the effects of MWCNTs addition on epoxy grout under tensile loading were compared. The tensile strength and Young's modulus of control grout (neat epoxy grout) and modified epoxy grout were found between 26 MPa to 40 MPa and 2.2 GPa to 2.4 GPa, respectively. The inclusion of MWCNTs in epoxy grout has significantly increased the strength and modulus under tensile loading. Fig. 8 shows that the tensile strength of epoxy grouts with 0.1 wt% and 0.5 wt% of MWCNTs nanofiller was 31% and 53.3 % better than the control grout, respectively. The increase of the tensile strength is believed to be due to the MWCNTs' nano-sized dimension. MWCNTs have large reactive surface areas, which contributed to effective stress distribution and reduced interfacial stress concentration [28–30]. However, there is a slight reduction in tensile modulus at a higher percentage of the MWCNTs filler.

Under tension, the bonding interaction is more important than the bridging effects. The strong interface between MWCNTs and matrix has led to higher strength and strain at break under tensile loading. This strong interface allowed the load to be transferred from the matrix to the MWCNTs filler. This enhancement is supported by the Field Emission Scanning Electron Microscope (FESEM) image as presented in Fig. 9. The image indicates that the MWCNTs were evenly distributed within the matrix. From the observation, most of the MWCNTs nanofiller were dispersed into smaller broken particles and ranging out of the epoxy resin, showing a rough profile compared to control grout. This reflects the strong interfacial strength between MWCNTs and the resin matrix, which prevents MWCNTs from being pulled out [31]. Thus, it effectually improves the mechanical properties of modified epoxy grout. However, some MWCNTs bundles

were observed at higher content of MWCNTs, which is referred to as re-agglomeration that might have occurred during the curing process. This could be a reason for the modulus reduction on the higher MWCNTs content.

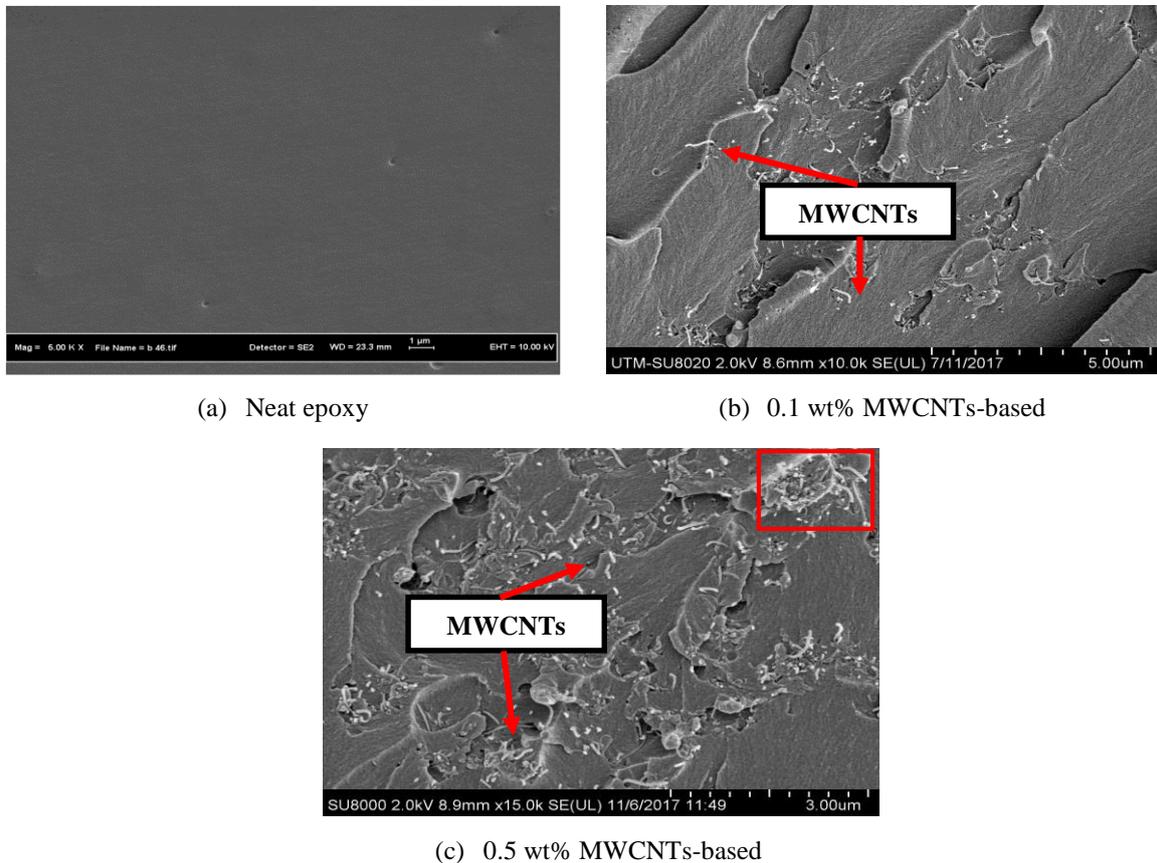
Fig. 9 - FESEM image of the fracture surface of control and modified epoxy grout

The dispersion of CNTs using ultrasonication and a three-roll mill has shown good results that correlate with previous studies [32–34]. The effect of shearing in the three-roll mill surely has succeeded in tearing the MWCNTs agglomeration. The material’s high strength is attributed to an exceptionally high surface area of MWCNTs, which in turn exhibits a very high interfacial area [35]. Hence, the stress transferability across the interface is easily facilitated. The surface area provided, which was combined with the specific mechanical nature of the nanofiller and the aspect ratio is a determining factor for strengthening the epoxy mechanical matrix by nanoparticles. Therefore, a good nanofiller impregnation is a prerequisite before the potential of MWCNTs as structural reinforcement.

A strong bond at the adhesive/substrate interface indicated that the interaction between MWCNTs and the matrix was achieved, which improved the adhesion performance of the MWCNTs/epoxy grout material to the substrate. MWCNTs nanofiller was also found to increase the roughness surface of the matrix as captured in the FESEM image. Hence, the mixture of an epoxy grout with MWCNTs increased the bonding strength of particles with the material in contact. This indicates that the component will be durable throughout its service life. Other than that, it also can be explained that MWCNTs might have infiltrated properly within an epoxy matrix. However, no further improvement was observed at the higher content of MWCNTs. Since infill material is only used in small quantities, further addition of MWCNTs content might not be appropriate. The FESEM image also shows a bundle of MWCNTs in the matrix, which restricts load transfer from the matrix to the nanofiller.

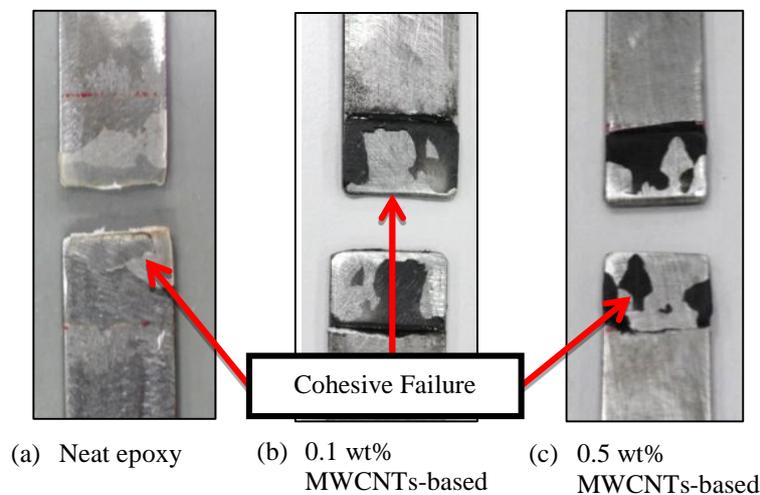
Fig. 10 - The failure of shear specimens

The findings show that the addition of the MWCNTs improves the adhesive strength of the epoxy grout. For both modified epoxy grout, the bonding strength increases by around 13% compared to the control grout, from 5.83 MPa to over 6.62 MPa and 6.63 MPa. On average, modified epoxy grout with 0.1 wt% and 0.5 wt% of MWCNTs show comparable shear strength despite differences in nanofiller content. The improvements in shear strength using this nanofiller have also been reported in the literature [10], [36]. The failure surface of the tested grouts is shown in Fig. 10. As can be seen, parts of the matrix remain on both surfaces of the steel coupons, signifying the cohesive failure pattern for all tested grout. This shows that the chemical bond between the matrix and the steel coupon (steel) exceeds the solidity of the matrix.
