**MECHANICAL PROPERTIES OF CARBON-  
BASED EPOXY GROUT AS INFILL MATERIAL  
FOR STEEL PIPELINE REPAIR**

RESEARCH VOTE NO.:

RDU1703239

Faculty of Civil Engineering & Earth Resources  
Universiti Malaysia Pahang

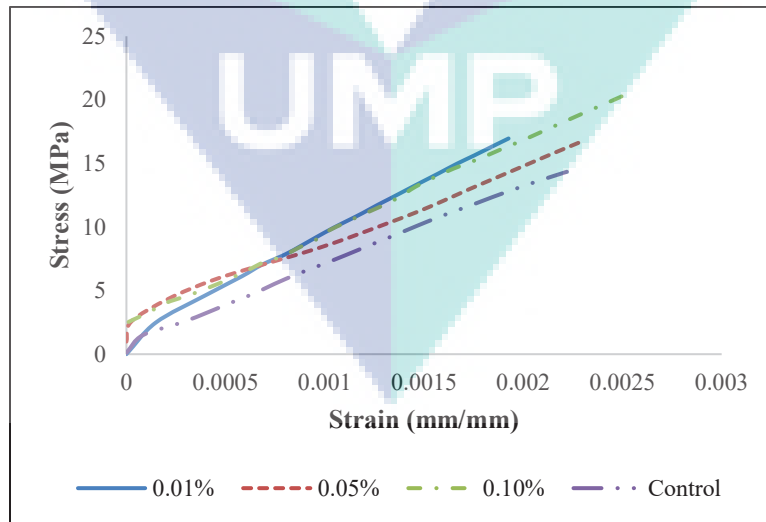
FIGURE 3. Relationship of stress-strain for tensile strength.

Figures 3 and 4 show the stress and strain relationship for tensile and compression tests, respectively. As can be observed in both figures, only linear behaviour is exhibited which represents elastic behaviour up to failure. There is no noticeable plastic deformation can be detected in the figures. This signifies the brittle nature of the all samples. This finding also supported when close observation is done to examine the failure pattern of the samples. Figure 5 shows the failure pattern for tensile (top) and compressive sample (bottom). The tensile sample split into two parts while a vertical crack was noticed for compressive sample at maximum stress.

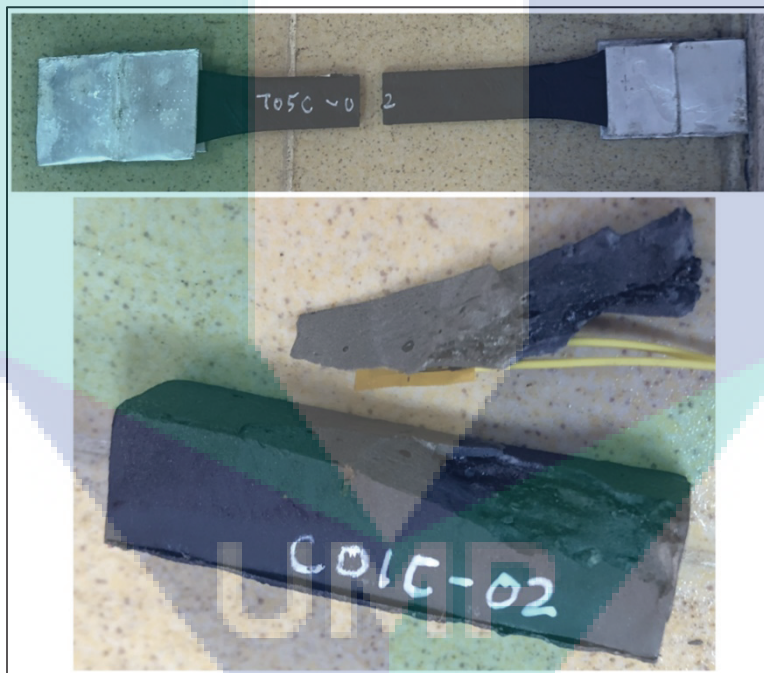
FIGURE 5. Failure pattern of tensile (top) and compression (bottom) specimen.

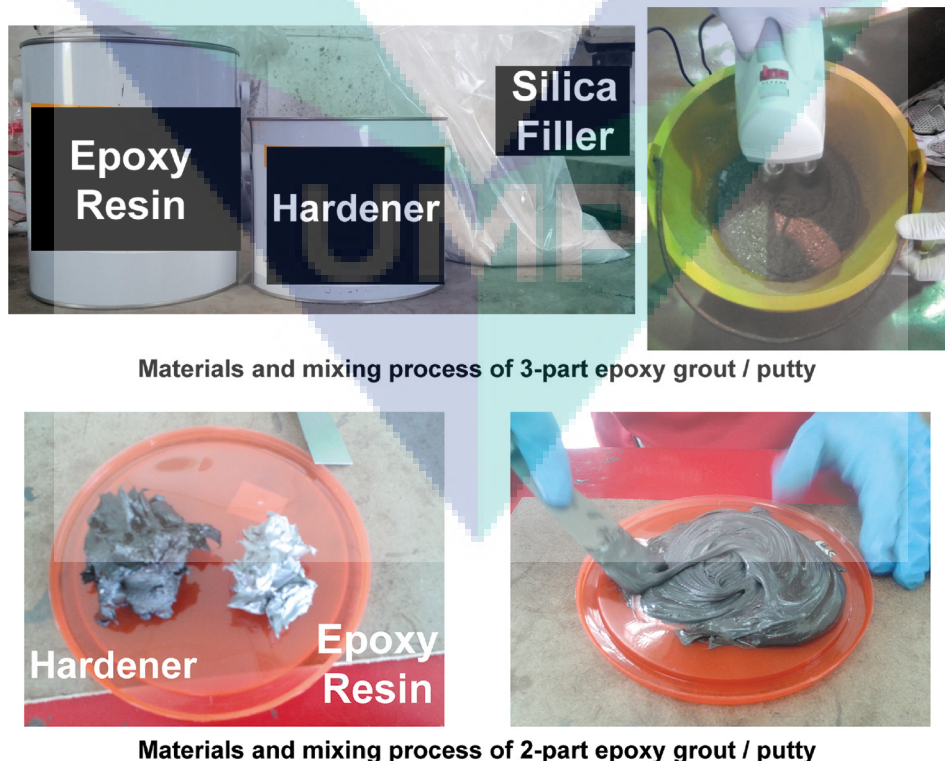
Fig. 1 Material preparation

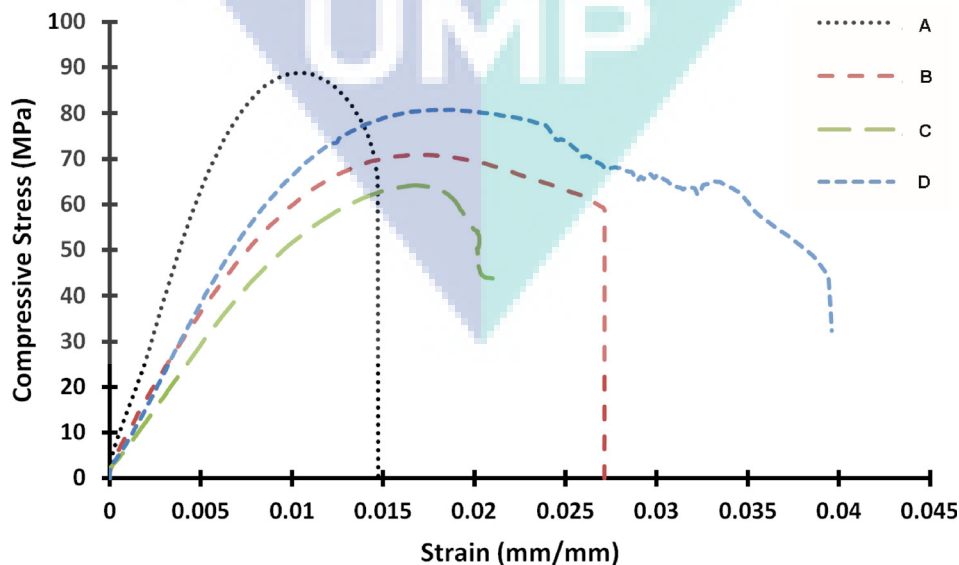
Fig. 4 Stress-strain behavior of all grouts under compression loading

stress-strain behavior. This behavior is often observed for polymeric material under compression loading.

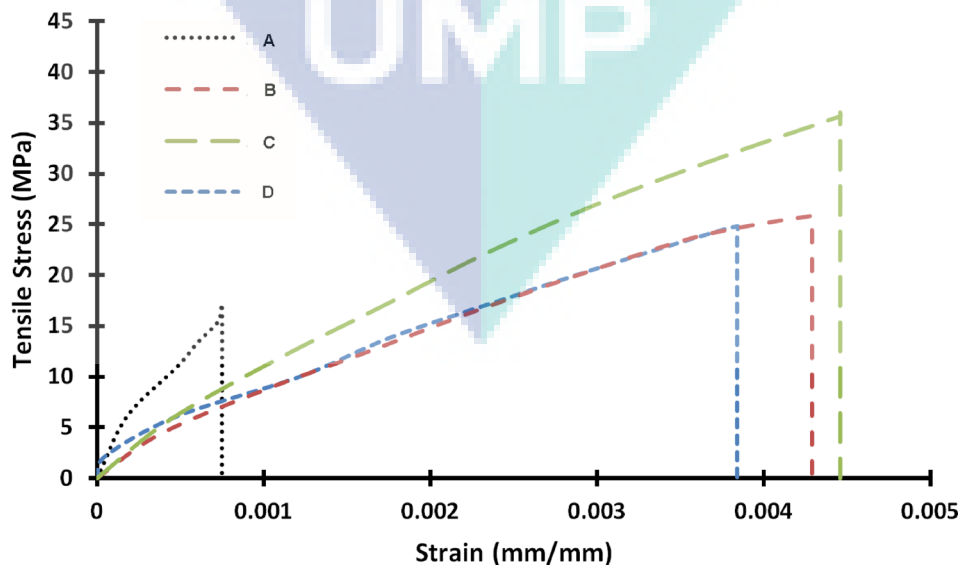
Fig. 6 Stress–strain behavior of all grouts under tensile loading

Figure 6 shows the stress-strain curve for all grouts under uniaxial tensile test. All grouts exhibit much lower ductility under tension as compared with their compression behavior. In addition, the ultimate strength in tension is much lower than those exhibited under compression. As shown in Fig. 6, all grouts exhibit a brittle behavior where no plastic deformation was detected in the stress-strain curve. Linear and slightly nonlinear behavior was observed for all grouts. No noticeable strain hardening or softening behavior can be seen in the graph. Grouts B, C, and D show relatively prolonged deformation as compared to grout A. All samples failed due to splitting, perpendicular to the loading direction when it reached peak stress. Figure 7 shows the fractured sample of all grouts for tensile test. No noticeable deformation such as necking was observed in all samples. Suwanprateeb [35] discussed the failure mechanism of fine calcium carbonate in polyethylene composite. The effect of coarse filler in the resin matrix can be explained in two different ways. First opinion is that the aggregate may be strong enough to provide sufficient

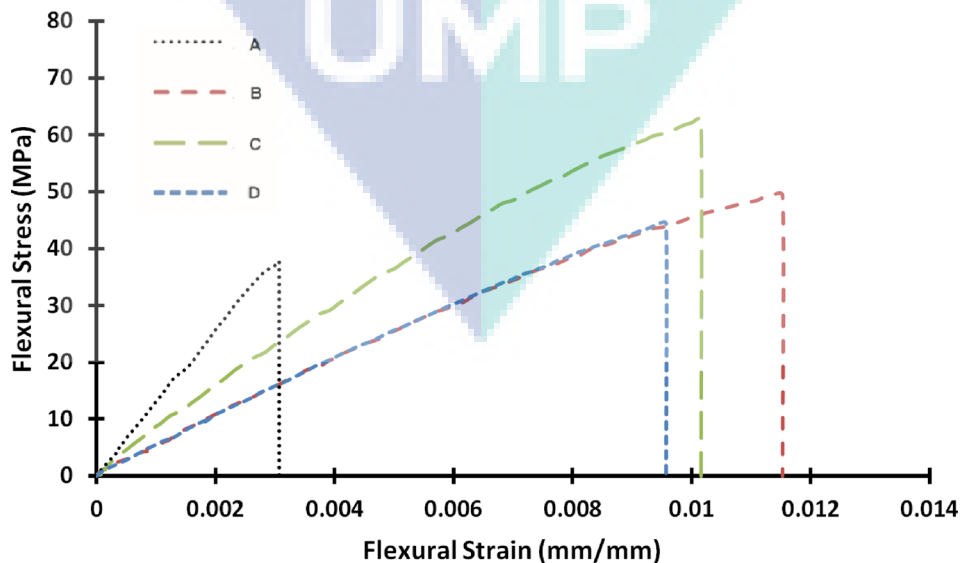
Fig. 8 Stress-strain behavior of all grouts under flexural loading

The stress–strain response of all grouts under flexural loading is illustrated in Fig. 8. The flexural behavior of all grouts is comparable to their respective tensile behavior. Linear and slightly non-linear behavior can be seen for all grouts where grouts B, C, and D exhibit prolonged deflection under flexural loading. Grout A

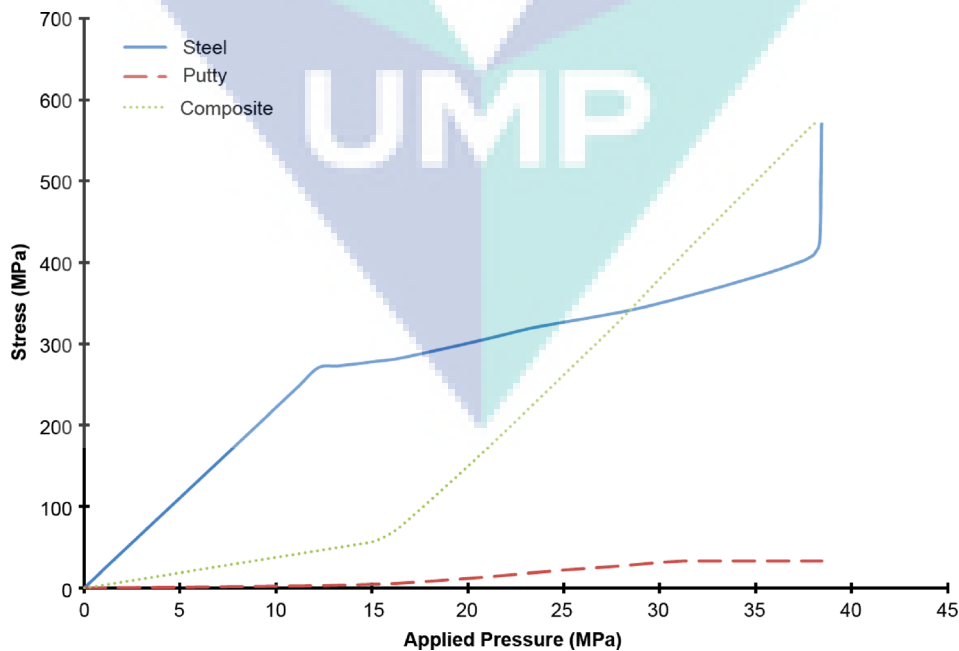
Fig. 10 Stress versus applied pressure of benchmark model

**3.4 Finite Element Analysis.** Representative finite element simulation results at the failure pressure are shown in Figs. 10 and 11. The predicted burst pressure of the benchmark model was 38.9 MPa. The margin of error between the benchmark model and the experimental result is 9.7%. Chan et al. [16] investigated the performance of carbon fiber reinforced polyethylene strip for repairing externally corroded defective pipeline. The authors found a good agreement between the simulated and experimental results with margin of error less than 10%. A variation of 10% difference between the simulated and the experimental burst pressure is regarded as acceptable [16,31]. As seen in Fig. 11, highest stress concentration was observed near the edge of the defect region of steel pipe as shown by the arrow. This is the predicted failure location in the model and matches the failure location in the experimental test conducted by Duell et al. [29]. As seen in Fig. 10, at the initial loading stage, the stress of steel pipe was found relatively higher than composite and putty. This phenomenon can

be linked to the stiffness of all components. The stiffness of steel pipe (207 GPa) is relatively higher than putty (1.74 GPa) and composite (49 GPa). At this elastic zone, the higher the stiffness, the higher the resultant stress. At this stage, the deformation (bulging) is restricted, and therefore, only small portion of load is being transferred to other components. As the pressure continues to increase beyond the yield stress of the pipe, the stress rate of steel pipe has decreased as indicated by the gradient of the stress-pressure curve. This signifies that the stress of pipe is being largely transferred and shared out to other components. At pressures beyond 29 MPa, the stress in composite has surpassed the stress in steel. As the pressure continues to increase to about 38 MPa, the composite has reached its ultimate stress (576 MPa). At the same applied pressure, a sudden increase of stress was observed in steel pipe (from around 410 MPa to 570 MPa), indicating that the failure in steel pipe has occurred. This can be explained as the additional strength provided by the composite is

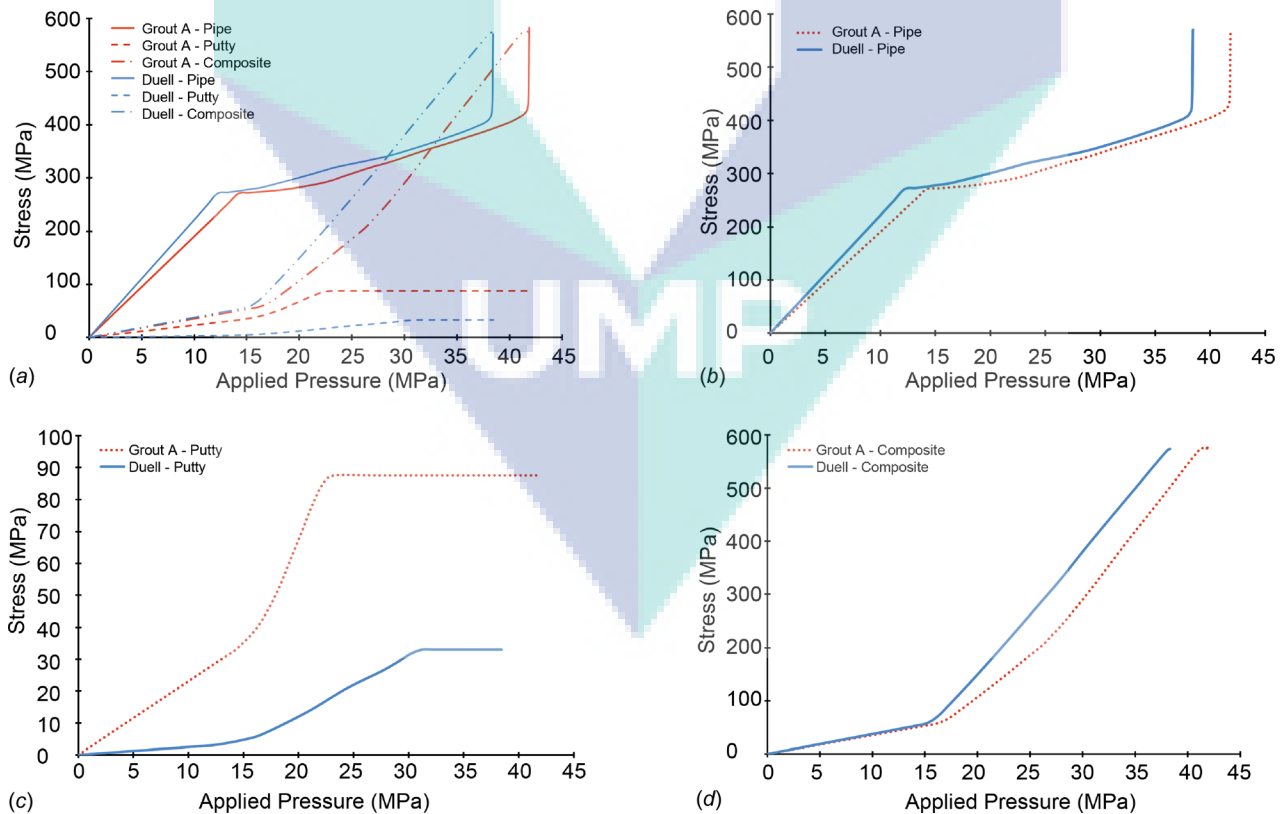
Fig. 12 Comparison of FEA predicted stress as a function of applied internal pressure in steel pipe for benchmark model and grout A model: (a) stress-pressure curve in pipe, putty and composite, (b) stress-pressure curve in pipe, (c) stress-pressure curve in putty, and (d) stress-pressure curve in composite

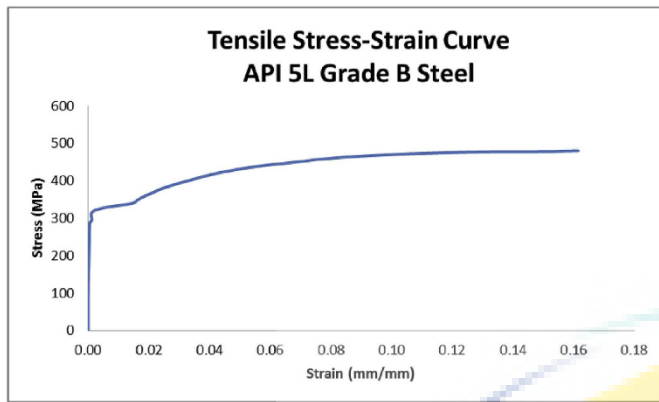
Fig. 4. Stress-strain curve of the steel pipe.

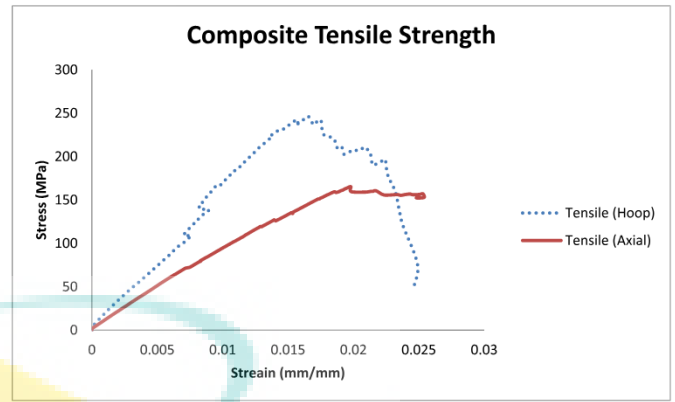
Fig. 5. Tensile stress-strain behaviour of the composite wrap.

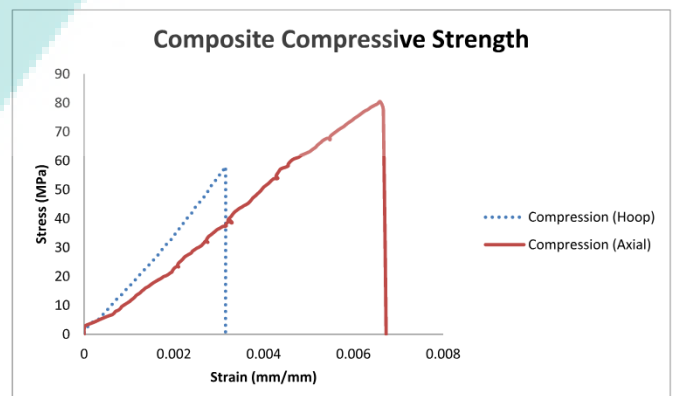
Fig. 6. Compression stress-strain behaviour of the composite wrap.

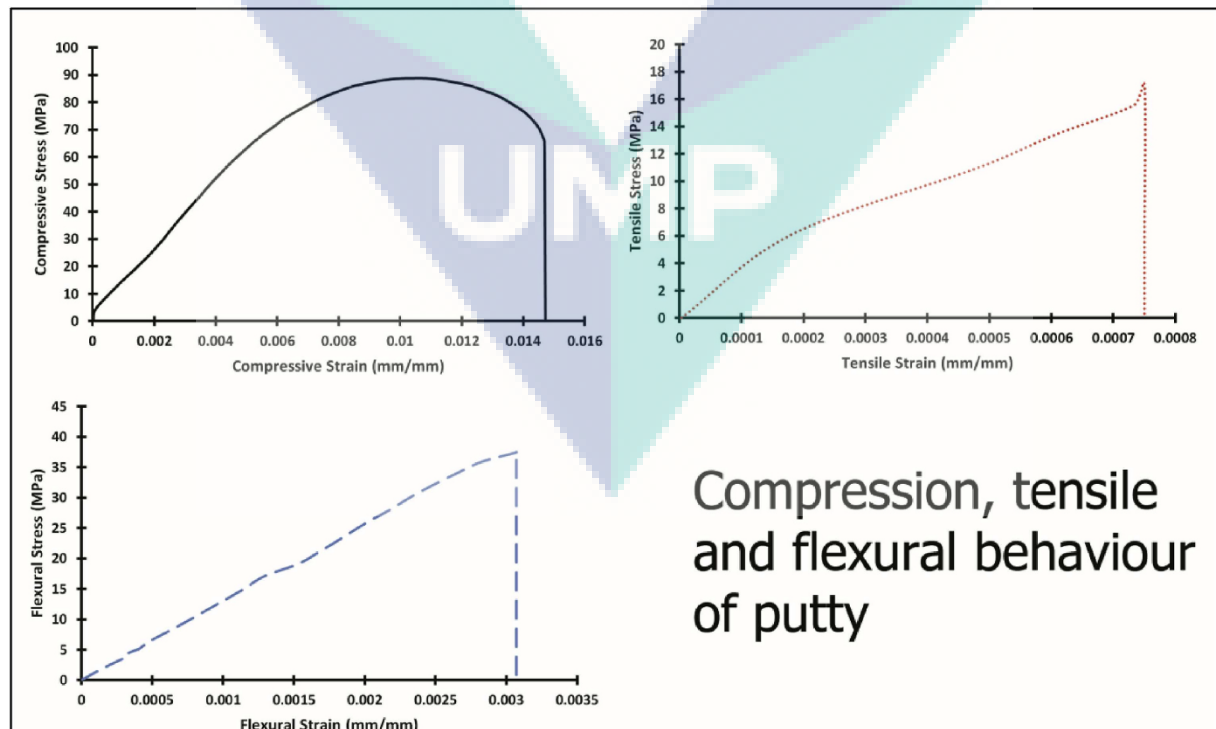
Fig. 7. Stress-strain behaviour of putty under various loading conditions.

12.64 GPa, respectively. Fig. 7 shows the stress-strain curves of the tested putty under compression, tensile, and flexural conditions. A linear and slightly non-linear behaviour was observed in the tests. No noticeable strain hardening or softening could be observed in the graphs. The stress-strain curve plummeted suddenly beyond the ultimate stress region, which indicates brittle behaviour. This is very similar to the compressive behaviour of polymer concrete. Fig. 8 shows the typical failure patterns of the tested putty. The putty exhibits brittle failure behaviour without any noticeable deformation prior to ultimate stress. During compression testing, a vertical crack propagating along the centre of the sample was observed beyond the ultimate stress. An ‘explosion’-like sound was heard and the stress plummeted sharply when failure occurred. No noticeable deformation, such as necking or bending, was observed during tensile and flexural tests [37]. The failure mechanism of fine calcium carbonate in polyethylene composites. The effect of fillers in the resin matrix can be explained in two different ways. According to the first theory, the filler may be strong enough to provide sufficient resistance against failure when failure occurs at the interface of the resin matrix and filler, provided the matrix is stronger than the interface. The second possibility may be that the filler is weaker than the resin matrix and interface. In this case, the rigid fillers act as defects in the composites, which is the case for silica-filled epoxy grouts in the present study. This behaviour justifies the reduction in strength in the tensile specimens of the putty. The highest strength and modulus were recorded under compression testing. The tensile strength of the putty is about 20% of its compressive strength, which indicates a low tensile-compression ratio. This indicates that the tested

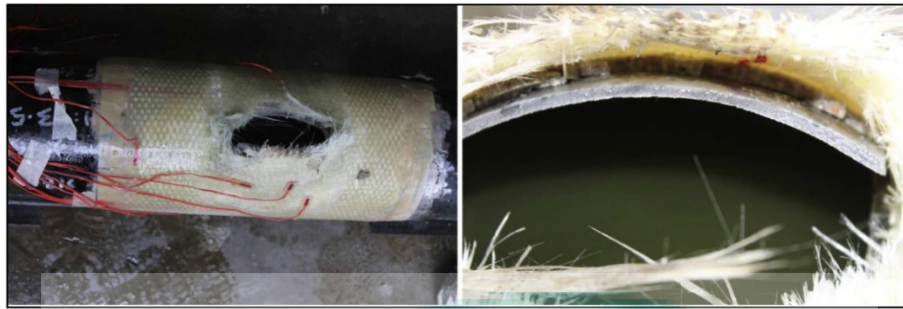
Fig. 12. Failure pattern of the repaired pipe.

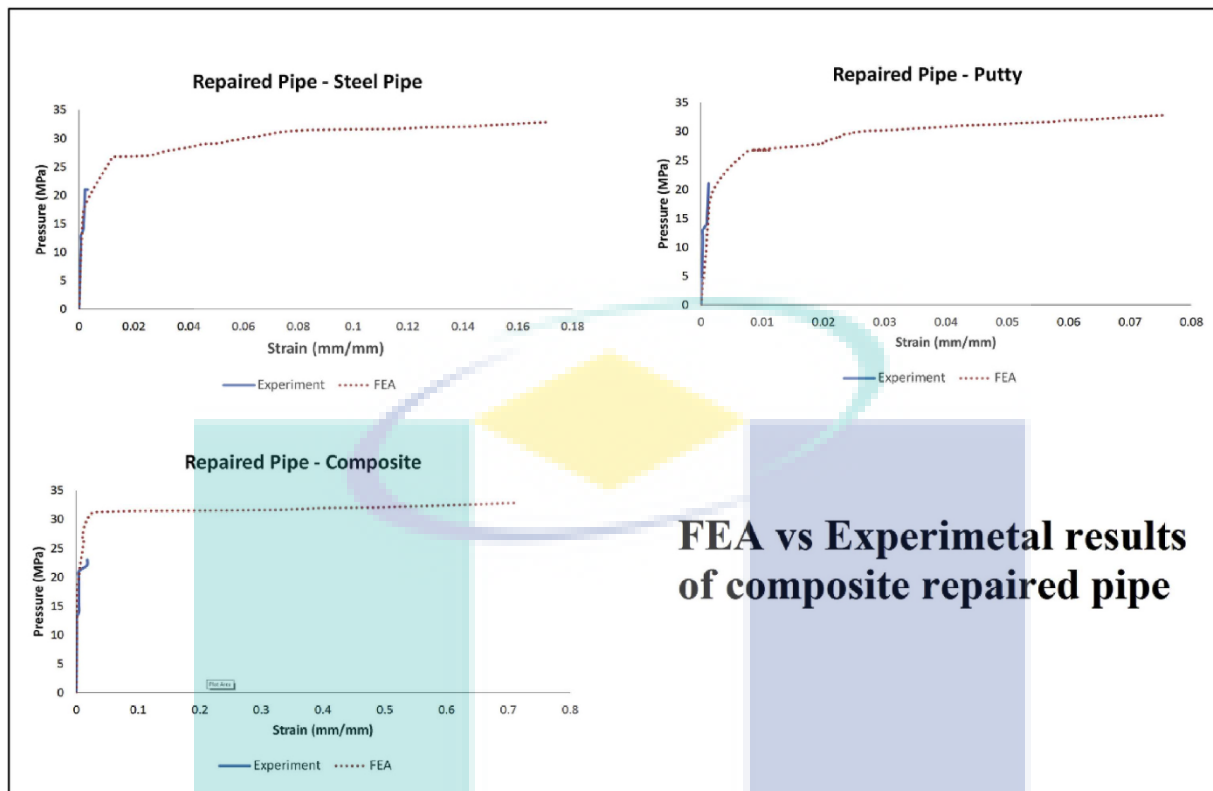
Fig. 16. Comparison between the experimental and FEA results for the repaired pipe.

Fig. 16 compares the experimental and FEA-predicted pressure-strain curves corresponding to the surface of the pipe defect (top left), putty (top right), and composite (bottom left). As can be seen in Fig. 16, the experimental and FEA strain readings of the pipe defect were similar to each other up to 18 MPa, indicating that the simulated result is good up to this point. When the applied pressure exceeded 18 MPa, the FEA model predicted a slightly higher strain than the experimental results, which signifies that the FEA slightly underestimated the performance of the pipe up to a pressure of 21 MPa. Fig. 16 (top right) depicts the comparison between the experimental and FEA results corresponding to the putty. Similarly, with respect to the steel pipe, it was found that the FEA model marginally under-predicted the performance of the putty, which was reflected by a higher strain reading at an equivalent applied pressure. On the other hand, the FEA model was found to slightly overestimate the performance of the composite, as can be seen in the bottom left portion of Fig. 16. The experimental and FEA

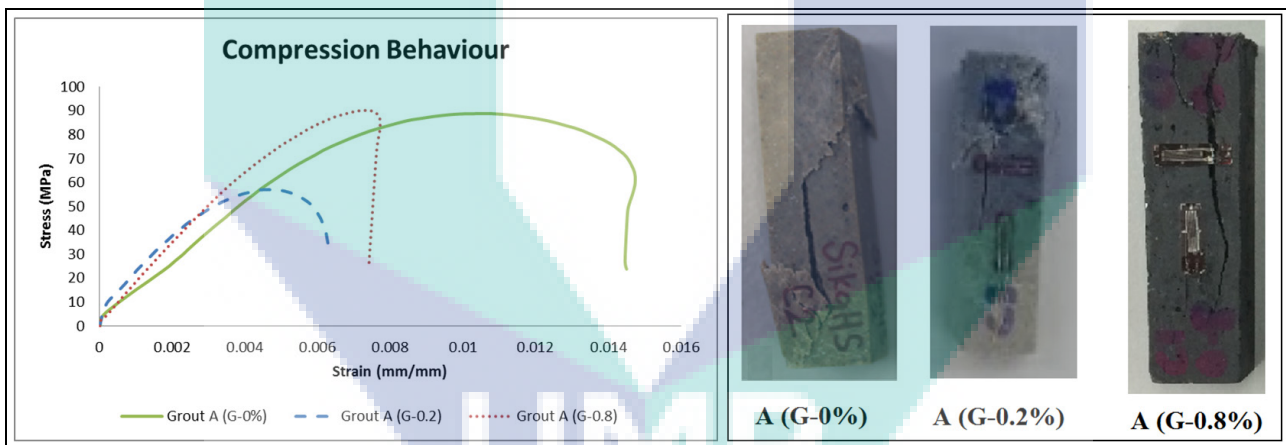
Figure 1 Stress-strain behaviour (left) and failure pattern (right) of compression samples

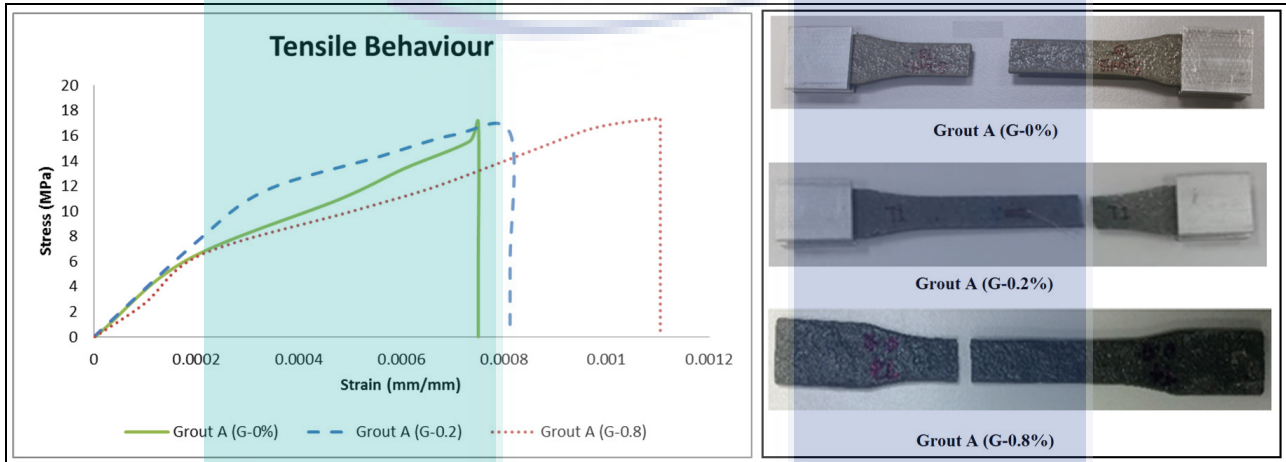
Figure 2 Stress-strain behaviour (left) and failure pattern (right) of tensile samples

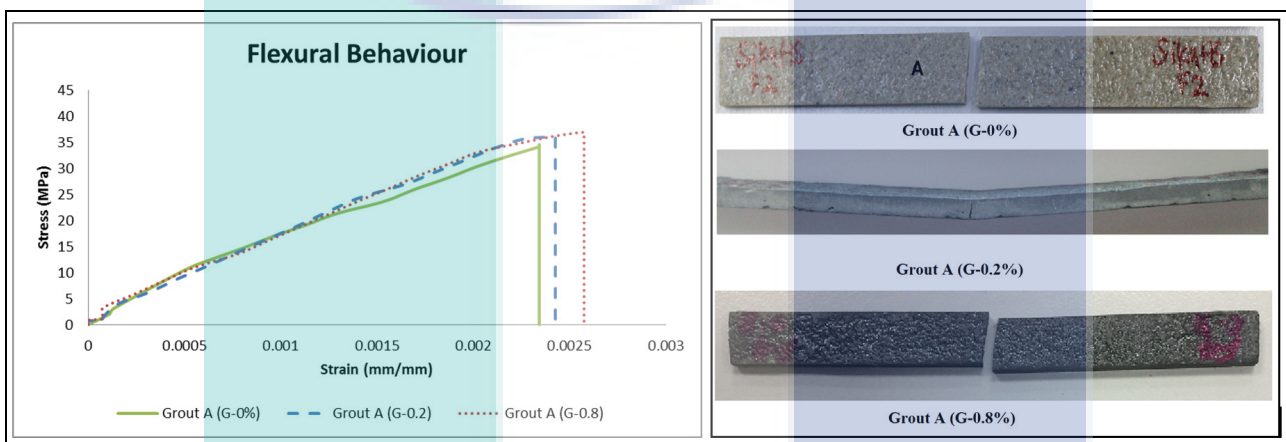
Figure 3 Stress-strain behaviour (left) and failure pattern (right) of flexural samples
