# Case study of Block 1, Highland Towers Condominium collapsed in Taman Hillview, Ulu Klang, Selangor, Malaysia on 11th December 1993

Solahuddin Bin Azuwa<sup>\*</sup>, Fadzil Bin Mat Yahaya

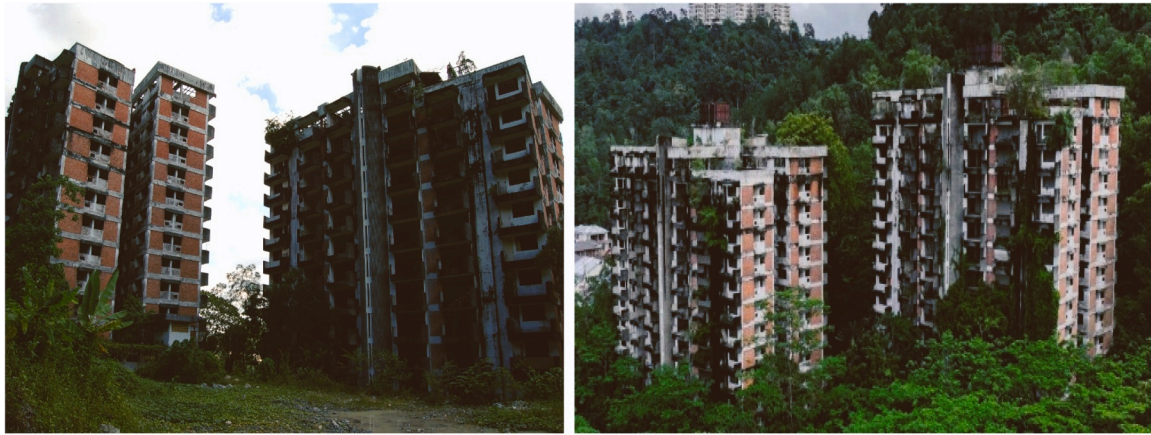
Fig. 3. Blocks 2 and 3, which are firmly standing until now.

The Highland Towers condominium has three building Blocks, each with 12 stories. Between 1974 and 1990, it was constructed in several stages. Blocks 1, 2 and 3 were entirely built in 1975, 1985, and 1990. Block 1 is located in the southernmost region. Block 2 is located northwest of Block 1, while Block 3 is situated west of Block 2. The Highland Towers were residences by upper and middle-class families, including local Malaysian people and foreigners. On 11th December

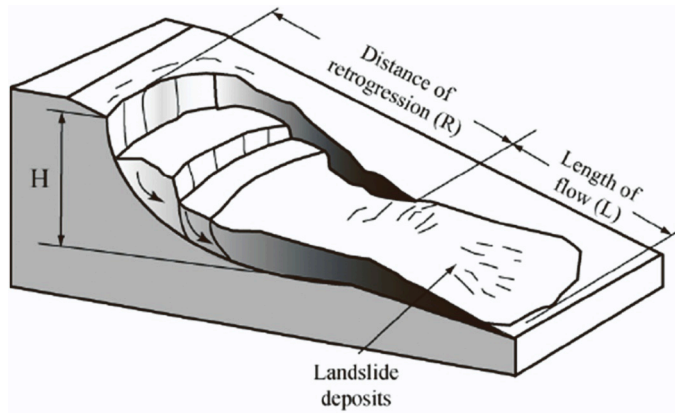
Fig. 5. Retrogressive landslide.

lousy condition during a pre-construction site visit in pre-design phase, and inadequate retaining wall design are the landslide factors [12–16]. Furthermore, the heavy rain triggers a retrogressive landslide behind Block 1, leading to rail piling foundation instability, which cannot withstand the lateral stress. The surface runoff and infiltration rates increase, causing the slope materials to lose, followed by the inclination of the landslide chain reaction [17,18]. Besides that, the drainage flow system is also poor and lacks maintenance. In addition to the numerous previous landslide that have occurred nearby, the landslide at Highland Towers is being studied in detail since it causes substantial compensatory and non-compensatory building damages. Fig. 4 demonstrates block 1’s cross-section, including side, front and plan views [18], while Fig. 5 illustrates retrogressive landslide.

The pile foundation of Highland Towers is unstable, which leads to the building's collapse. When the rotating retrogressive slide happens, the downhill forward movement creates a surcharge load over the foundation since the engineer did not correctly estimate the horizontal load design. Moreover, it collapses because its foundation cannot withstand horizontal loads due to landslide. Since landslide is becoming more common, slope engineering is currently a top priority. The artificial slope is considered the leading cause of landslide failures. Thus, this issue shall be addressed immediately. This landslide occurs because of bad city planning, shoddy quality, and lack of technical knowledge. According to one assessment from a specific industry in Malaysia, 90% of 50 big landslide in a country can be traced back to the slopes created by humanity [22,23]. The necessity to methodologically address the uncertainty caused by human variables is still not widely acknowledged. Some experts agree that the tensions ruling with soil parameters and the chosen models are analogous to the delays in building construction projects. The Malaysian authorities also acknowledged the significance of human uncertainty factors. In the simplest form, human reliability analysis determines how much attention should be paid to various sources of uncertainty arising from human activities that cause landslide. When discussing building designs, the influence of human uncertainty under the label of the humanity factor is also recorded [24–26]. The human factor term describes a physical or cognitive characteristic of individual or societal behaviour that seems unique to humans and affects the technology operation system and human environment. Subsequently, human factors are depicted as the primary cause of the uncertainty increases. These human factors are challenging to consider during the building designs, which can cause stress on the reliability and safety of a building. Errors in the design and construction of a product or system might occur when the relevant information for failure avoidance is unavailable, unused, or wrongly used in the design applied in a component system [27–29].

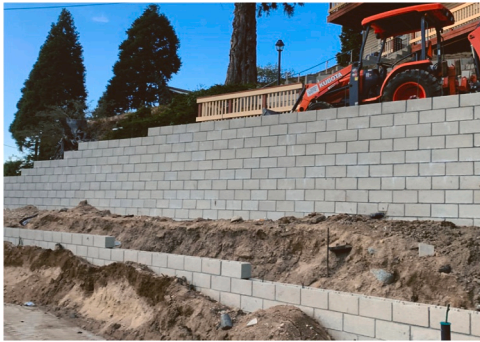
Fig. 9. Gravity retaining wall.

When earth or other material substances are piled up behind a wall, the wall is considered a gravity retaining wall [30–32]. The purpose of gravity retaining wall is to prevent potential landslide by detaining the soil's lateral force load [33–35]. Besides that, it is also a crucial structural component of highways and other environmental constructions when constructed on contoured soils or soils with varying elevations [36,37]. The size and location of the area where lateral soil pressure acts must be fully and carefully investigated before constructing a gravity retaining wall or any other retaining wall. The gravity retaining wall design must be correctly calculated to save it from hazards and disasters. In order to properly plan the gravity retaining wall construction, it is necessary to identify several factors at the site, like soil type, sliding angle, and weight of soil volume [38]. Several studies recommend that the gravity retaining wall be designed to withstand slope earthquakes [39,40]. Fig. 9 shows the gravity retaining wall.

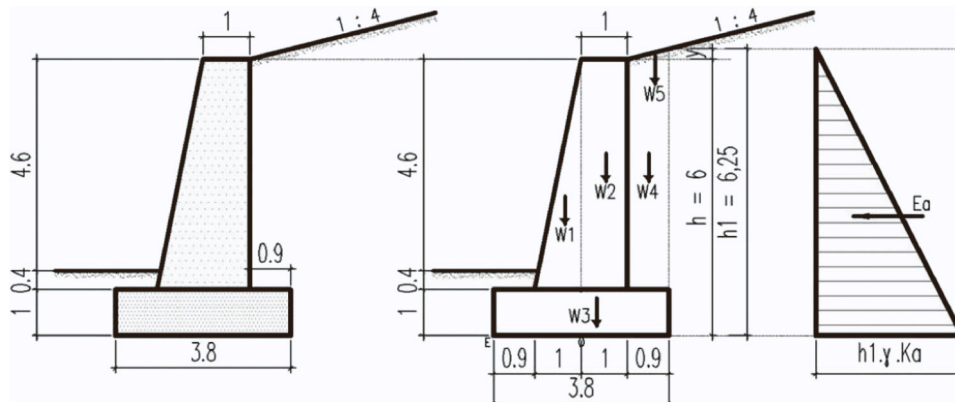
Fig. 10. Dimension (4–4.5 km).

The proposed length of the gravity retaining wall used in this case study is 4–4.5 km. The value details are delineated in Table 2, while the gravity retaining wall dimension is depicted in Fig. 10.

Detail	Value (m)
Peak width (a)	2
Width of foundation base (b)	4
Thickness of foot (c)	2
Width of foot (d)	1
Depth of foundation (e)	2
Foundation base to wall height (f)	7
Width of wall (g)	3

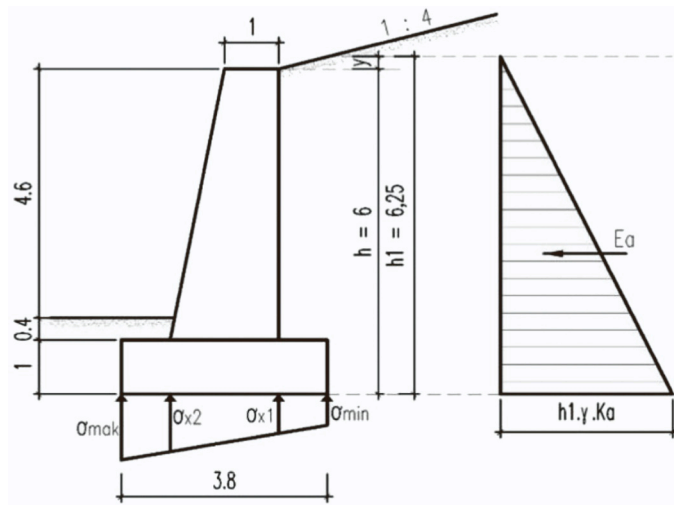
Fig. 11. Construction strength (4–4.5 km).

(1) Construction strength checking (Fig. 11)

$$N_{x1} = N_{\min} + \left(\frac{N_{\max} - N_{\min}}{b}\right)d = 9.28 + \left(\frac{10.31 - 9.28}{4}\right)1 = 9.54 \frac{\text{tonnes}}{\text{m}^2} \quad (10)$$

$$N_{x2} = N_{\min} + \left(\frac{N_{\max} - N_{\min}}{b}\right)(b - d) = 9.28 + \left(\frac{10.47 - 9.28}{4}\right)(4 - 1) = 8.39 \frac{\text{tonnes}}{\text{m}^2} \quad (11)$$

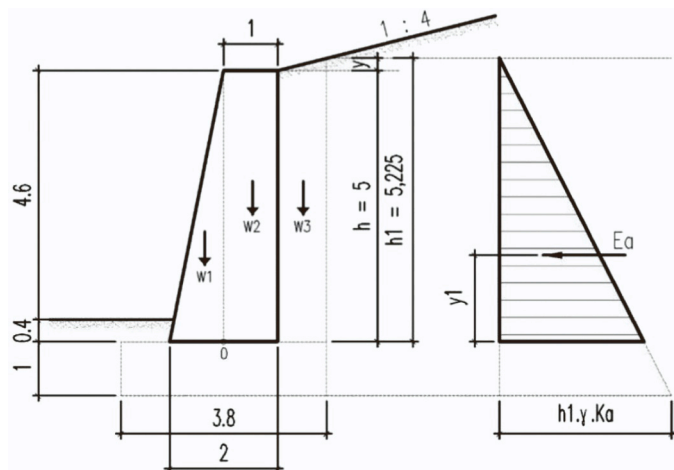
Fig. 12. Body strength (4–4.5 km).

(4) Body strength (Fig. 12)

$G' = 14.58 \text{ tonnes/m}^2$  is less than the allowable amount,  $G'_{\text{allow}} = 150 \text{ tonnes/m}^2$  and another  $G' = 10.65 \text{ tonnes/m}^2$  is less than the permissible amount,  $G' = 30 \text{ tonnes/m}^2$ . Both values are proven to show that the design is safe.

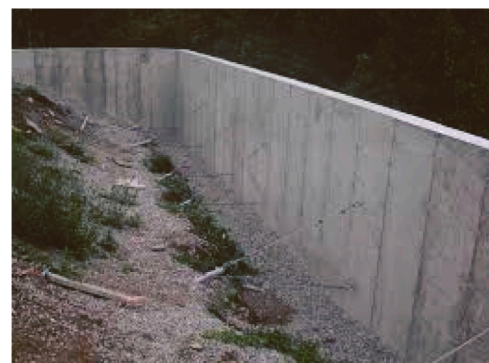
Fig. 13. Cantilever retaining wall.

A cantilever retaining wall refers to a wall that is not directly attached to the ground. A cantilever wall must be adequately designed since it retains a large soil volume. It is also the most typical retaining wall used in construction and is supported by a concrete slab below the surface. Instead of slab base weight, the weight of backfill and surcharge also prevents the wall from sliding and toppling over. Therefore, soil instability and landslide can be avoided and prevented. Steel, concrete or masonry is often in an inverted T shape and serves as an internal stem in a cantilever retaining wall. This wall transfers horizontal pressures from behind the wall as vertical pressures to the ground below. This pressure transfer increases the structural footing stability. In order to withstand heavy loads, the cantilever wall is sometimes buttressed at the front or has a counterfort at the rear. The buttress is an auxiliary wall projected outward from the main wall at a right angle. The concrete footing shall be set at a higher depth than the average seasonal frost depth to maintain stability. On the other hand, this cantilever retaining wall construction also requires less construction materials than gravity retaining wall. Figs. 13 and 14 demonstrates a cantilever retaining wall, while Fig. 13 illustrates the dimension of cantilever retaining wall.

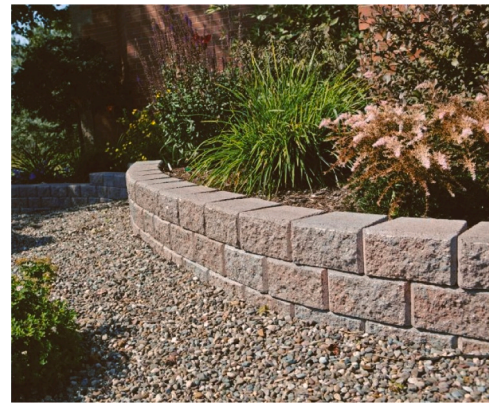
Fig. 16. Wedge blocks at a wall.

$$C = A \sin \phi + B \cos \phi \quad (67)$$

The variable  $\phi$  represents the sliding plane angle. The expression of shear resistive force is based on the Mohr-Coulomb criteria dominated.

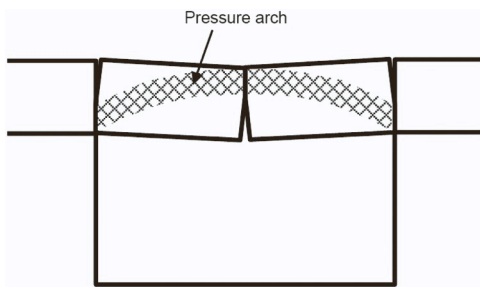
Fig. 18. Two ceiling blocks.

The elucidation of the natural pressure arch notion is facilitated by the arching phenomenon observed in the two block arrangements, as depicted in Fig. 18. An excavation has been made in a rock mass with layers, and the uppermost part of this excavation consists of two distinct blocks that have been generated due to three cracks that emerged across the roof stratum. The low displacement prevention of the two blocks is attributed to frictional forces acting on the fracture planes. Subsequently, due to the influence of gravitational forces, the two blocks undergo rotational motion and exert pressure on each other. Specifically, this pressure occurs at abutment and central fracture plane sections. Consequently, a pressure arch is generated between the two blocks, making them more stable. The original pressure arch is significantly situated from the subterranean aperture ceiling when the

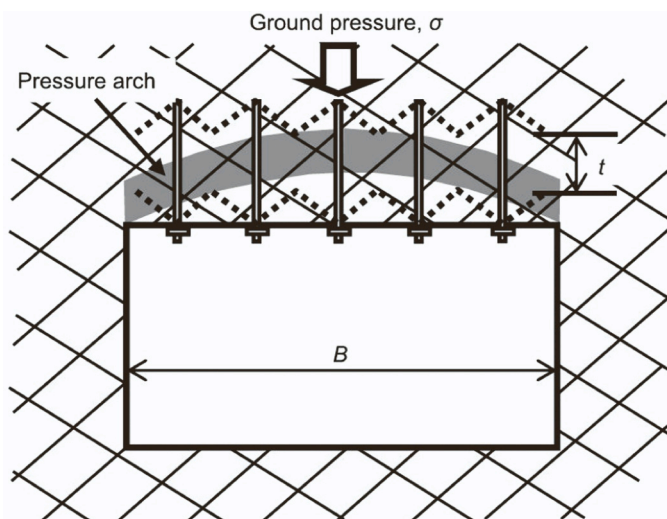
Fig. 19. Bolt-reinforced roof.

The variable  $\sigma_{max}$  represents the upper limit of ground pressure that the pressure arch can withstand. Subsequently,  $\sigma_u$  denotes the rock mass's uniaxial compressive strength (UCS) strengthened by bolts. The

coefficient I exhibits a direct proportionality with the moment arm length within the pressure arch. The I value was determined to be one according to the design calculation steps [47].

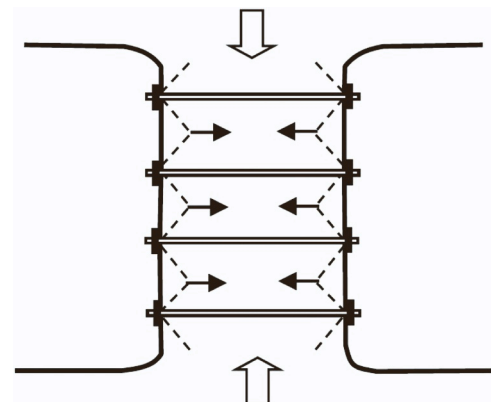
Fig. 20. Tieback bolting.

Rock pillars are commonly used in tieback bolting. Tieback bolting involves using bolts that are in a pre-tensioned state with a reasonably high load and placed over the pillar width (Fig. 20). It's important to keep in mind that tieback bolting isn't meant to increase the pillar's peak strength to avoid failure but rather to keep the pillar together after it fails. The Mohr-Coulomb method expresses the rock strength inflation based on confining pressure  $s_3$  as indicated below:

Consider a pillar fortified with tieback bolts having a 2 m spacing interval. The maximum confining stress imposed on the rock by the bolts is 0.3 MPa with 300 kN ultimate load. The internal friction angles at peak and residual are  $40^\circ$  and  $50^\circ$ , respectively. The enhanced peak and residual strengths are 0.7 MPa and 1 MPa, which are determined from Eq. (8). Normally, rocks have a UCS over 60 MPa. 0.9 MPa strength rise is more significant than the rock's innate strength. Nevertheless, most rock types have weak and unconfined residual strength. Thus, if 0.7 MPa could increase the pillar's residual strength, its behaviour after failure would be enhanced. A hydroelectric plant wall is excavated to create two niches, each measuring 7 m ( $w$ ) x 9 m ( $d$ ), as delineated in Fig. 21. The excavating process caused an extension fracture in the pillar. 2 MN-rated cable bolts were installed at 3 m spacing across the pillar with 500 kN pre-tensioned force. 400 mm concrete cover thickness was cast on both pillars to increase and ensure the weight transmission efficiency from cable bolts to pillar achieves the highest rate. The cable fasteners were strengthened and reinforced with 300 mm x 300 mm square

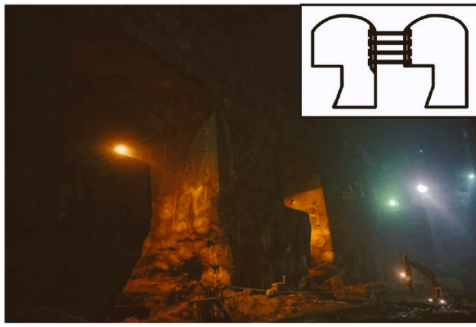
Fig. 21. Pillar cable bolting.

plates. Besides that, the cable bolts produce a maximum confining pressure of about  $2 \text{ MN}/(3 \text{ m} \times 3 \text{ m}) = 0.22 \text{ MPa}$ . For a  $7 \text{ m} \times 9 \text{ m}$  pillar, the load capacity increases from  $25 \text{ MN}$  to  $37 \text{ MN}$  with  $40^\circ$  internal friction angle and  $0.8 \text{ MPa}$  estimated increase in pillar strength.
