APPLICATION OF THE NON-DESTRUCTIVE  
TEST FOR RC ELEVATED WATER TANK  
EVALUATION

Thesis submitted in fulfillment of the requirements  
for the award of  
Diploma in Civil Engineering

Faculty of Civil Engineering Technology  
UNIVERSITI MALAYSIA PAHANG

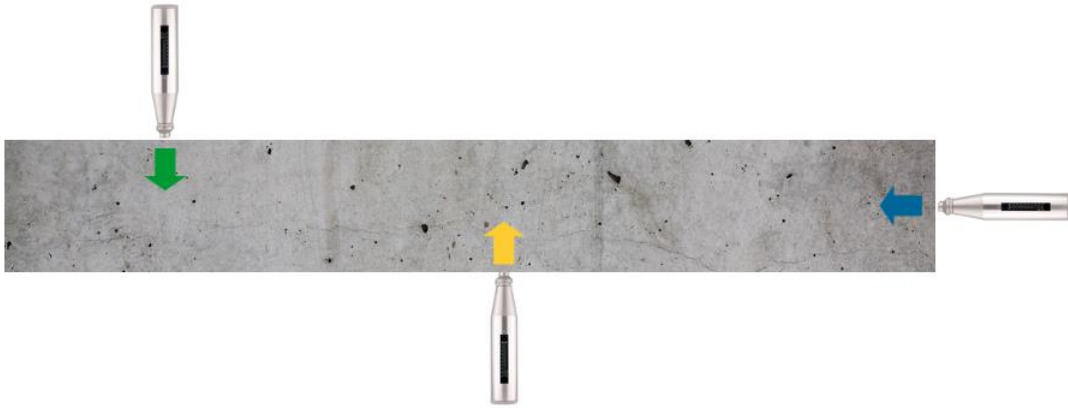
However, the results of the test on concrete are affected by various factors such as the smoothness of the surface, geometric properties of the test specimen, and age of the test specimen (Maitham Alwash et al., 2015). The concrete surface should be carefully selected and prepared to be used by polishing so that the test surface is then ground smooth. A fixed power then applies by pushing the hammer against the surface. The slope angle of the hammer also affects the result. The concrete surface should be carefully selected and prepared to be used by polishing so that the test surface is then ground smooth. A fixed power then applies by pushing the hammer against the surface. The slope angle of the hammer also affects the result.

Figure 2.2 Rebound hammer direction

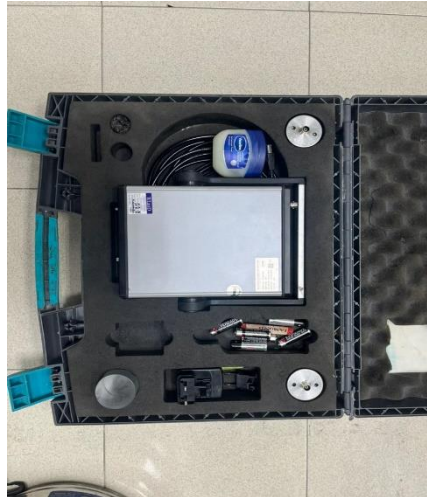
display unit. A pulser/receiver is an electronic device shown in Figure 2.3 that can produce high-voltage electrical pulses to the transducer.

Figure 2.3 Proceq's PUNDIT  
Source: Pundit Lab. Ultrasonic Pulse Velocity Tester (2020)

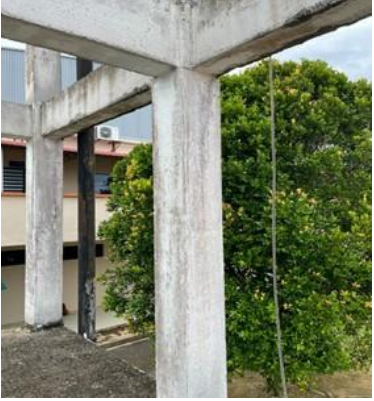
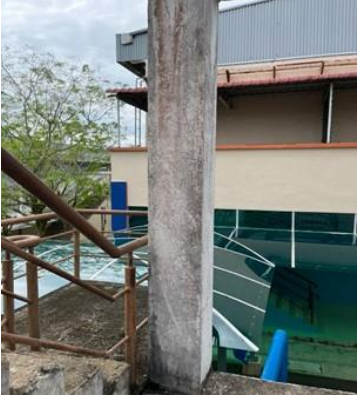
ELEMENT	Column 1 (C1)	Column 2 (C2)
PICTURE

Figure 3.4 Selected columns for testing

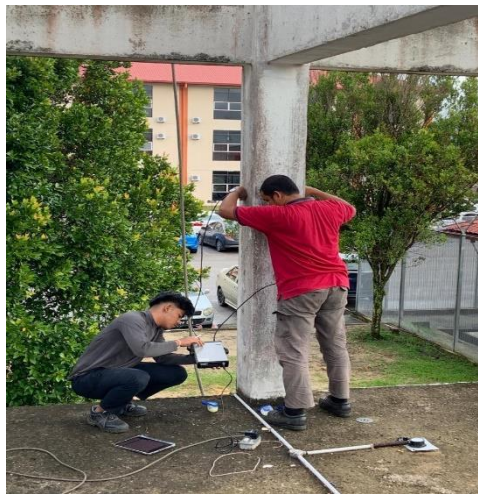
The direct method is used for this test because the maximum pulse energy is received at the receiving head, and there are five (5) readings that were taken for each element. The reading was taken at the top, mid-height, and bottom of the columns, while in the beams, the readings were taken on the right side, left side, and mid-span. The data analysis was done based on BS 1881: Part 203: 1986. Figure 3.8 illustrate the direct method was used for column testing at mid-height.

Figure 3.8 Direct method on mid-height of the column

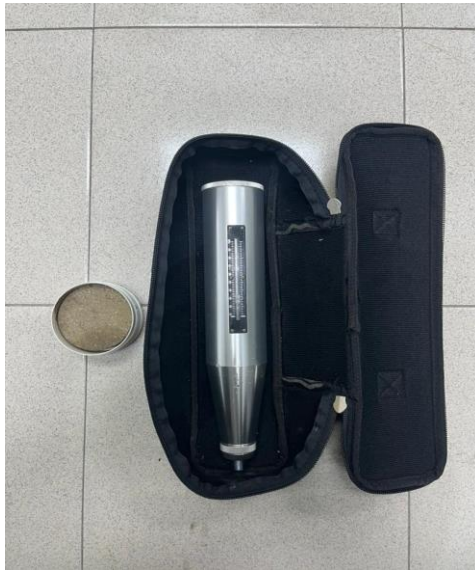
The rebound hammer test was carried out for this study in accordance with BS1881: Part 202: 1986. Figure 3.9 below shows the rebound hammer and grindstone that use for this study.

Figure 3.9 Rebound hammer and grindstone

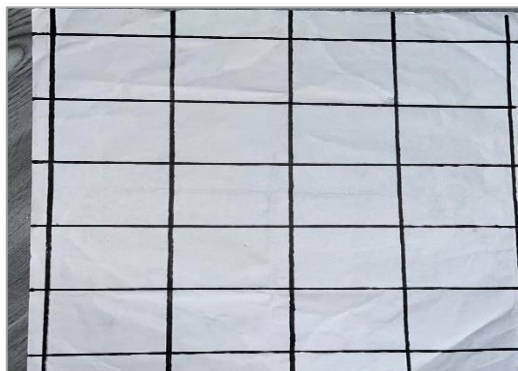
Concrete of columns and beam to be tested were carefully selected, the concrete surface was prepared and smoothed by grindstone. Then, a 500 mm by 500 mm grid are drawn on a sheet of paper as shown in Figure 3.10. The grids will serve as testing grounds for the experiments. The preparation of the grid sheets will precede the testing of the beams and columns for the rebound hammer test. The rebound hammer was positioned against the test surface and the rebound hammer was pushed against the surface at a moderate speed with a fixed amount of energy applied until an impact is triggered.

Figure 3.10 Grid size 500 mm x 500 mm on sheet paper for rebound hammer testing

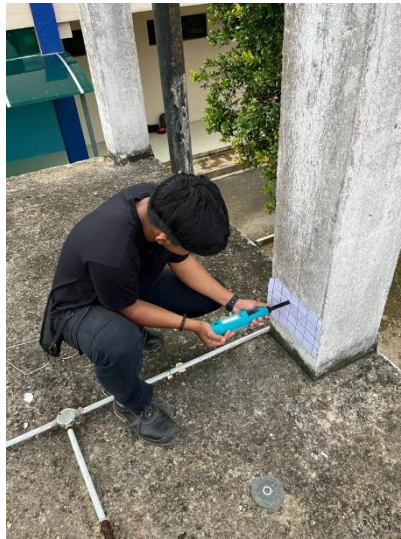
For this test, the direction that has been used is dependent of the location of element. Figure 3.11 illustrate the horizontal direction on column for testing. On other hand, Figure 3.12 shown the horizontal position of rebound hammer on beam during testing. The rebound values after impact were recorded taking at least 36 readings from each part which is three (3) parts for the whole elements which means 432 readings were recorded for two beams and two columns.

Figure 3.11 Rebound hammer testing (horizontal) on the column

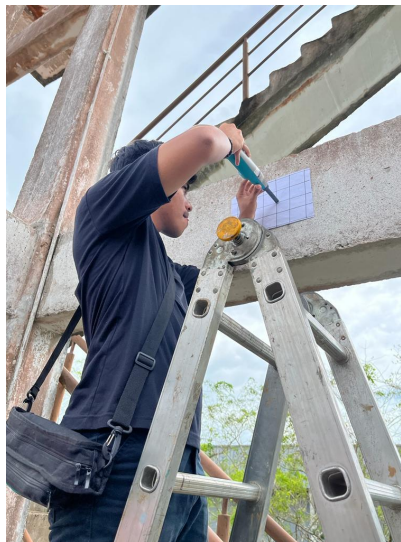
Figure 3.12 Rebound hammer testing (horizontal) on the beam

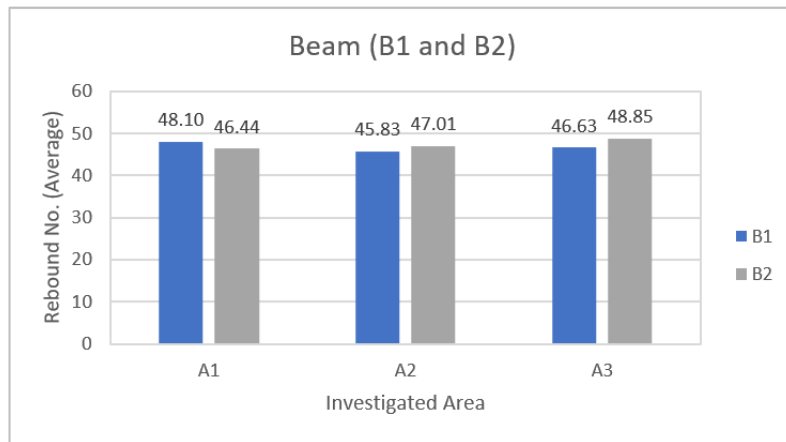
Figure 4.1 demonstrates the results on the average rebound number (index) for the beam on RC elevated water tank. There are three different locations (areas) were tested which are A1, A2 and A3. The result in the figure shows the quality of the concrete surface for the RC elevated water tank. The rebound number for beam 1 (B1) located at A1, A2 and A3 was found to be 48.10, 45.83 and 46.63, respectively. For beam 2 (B2), the rebound number attained for A1 was 46.44, A2 is 47.01 and A3 is 48.85. The quality of concrete for B1 and B2 can be identified as a very good hard layer where the rebound number obtained is greater than 40. The figure also illustrated that the higher value of the rebound number was marked on B2 (A3) followed by B1 (A1).

Figure 4.1 Rebound number for beams

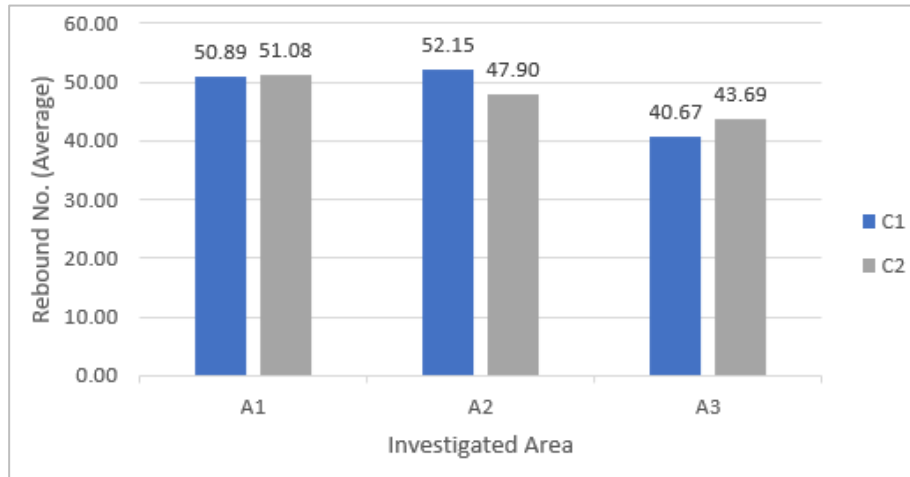
However, Figure 4.3. below are show the results on the average rebound number (index) for the columns. This element also was tested about three (3) different locations which is A1, A2 and A3. The result in the figure shows the quality of the concrete surface for the RC elevated water tank. The rebound number for column 1 (C1) is 50.89, 52.12

and 40.67 which located at A1, A2 and A3 for each value. For column 2 (C2), the rebound number at A1 was 46.44, A2 is 47.01 and A3 is 48.85. The quality of concrete for both columns are in condition very good hard layer where the rebound number is greater than 40.

Figure 4.3 Rebound number for beams

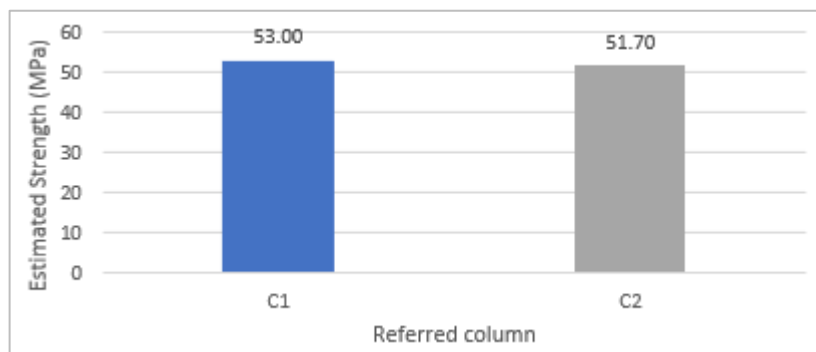
Figure 4.4 shows the predicted concrete strength for the RC raised water tank. According to the graph, column 1 (C1) and column 2 (C2) compressive strengths were 51.03 MPa and 49.00 MPa, respectively.

Figure 4.4 Prediction of concrete strength for columns

The rebound hammer method of estimating concrete strength is not very accurate, and the probable accuracy of predicting concrete strength in a structure is 25% (The Contractor, n.d). For concrete work, the target mean strength should be more than 30

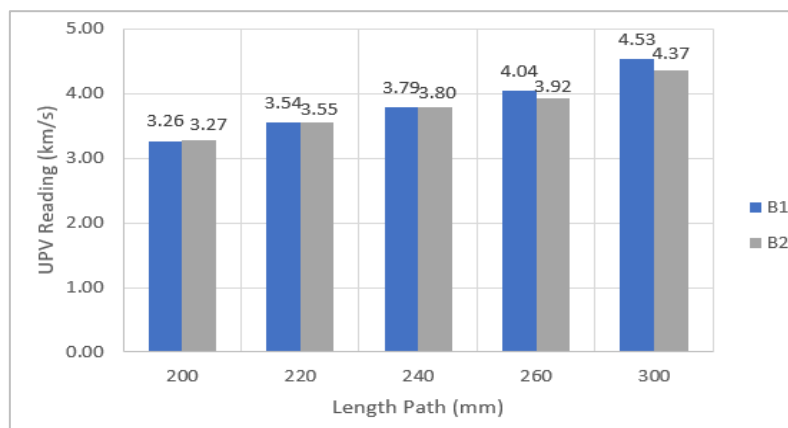
Ultra-pulse velocity was conducted during the test to evaluate the condition of the beams and columns on the RC Elevated Water Tank structure. As can be seen from Figure 4.5, the results of UPV readings for two (2) different beams. It is discovered that the UPV readings are impacted by the various of lengths between the UPV transducers. The UPV readings significantly improved when the path length increased, when the transducers were positioned widely apart from one another, higher UPV measurements were obtained. The value of UPV reading is directly proportional to the length of path.

The direct path length between both transducers may affect the UPV readings. The minimum UPV reading was found for path length is 200 mm for beam 1 (B1) and beam (B2). The UPV reading for both beams, B1 and B2 only 3.26 km/s and 3.27 km/s, respectively. The maximum UPV reading was recorded in B1, which is 4.53 km/s. Based on BS 1881: Part 203 (1986), the quality of beams B1 and B2 can be indicated as excellent because the UPV readings are marked greater than 4.00 km/s at a path length of 300 mm.

Figure 4.5 Effect of path length on UPV readings for the beams

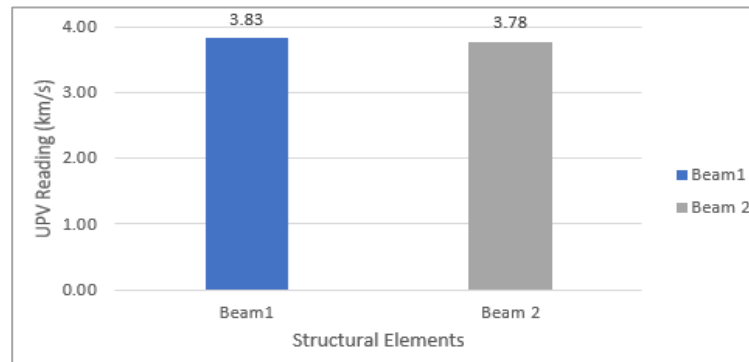
Figure 4.6 shows the typical UPV measurements for beams placed. While B2's UPV measurement was 3.78 km/s, B1's was discovered to be 3.83 km/s. Both in excellent condition in accordance with BS 1881: Part 203 (1986). UPV measurements for B1 and B2 are between 3.5 and 4 km/s, indicating that the quality of the concrete is high but that the concrete beam may have a small amount of porosity.

Figure 4.6 Average UPV reading for beams

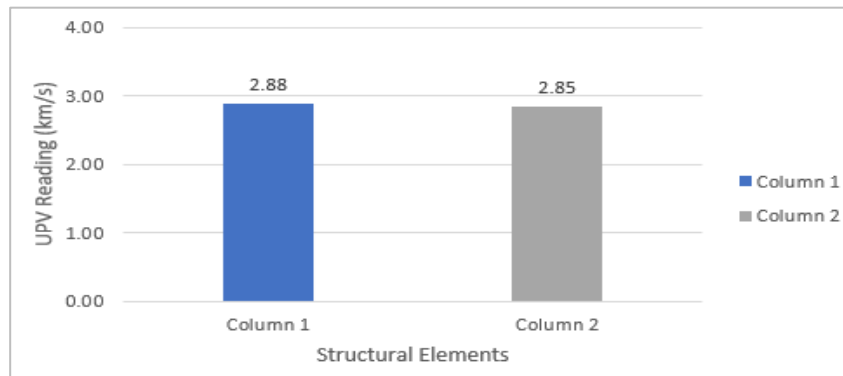
Figure 4.8 shows the average UPV for both columns. The graph shows UPV measurement for C1 was 2.88 km/s while C2 is 2.85 km/s. Based on the standard as mentioned before, both columns in poor condition because UPV measurements for C1 and C2 are below 3.0 km/s, indicating that the quality of the concrete is poor, and loss of integrity exist.

Figure 4.8 Average UPV reading for columns

There are few things that affect the concrete quality after several year. Been exposed to extreme weather may cause the strength of concrete was decrease. The humidity throughout the year causes the concrete to feel damp allowing the reinforcement to be exposed to corrosion. This shouldn't happen because reinforcement bar and

1. Ensure the concrete surface should be smooth, clean, and dry before testing is conducted.
2. Ant loose particles should be rubbed off from the concrete surface with a grinding wheel or stone, before hammer testing.
3. For UPV, constant pressure is achieved through good contact between the transducer and the concrete surface, and the use of a thin layer of grease between the transducers.
4. For inaccurate test results, some additional tests need to be done such as destructive tests.

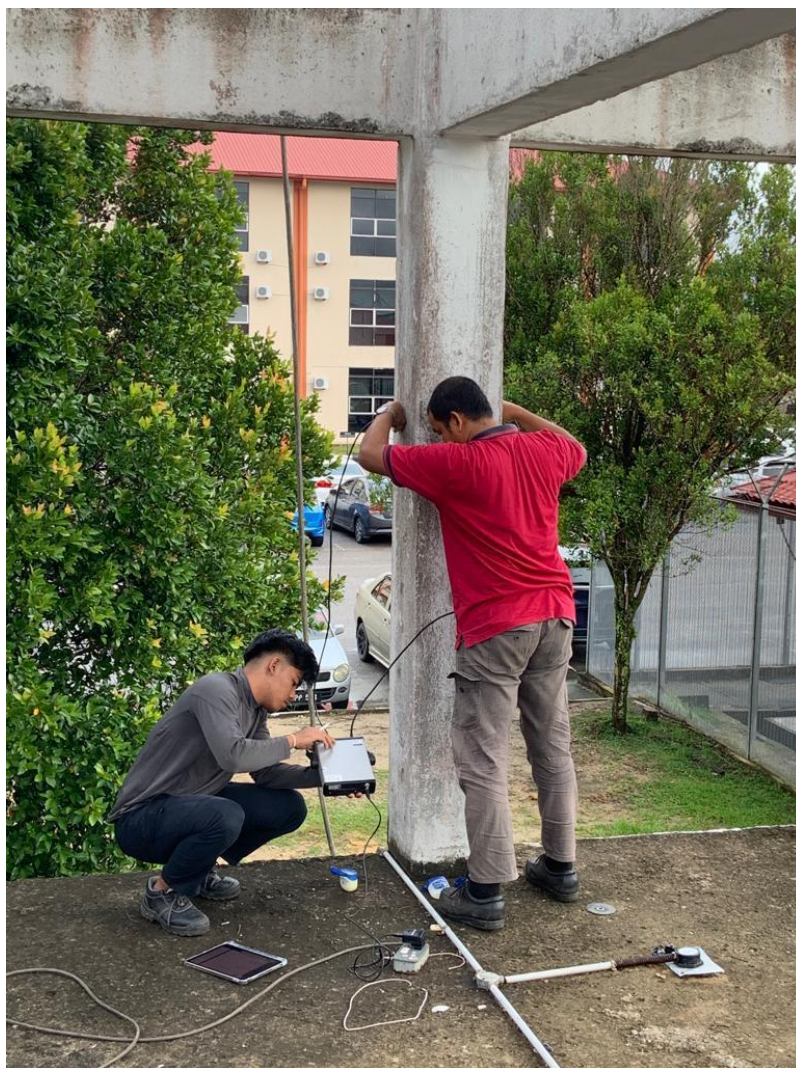
Appendix A: Ultra-pulse velocity (UPV) test on column at mid-height

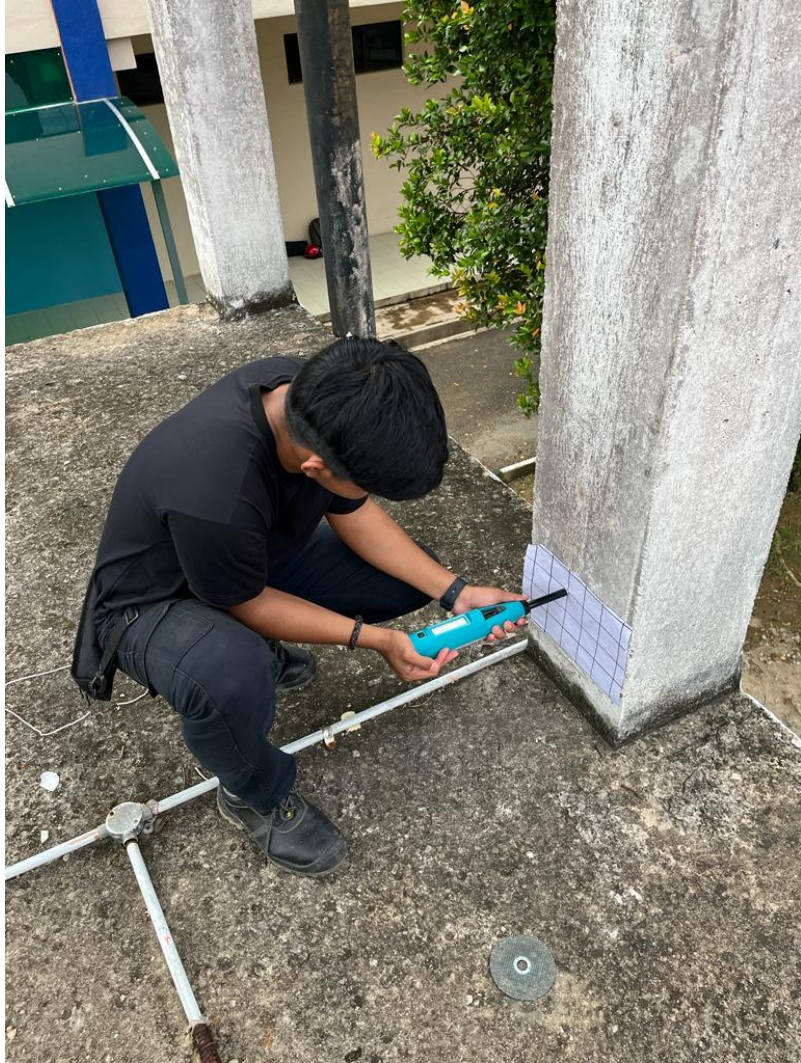
Appendix C: Rebound hammer test on column at bottom

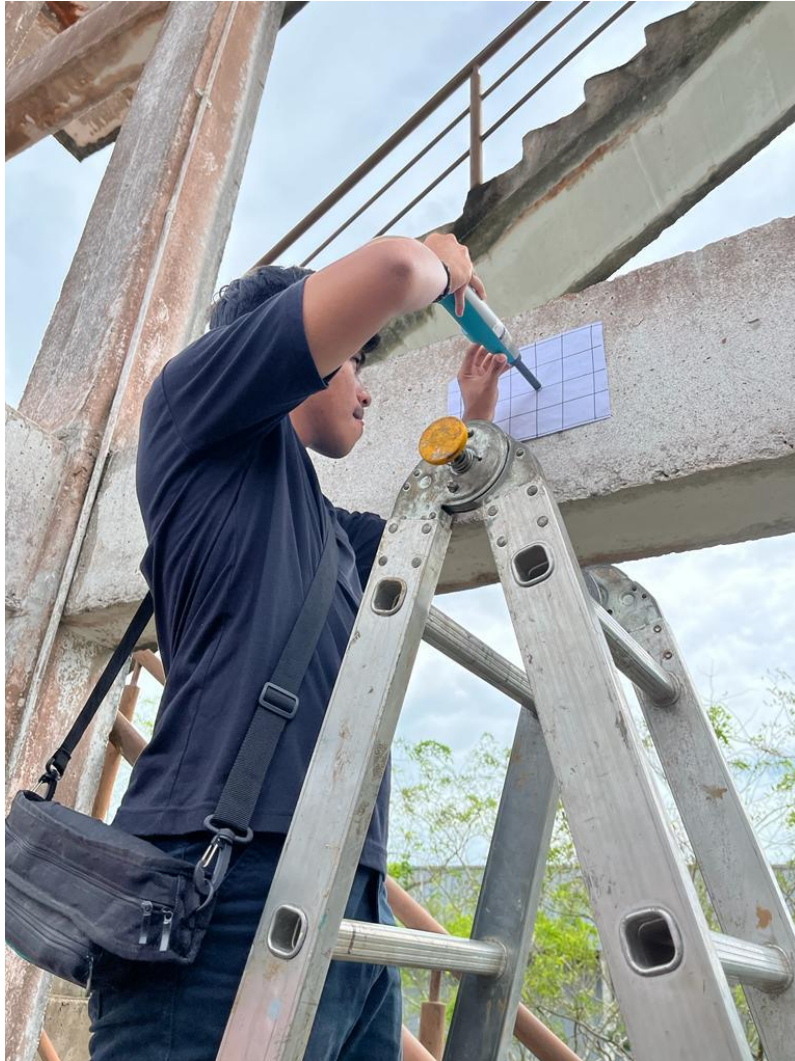
Appendix E: Rebound hammer test on beam
