Review article

A review on experimental observation on structural performance of bamboo reinforced concrete beam

Solahuddin Bin Azuwa

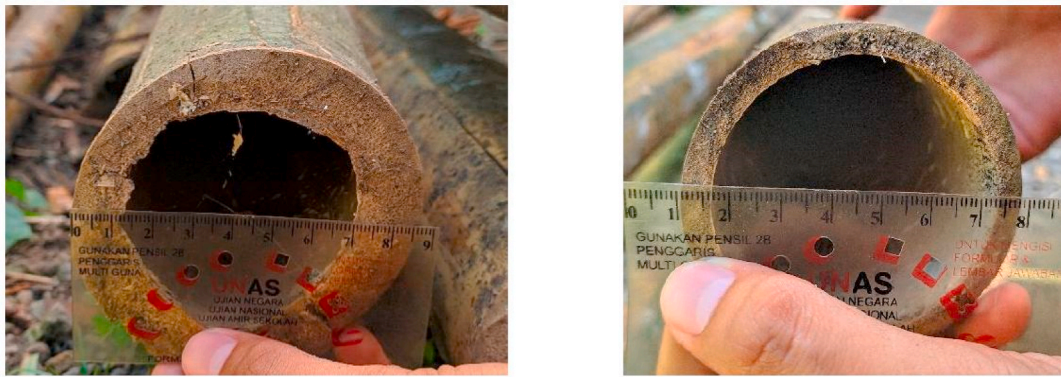
Fig. 3. Bamboo size details.

(a) Diameter=0.07 m, Radius=0.035 m, Volume = 0.33 m³ (b) Diameter=0.085 m, Radius=0.0425 m, Volume=0.4 m³

The UNESCO association estimates that 800 acres of bamboo can yield enough building materials for a thousand homes [58]. Using lumber may necessitate cutting down trees in a forest, which causes harmful environmental effects, such as air pollution, global warming, ultraviolet radiation and the like. So, bamboo is utilised in many China construction projects, especially in bridge construction projects, replacing regular steel reinforcing bars [58] and is also being used to strengthen roads in India [59]. Bamboo is strong enough to handle and support vehicles that weigh up to 20 tonnes passing on bridges and roads. Figs. 2 and 3(a) and 3(b) show the actual bamboo's form and size, respectively. The bamboo has two different diameters, 0.07 m and 0.085 cm, as depicted in Fig. 3(a)

and (b). The bigger the bamboo diameter, the higher the bamboo strength. The formula to calculate a bamboo volume is $V = \pi r^2 h$. The radius for the bamboo in Fig. 3(a) and (b) are 0.035 m and 0.0425 m. The standard bamboo length is 3 m. So, the bamboo volumes are $V = \pi r^2 h = 3.142 \times 0.035 \times 3 = 0.33 \text{ m}^3$ (Fig. 3(a)) and $V = 3.142 \times 0.0425 \times 3 = 0.4 \text{ m}^3$ (Fig. 3(b)). Bamboo in Fig. 3(b) has a higher volume than in Fig. 3(a). The bigger the bamboo volume, the higher the bamboo strength. So, the bigger bamboo volume gives high impact strength when used as internal reinforcement in RCB compared to smaller bamboo volumes and regular steel bars.

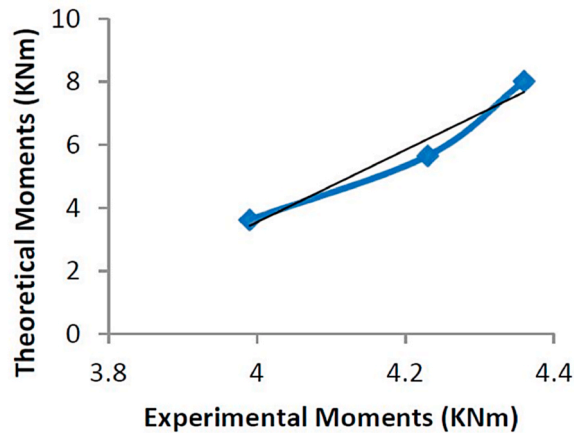
Fig. 6. Theoretical-experimental moments [61].

cracks in the tension zone. Moreover, both factors might have contributed to concrete separation in the compression zone, such as bond failure and dissimilar compressive capabilities of aerated concrete and bamboo reinforcement bars in the compression zone. The ultimate moment variability outcomes are depicted in Table 1. It was clear that the experimentally observed beam behaviour and performance increased with curing ages and bamboo splint counts in the stress zone. The higher the number of bamboo reinforcements in the stress area, the higher the resulting moments produced. The flexural performances of the beam specimens were enhanced by increasing the number of bamboo splints in stress zone. The number of bamboo splints in the tensile zone increased the actual and predicted moments. The theoretical moments were more massive than the moments demonstrated in experimental investigation. The low compressive strength of foamed aerated concrete was due to the voids in the concrete matrices contributing to theoretical moment weakness. It was displayed that the presence of voids in the concrete matrices significantly decreased its compressive strength. The impact of water curing might lead to high experimental moment values obtained compared to air curing. The beam strengths were shown to be increased when performing and getting the beam specimens' experimental results in a wet state, especially immersed in water. In water curing, the beams' cracks and fractures hardly produce, spread, and propagate, contributing to the inclining of compressive and flexural strengths. The scatter plot in Fig. 6 illustrates the correlation between theoretical and experimental moments. The linear associations between theoretical and experimental ultimate moments were positive and significantly retained with a 0.923 statistical correlation coefficient.

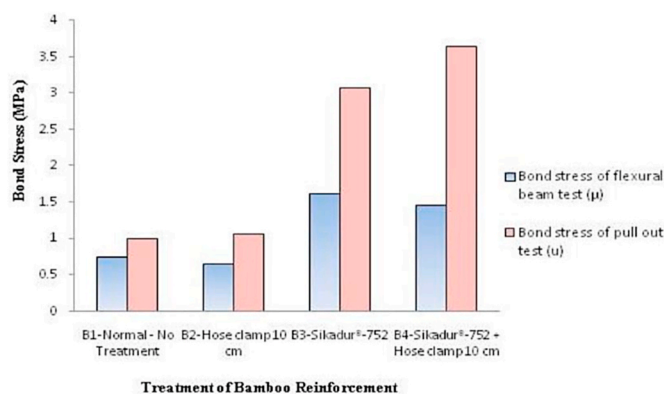
Fig. 7. Bond stress-bamboo reinforcement treatment [62].

In the pull-out test, the bamboo reinforcement embedded in concrete cylinders with a coating of sikadur 863 and a hose clamp ring illustrated an increase in adhesion stress from 475 % to 522 % compared to normal beam without any bamboo reinforcement with distances of 55 mm and 105 mm between the hose clamps. The beams demonstrate various failure patterns, including concrete bond cone and node failures in bamboo reinforcement. They showed that the placement of hose clamps benefited the beam since the bamboo reinforcement was still attached and not ripped off. Collapse bond-slip failure is shown for specimens lacking hose clamp rings. In a few minor cases, the tensile strengths of bamboo samples were substantially higher than the maximum binding stress acquired between the bamboo reinforcement and concrete, causing the bamboo samples to break down during slippage. Besides that, the needless eccentricity was lacking in alignment introduced by the beams during the test. Compressive and tensile forces acted on the concrete surface. The stress was produced by juxtaposition based on the pull-out test. Then, it multiplied with the beam's shear reinforcement area to get the bamboo reinforcement tensile result. The bamboo reinforced concrete beam failed due to a link breaking between bamboo and concrete. The finding and estimation results from the flexural tests conducted on the bamboo RCB were investigated. The bond stress obtained from the pull-out test was higher than the flexural stress. Fig. 7 demonstrates that the bond strength of the regular bamboo reinforcement (B1 and B2) was less than the water-resistant bamboo reinforcement (B3 and B4) with hose clamped at 105 mm distance. Due to subpar hose clamp installation, beams reinforced with bamboo and hose clamp at 105 mm distance were stiffer than normal beams without bamboo reinforcement.

In most cases, the initial loading stage normally occurred with minimal slippage, followed by a steep increase as well as the load approaching the highest support load. Four beams exhibited excellent bonding performance during early loading phases, causing the load-slip curves to become almost linear. Furthermore, a chemical adhesion reaction governed the binding mechanism between concrete and bamboo reinforcement at the load-slip curves' linear point. The friction force between concrete and bamboo reinforcement occurred once the chemical adhesion link broke down. The bond slips between concrete and bamboo reinforcement was formed as the load became higher, causing to reduce the friction force and contact surface damage. Abrupt beam failure was depicted when the applied load approached the maximum support load. B1 and B2 quickly reached their highest loads at 61 kN and 53 kN at low

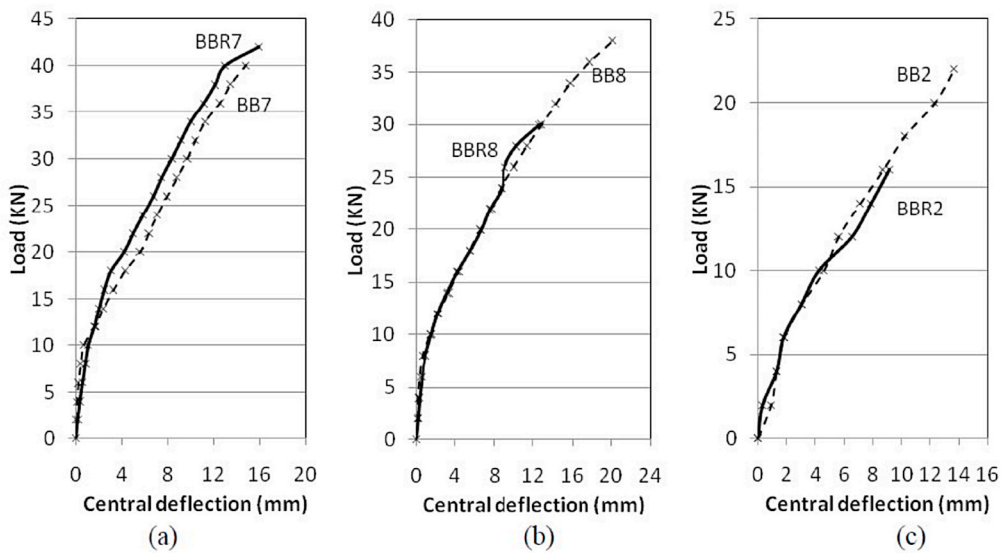
Fig. 10. Load-central deflection [65].

reinforced with a low percentage of bamboo had higher elasticity and ductility than regular beams without bamboo reinforcement. Fig. 10(a) and (b) display two pairs of beams, BBR7/BB7 and BBR8/BB8, that were identical in size and number of shear stirrups but with different tension bamboo reinforcements and concrete strengths. Despite having great tension bamboo reinforcements and concrete strengths, these two beams, BBR7 and BBR8, did not produce the greatest failure load and displacement. Similar beams with lower tension reinforcement than BBR7 and BBR8 had greater failure loads, as shown in Fig. 10(c). BB5-BB8, with tension reinforcement of 5%–6% of the beam cross-section area with less compressive strength, recorded the highest failure load and displacement values compared to other beam groups. These current findings verified the previous findings that 4%–6% of the beam cross-section area should be reinforced with bamboo to produce the maximum tensile strength.

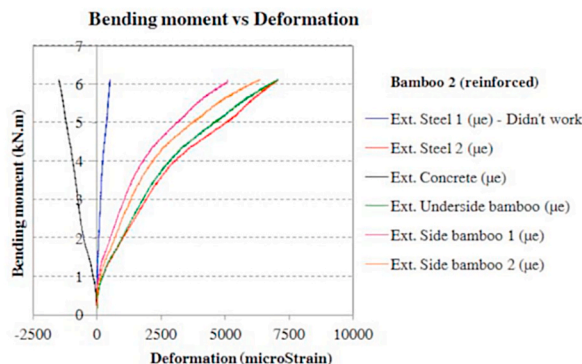
Fig. 15. Bending moment-deformation [68].

The regular beam depicted a typical flow level with more than 8 % deformation for the traction reinforcement in the circumstance corresponding to the final bending moment. Both compressed and crushing concrete areas were diminished due to the concrete's linear behaviour and abrupt elevation of horizontal x and vertical y neutral lines closed to the rupture point. The normal and bamboo beams deformed by 1.36 % and 2 % prior to the beginning of concrete crushing. Nevertheless, the deformation of the bamboo placed on the beam's underside surface practically coincided, indicating that the bamboo was strongly fastened in the beam's internal reinforcement. The lateral bamboo experienced a deformation of 6 %, which made sense as its centre of gravity was situated at the beam mid-span. The regular steel had less deformation than bamboo because the bamboo caused the tensile stress of the beam to incline. There was no clear flow seen when the plastification process began. Concrete crushing, as well as the neutral line fluctuated from its actual position, causing a large deformation to occur in beam 2. The increased strength of the compressed concrete counteracted the tensile stress provided by the bamboo and steel reinforcements, allowing the beam to remain stable until it failed. The beams' cracking pattern is depicted in Fig. 16(a), while the normal and bamboo RCB behaviour is depicted in Fig. 16(b). As forecasted, it could be seen that the beams broke in the middle span right away, where they were subjected to the greatest bending moment. All the tested beams appeared to have similar cracking patterns.

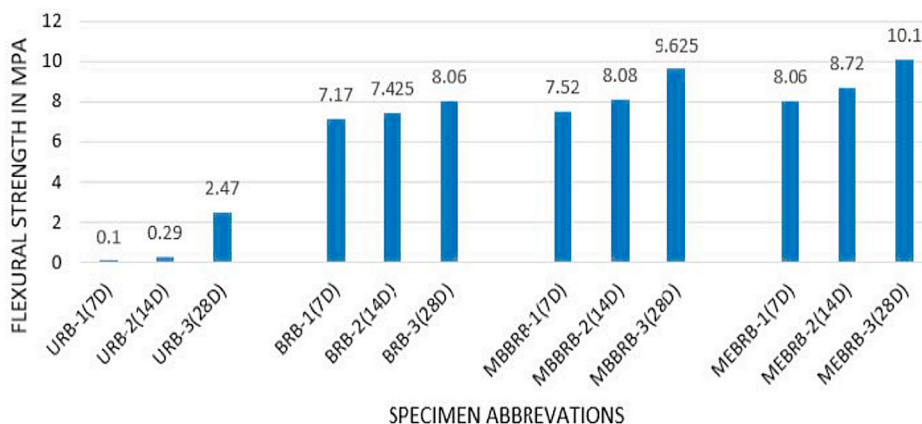
Fig. 18. Flexural strength (7 days) [70].

Based on the experimental results, Fig. 18 clearly shows that the beam reinforced with 3 % bamboo could support greater weight than 1.5 % bamboo and plain concrete beams. The flexural failure load of the uncoated bamboo strengthened beam was six times higher than the unreinforced bamboo beam. The improved bamboo reinforced beams could also support greater weight than their unmodified bamboo counterparts. The load-bearing capacity of bamboo-reinforced beams treated with waterproofing was two times bigger than untreated beams. This bigger load-bearing capacity was because the modified bamboo reinforced beams had better and stronger bonding between concrete surrounding and bamboo reinforcement for load transmission. In addition, the beams comprised covered bamboo with coarse aggregate and sand sprinkled on the top of the bamboo reinforcement. It eliminated the bamboo from taking any moisture from the environmental surrounding. Increasing the bamboo reinforcement percentage usage in beams increased their compressive, flexural, and tensile strengths. The tensile strengths of all bamboo splint cycles were shown. The tensile strength decreased as the number of soaking and drying cycles rose. This result demonstrated that additional soaking and drying bamboo splint cycles diminished the bamboo strength. Subsequently, constant and permanent swelling and contracting caused the bamboo splint to

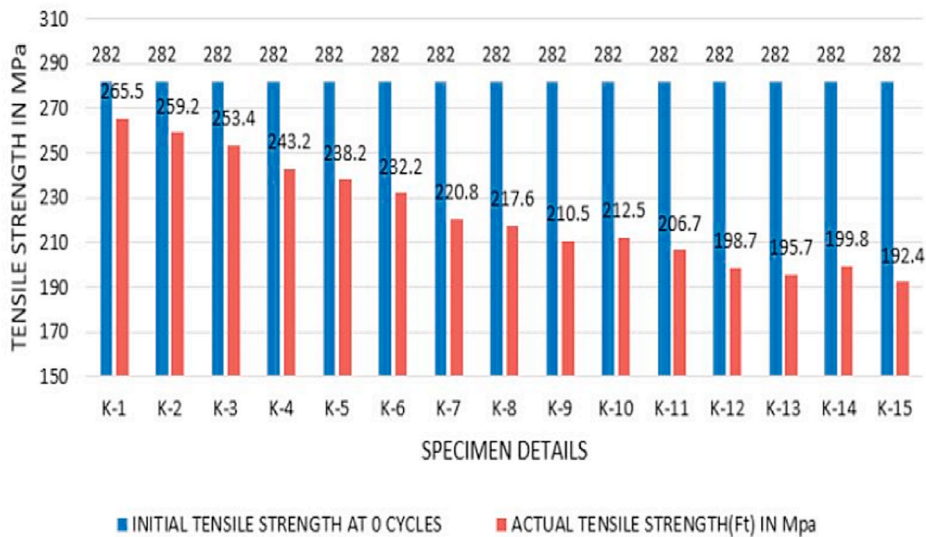
Fig. 19. Tensile strength [70].

lose the fibre bond gradually. The tensile strength results of bamboo splints after alternating soaking and drying in magnesium sulphate solution were investigated. Another thing was the beam tensile strength declined as the number of soaking and drying bamboo cycles inclined. This proved that the bamboo’s durability continued deteriorating when it was subjected to repeated soaking and drying cycles.
