## A comprehensive review of weathering patterns and protective materials for stone relics

To cite this article: Chuang Ma *et al* 2025 *J. Phys.: Conf. Ser.* **3003** 012004

Chuang Ma<sup>1,2</sup>, S. Y. Chin<sup>1\*</sup>, Ashwin C. Benedict<sup>1</sup>, S. Ghazali<sup>1</sup>, and Luxin Yang<sup>2</sup>

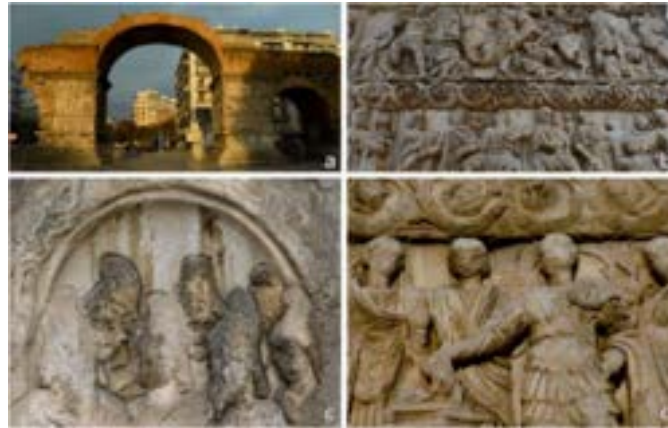
**Figure 1.** The Triumphal Arch of Galerius and the statues as of 2020. a) Arch covered in black crust, b) erosion of etchings, c) significant loss of statue details, and d) loss of finer etchings especially on face and hands of statue.

Figure 1 depicts the current status of the Triumphal Arch of Galerius in Thessaloniki, Greece, which was built during 298 AD and 305 AD, which depicts the damage sustained by the Triumphal Arc of Galerius as of 2020. Figure 1 (a) show the stone surface covered with black crusts, in Figure 1 (b), the statues details have gradually been eroded, in Figure 1 (c), many parts of the reliefs are vanishing, and in the Figure 1 (d), the details especially the faces of the statues have worn away.

In a nutshell, the Arch has experiences significant deterioration due to weathering in recent years [24].

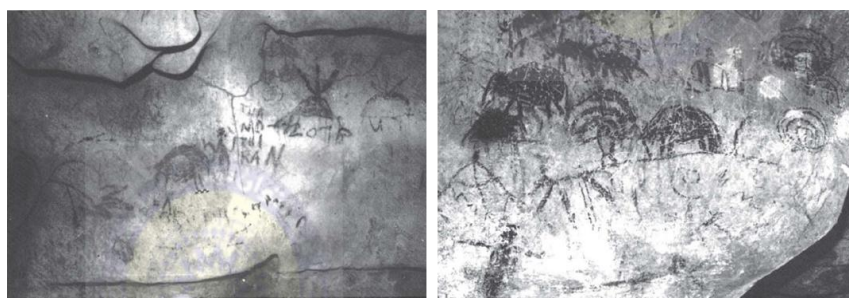
**Figure 4.** Paintings in the Gua Kelawar cave, Perak, Malaysia.

Figure 4 shows the paintings in the Gua Kelawar cave, Perak, Malaysia, which were excavated by Callenfels and Nooe (1940) [25]. They can be dated back to a recent period, maybe the product of the Orang Asli (aborigine people) ancestors who lived within the area. From the images we can see that the drawings have faded and there is loss of resolution, some parts of them graffitied.

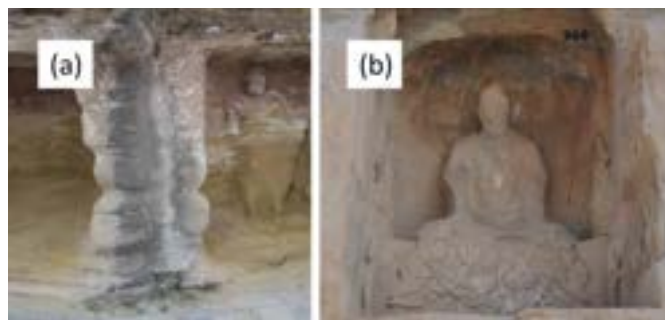
**Figure 5.** Damage to Qingyang North Grottoes in Gansu Province, China: a) visible biological colonization, and b) effect of weathering causing the rounded edges and lack of definition.

In the northern China, there are numerous stone heritages, which can be damaged by freezing-thawing due to the noticeable variation of temperature between day and night, and the changes in humidity during different seasons. Qingyang is a city in Gansu Province, which is in the northwest of China. Figure 5 shows damage to the North Grottoes of Qingyang. The bottom and interior of the heritage are deteriorated severely by seepage erosion as evidenced by the less distinct and rounded edges of the carvings, in addition, there are lots of transverse pore cracks on the surface of stone after undergoing many of freezing-thawing cycles [28]. The upper and middle part of the cave and Buddha were affected by capillary action, and there can be seen some of the white precipitation. which may indicate salt crystallization. When water from ground sources seep into the pores and cracks of these stone relics, the salt crystals can accumulate and as they crystallize, the expansion puts pressure on the surface causing pitting, flaking and disintegration which may explain the damage observed to the statue in Figure 5b.

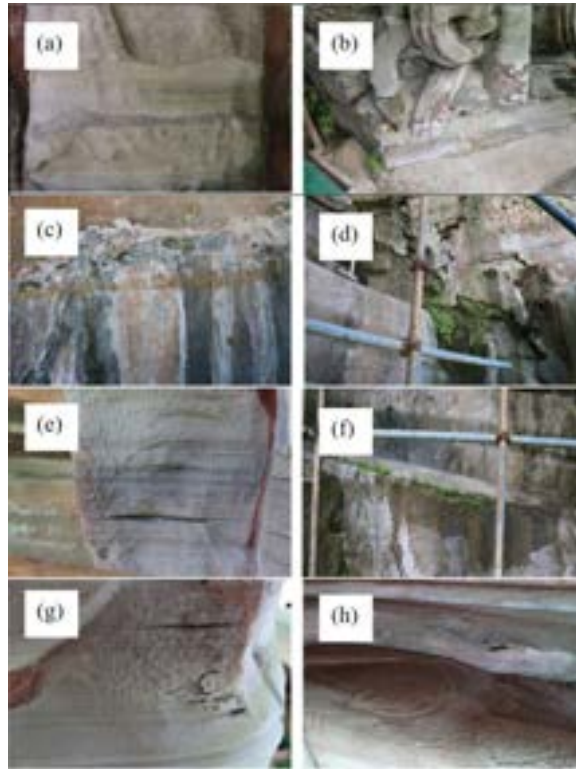
**Figure 6.** Surface condition of stone relics of that a is Dazu Rock Carvings.

Figure 6 illustrates the surface condition of the foundation of Sakyamuni niche, as can be seen from that most of degradation and cracks processes occur on the surface of the stone heritages, that can be attributed to the environment, stone composition and other properties [29]. From Figure 6 it can be observed that the surface weathering is due to multiple factors, namely a) granular disintegration, b) salt efflorescence, c) moss and abscess, d) structural cracking, e) weathering crack, f) water seepage, g) scaling, h) blistering, which are based on the Glossary on Stone Deterioration Patterns published by ICOMOS International Scientific Committee for stone deterioration. The cracking and water seepage are the largest contribution factors to the surface damage [30]. Therefore, it is time to take some effective measures to protect the stone, or risk forever losing cultural heritage sites such as this.

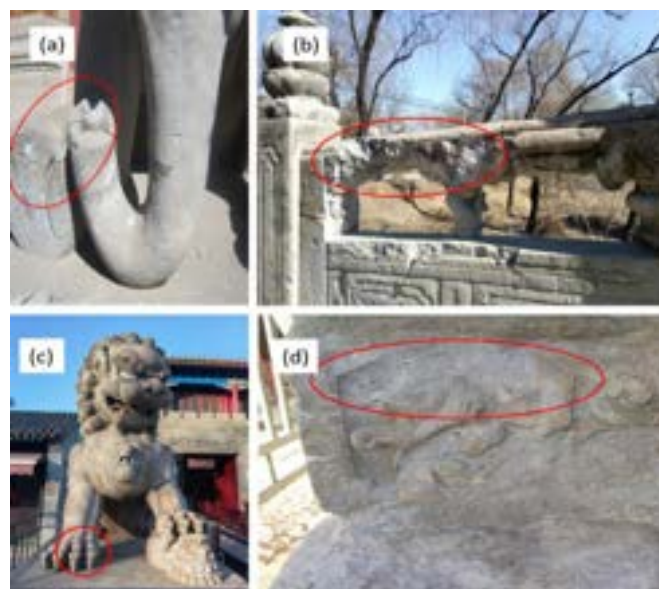
**Figure 7.** The stone elephant (a), stone bridge (b), stone lion (c) and the pedestal of the stone lion in Xumifushou Temple and Chengde Mountain Resort.

Figure 7 shows damage to the Xumifushou Temple located in the Chengde Mountain Resort comprising of a) stone elephants, b) stone arch bridge, c) stone lion, and d) its pedestal constructed more than 250 years ago. Figure 7 a) indicates weathering damage found on the stone elephants - the trunk and legs exhibit substantial cracks after rainwater erosion and multiple freeze-thaw cycles. In Figure 7 b) we can see that the carved balustrades of the stone bridge have been fissured and exfoliated, which may be caused by vandalism and weathering, the lower part of the wall has been corroded due to the long-term soaking by rainwater. Figure 7 c) shows the

surface exfoliation of the lion body, its claws and foundation which are situated in front of Chengde Mountain Resort gate.

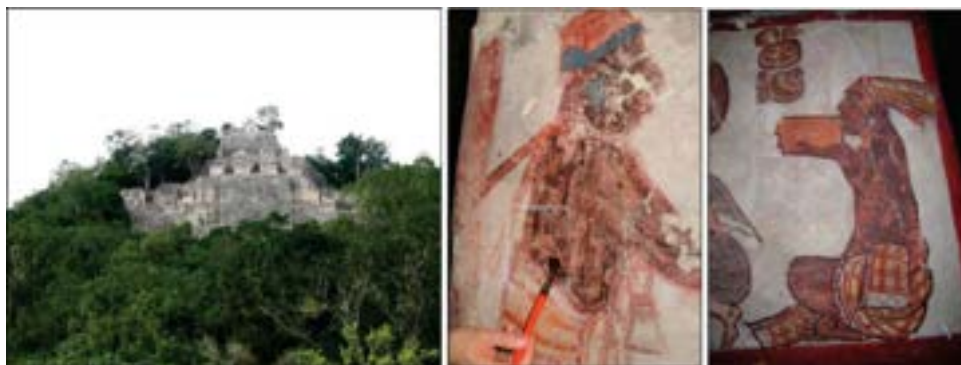
**Figure 8.** Wall paintings from Mayan Classic period in Calakmul (Mexico). Calcium hydroxide nanoparticles were used for consolidation.

Calcium carbonate is highly breathable, which allows moisture to evaporate from the stone surface and prevents the buildup of internal moisture that can lead to stone decay [47]. It is also highly compatible with stone, which minimizes the risk of damage to the stone surface, what is more, it is non-toxic and does not damage the stone surface, making it ideal for use in conservation projects. The example is the Wall paintings from Mayan Classic period were consolidation by calcium hydroxide as shown in Figure 8 [48].
