THE EFFECT OF WIND FORCE ON METAL DECK ROOF JOINT

Thesis submitted in fulfillment of the requirements
for the award of the degree of
Bachelor Of Civil Engineering (Hons)

Faculty of Civil Engineering and Earth Resources
UNIVERSITI MALAYSIA PAHANG

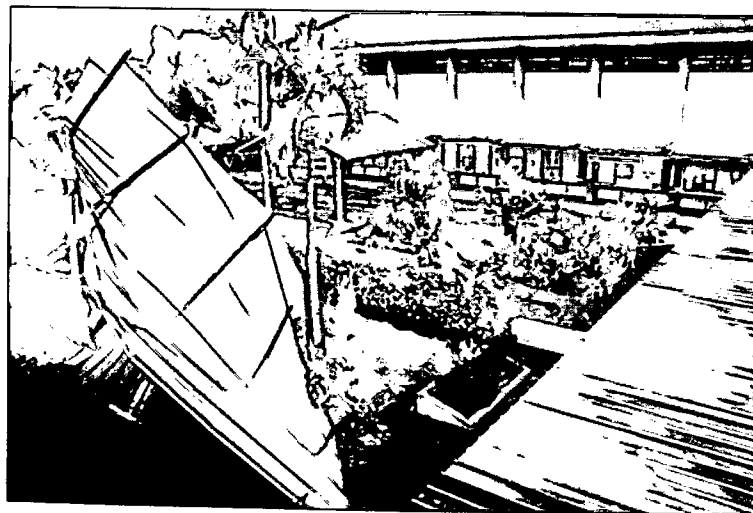
Figure 1.1: Metal deck roof damage in SMK Tinggi Setapak, Selangor.

The failure of the roof is the problems happen at least 3 times per year in Malaysia itself. The failure roof, damage roof, the 'fly roof' happens in Malaysia rapidly every year and reported at many channels of news. Berita Harian and Sinar Harian reporting at least 1 (one) cases in 2011, 2012 and in 2013 at least 6 (six) cases reported of the damage roof around Malaysia. In a mean time, institution of school usually will apply the metal deck roof as their some main part of the roof, and most of the cases involving the metal deck roof are from the school. The school reported is Sekolah Menengah Kebangsaan (SMK) Dol' Said, Melaka and SMK Tinggi Setapak Selangor.

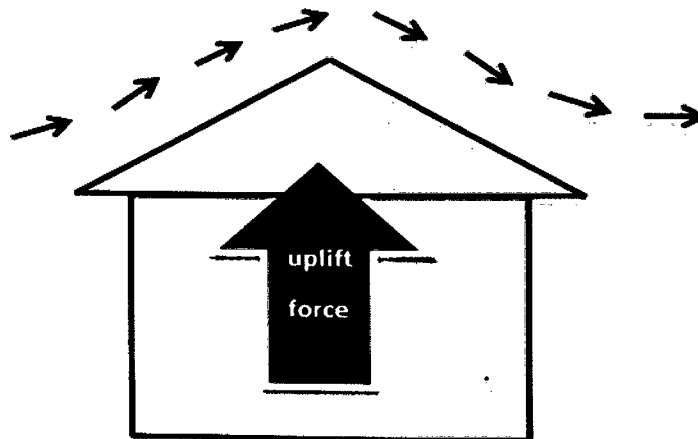
Figure 2.1: Uplift force of a House

When the pressure inside the building higher and the pressure above roof system decrease because the high winds flow will producing the uplift force? When the uplift force is higher than it should be or the system was designed for, the roof able to lift from the roof structure during rainstorm or heavy wind.

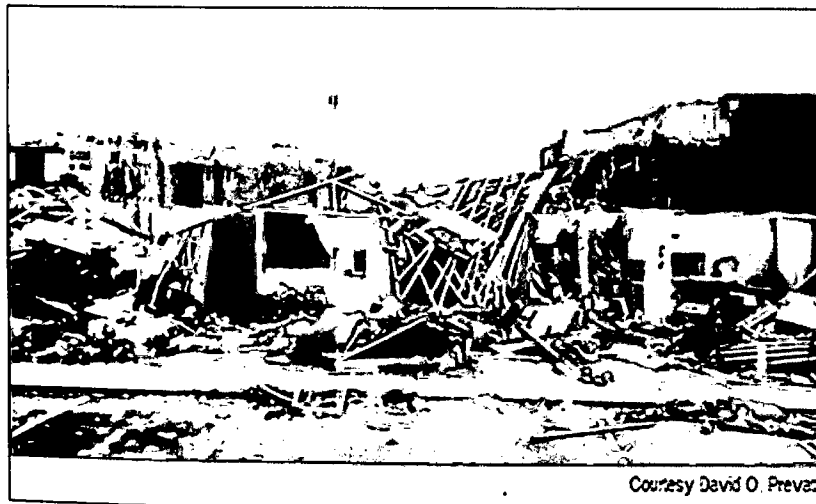
Figure 2.5: Damage for whole roof structure.

In the case of the inadequate connector between rafters or the batten was not connected properly may lead to the bigger failure such as the damage for whole roof system as seen in **Figure 2.5**.
