Cracks Monitoring and Resistivity Test for a Double-Storey House due to Cavity in the Soil

Abstract This paper presents the feasibility study of structural assessment and monitoring of two-story house due to soil settlement which was not well-compact before construction commenced. Two stages assessments were conducted to monitor and evaluate the structural integrity of existing double-story house which involves preliminary investigation and detailed assessment. Preliminary investigation includes visual inspection of cracks, soil settlement and structural damages. Meanwhile, detailed assessment comprises of crack width measurement, Non-Destructive Test (NDT) and resistivity test. The first detail assessment was carried out on 18th July 2019 which involved crack width measurement, Ultrasonic Pulse Velocity (UPV) test and rebound hammer test. The second inspection was conducted on 19th October 2019 to monitor and identify the integrity of the structure and the main causes of the problem. Visual inspection and non-destructive test indicate that the defects found in the house can be categorized as partial damage due to soil settlement. Resistivity test showed that there were cavities a

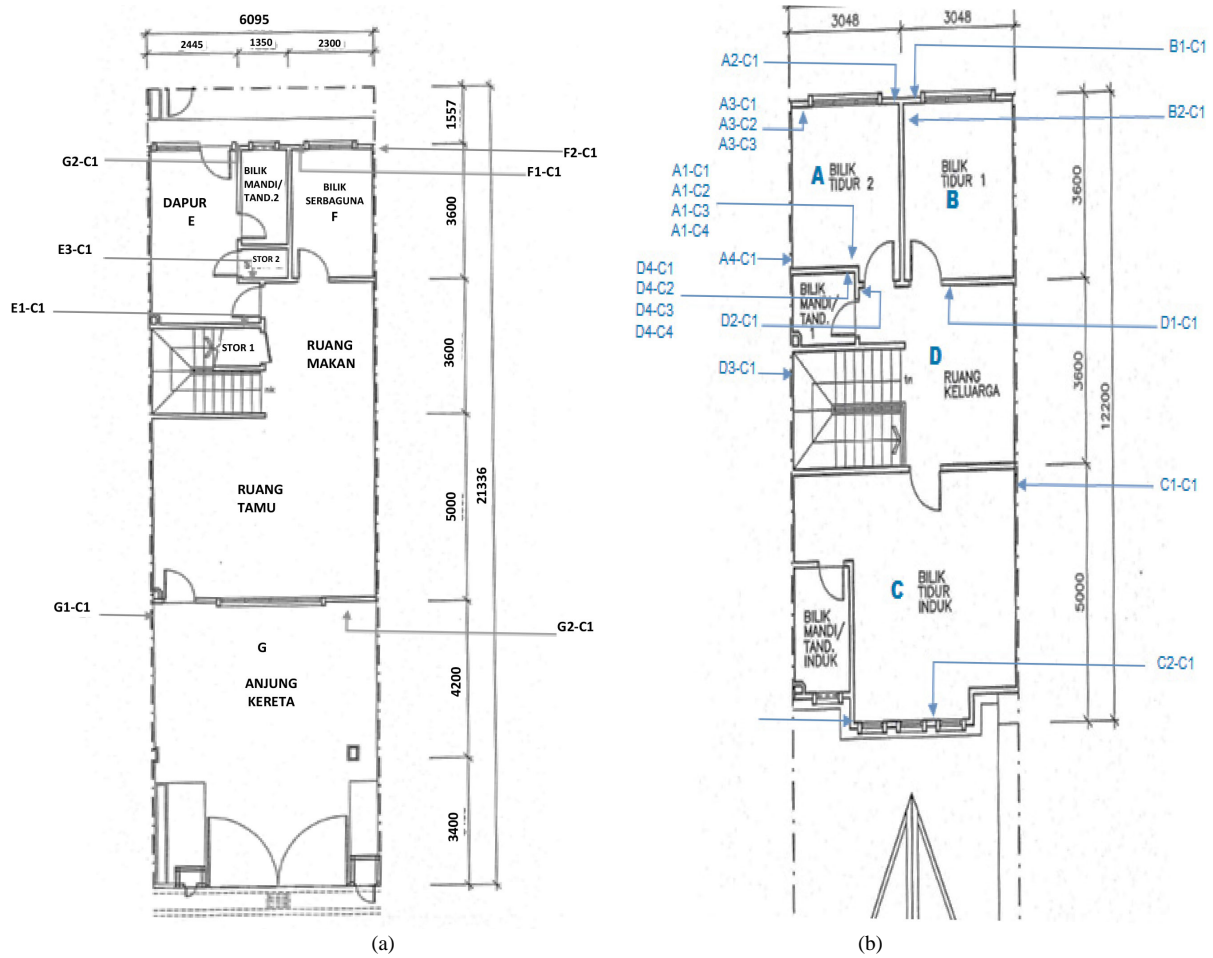
Figure 8. Layout plan of the case study house (a) Ground Floor (b) First Floor

Figure 8(a) shows the layout out plan for ground floor of the investigated house together with coding numbers of cracks' marks in blue color. Meanwhile, Figure 8(b) shows the plan view for the first floor of the house together with a lot of cracks' marks on the wall at bedroom A, bedroom B and toilet. The locations of visible cracks in double-storey house were observed at Bedroom A, Bedroom B, Hallway and Staircase D, Kitchen D and Parking Area G. Table 2 shows the photographs of visible cracks and defects which were observed in these locations during visual inspection and categorized the crack width based on Table 1.
