**THE EFFECT OF WIND LOAD TO NON-ENGINEERING ROOF SYSTEM**

**MUHAMMAD HASHRA IZREEN BIN MOHD HASHIDIN**

Report submitted in fulfilment of the requirements

B. Eng (Hons.) Civil Engineering

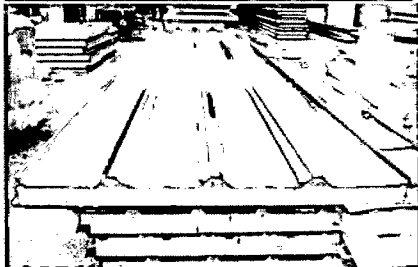
Corrugated Metal Deck	CGI coating: 30-300 g/m <sup>2</sup> Thickness : 0.14-4.0mm Width : 600-1250mm

**Table 1.1:** Typical Types of Corrugated Metal Roofing System

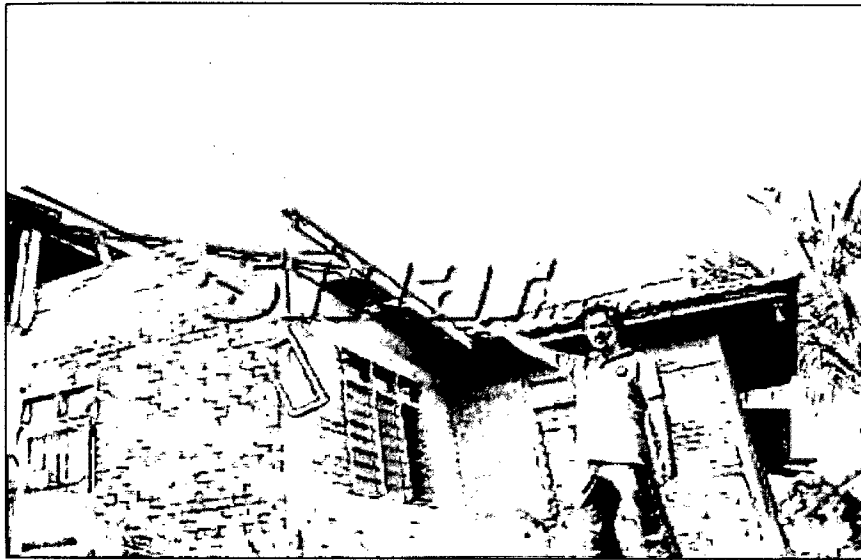
**Figure 1.1:** Roof Damage (1) (Sinar Harian, 2014)

For instance, there are some cases in Malaysia related to the effect wind load to non-engineering roof system. First cases of non-engineering roof system that failure is at Pasir Mas, Kelantan where this place is rural area and the roof structure is design by non-engineered designer. Unproven material also one of the factors that may be the reasons for the failure due to wind loads. The family member in that house is consisting of one huge family. When this disaster occurred, it is not secure for the family to stay in that house.

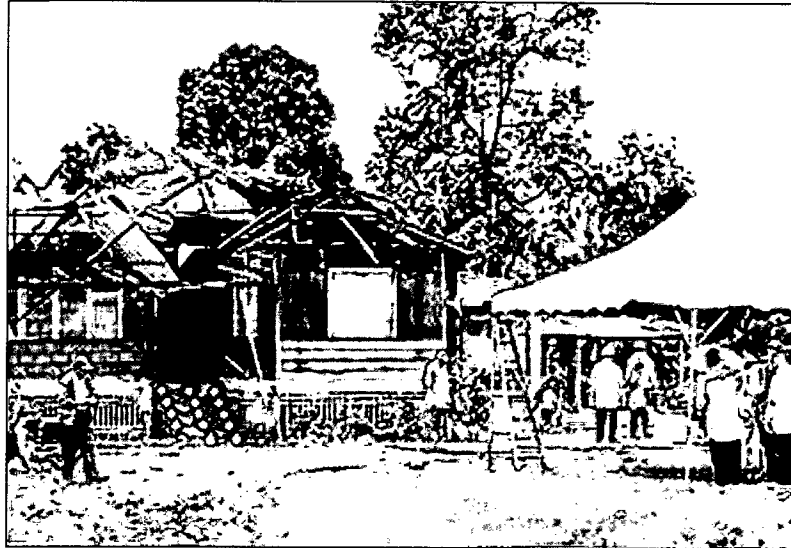
**Figure 1.2:** Roof Damage (2) (Utusan Malaysia, 2010)

Moreover, another residential with same type of roofing sheathing also failed due to effect on wind load. This failure related to number of joint. When the joint located so far, the strength to resist the wind load is slightly reduced and become easy to fail. This situation will be harmful to another people when thing flew and the worst part when the family members of the residential is trap inside the house. Therefore it is very unsafe to design the roofing system with non-engineered designer.

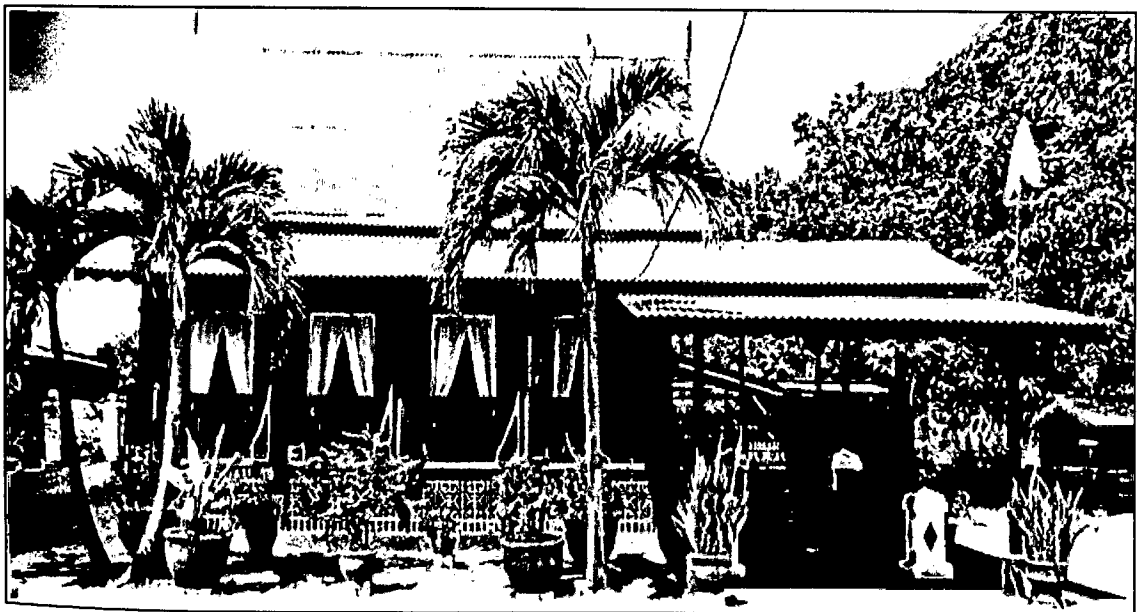
**Figure 2.4:** an example housing of non-engineering CGI roof system (fotomedia, 2009)

Wind load distribution on CGI roof system will give pressure on CGI roof and suction at another side of CGI roof area. Roof joint is important factor that involved to failure of non-engineering after its own material that is CGI roof sheeting. The distance of joint is an important role in determine the failure on CGI roof sheeting with same maximum wind speed in Malaysia which is 32.5 metre per second. This maximum wind speed is the speed of fifty years returns period wind speed. Performance under strong wind conditions is required to ensure the CGI roof sheeting can prevent large deformation of wind load distribution. "The fatigue phenomena on the connecting elements between the roofing system and the frames due to daily solar heating effects should be also taken seriously." (Tamura, Cao, 2009).
