Thermally-Induced Crack Evaluation in H13 Tool Steel

Abstract: This study reported the effect of thermal wear on cylindrical tool steel (AISI H13) under aluminum die-casting conditions. The AISIH13 steels were immersed in the molten aluminum alloy at 700 °C before water-quenching at room temperature. The process involved an alternating heating and cooling of each sample for a period of 24 s. The design of the immersion test apparatus stylistically simulated aluminum alloy dies casting conditions. The testing phase was performed at 1850, 3000, and 5000 cycles. The samples were subjected to visual inspection after each phase of testing, before being examined for metallographic studies, surface crack measurement, and hardness characteristics. Furthermore, the samples were segmented and examined under optical and Scanning Electron Microscopy (SEM). The areas around the crack zones were additionally examined under Energy Dispersive X-ray Spectroscopy (EDXS). The crack's maximum length and Vickers hardness profiles were obtained; and from the metallographic study, an increase in the number of cycles during the testing phase resulted in an increase in the surface crack formation; suggest

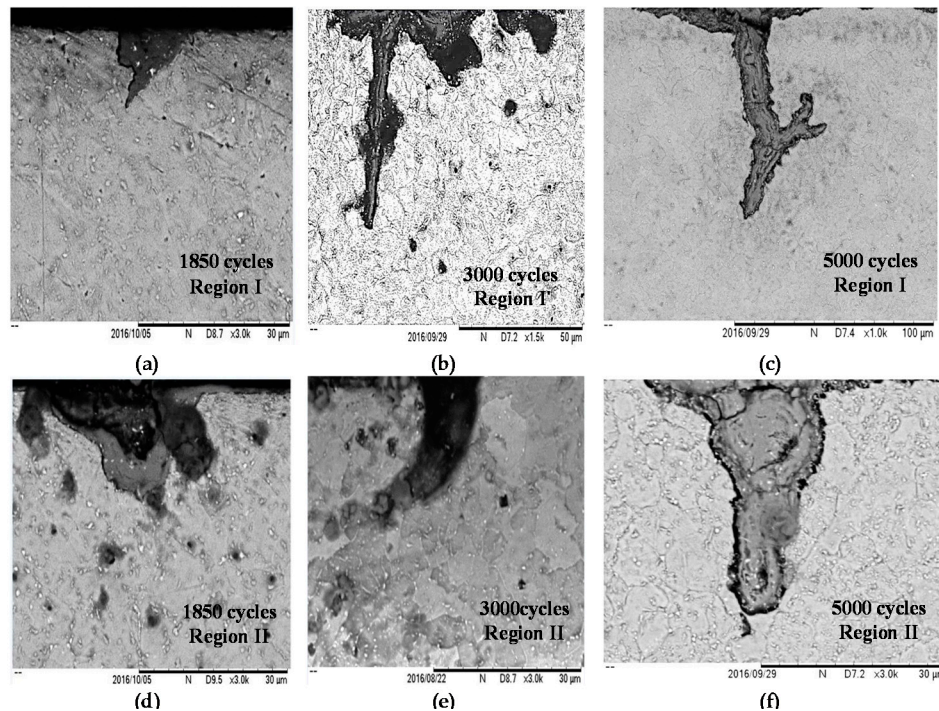
Figure 2. Micrographs of surface cracks in the thermally worn sample at (a,d) 1850; (b,e) 3000; and, (c,f) 5000.

Figure 2 shows the observed cracks on the surface of the thermally worn sample. There was a large surface crack of 28.3 μm in width due to the great temperature difference from the heating and cooling on samples. The Figure also showed the number of cycles for the initiation of the first thermal fatigue cracks. Figure 2a–c shows that the thermal cracks occurred at 1850, 3000, and 5000 cycles, respectively. Wear is a mechanical flux action against the die, while thermal wear results from repeated tension and compression due to rapid heating and cooling [13].

The maximum crack length at different thermal wear cycles is also shown in Figure 2, where the longest surface cracks occurred near Region I due to a higher temperature gradient from the operation temperature of 700 $^{\circ}\text{C}$ at the external surface, and 32 $^{\circ}\text{C}$ temperature on the inner surface. A great temperature difference can result in thermal stress on the sample's outer surface [25]. The mean crack length value varied from 42.2 to 111.2 μm in length depending on the cycle number. The cracks formation resulted from the continuous material contraction and thermal expansion during the heating

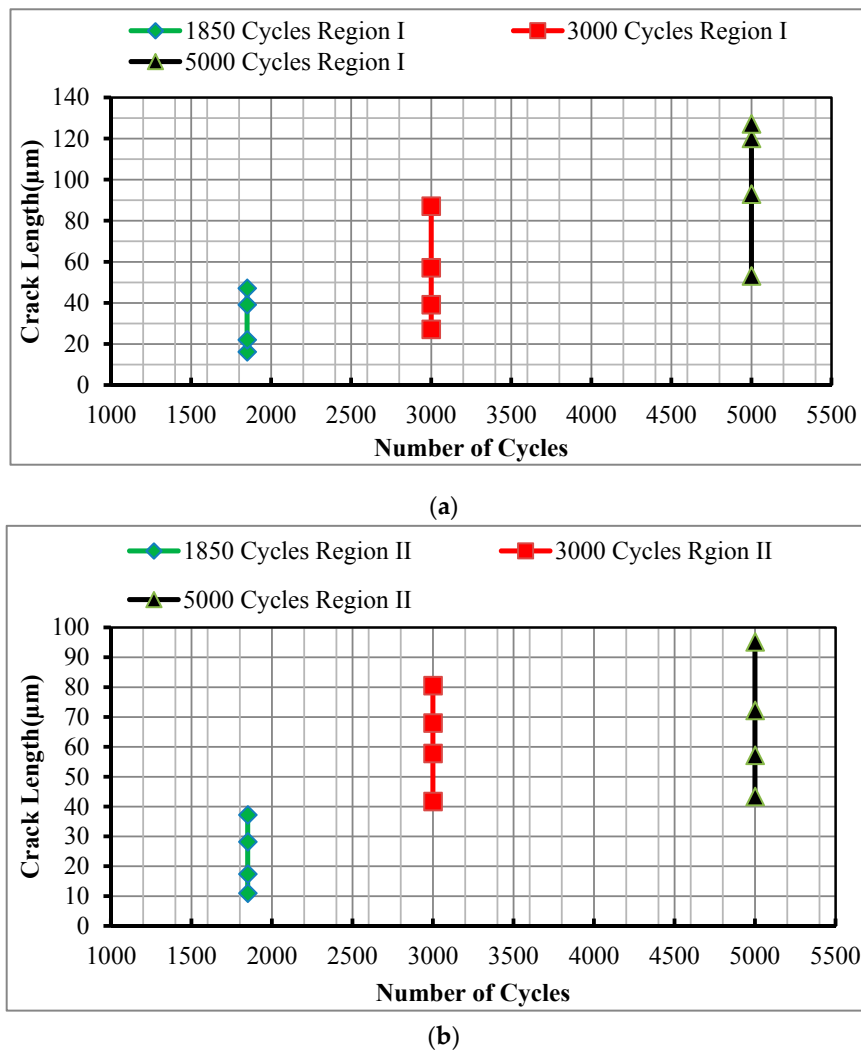
Figure 3. Maximum crack length in (a) Region I and (b) Region II of thermally worn samples at different wear cycles.

The relationship between crack length and cycle number is shown in Figure 3a,b. Region I and Region II in the figures represent the round ended samples and cylindrically shaped surfaces. There were evident cracks on the sample surface and in the cross-sections. Figure 3a,b represent the mean and maximum crack lengths at different cycles; the crack length propagated from 16.3 to 47.2 μm (Figure 3a), while the maximum crack length propagated from 53.2 to 127.2 μm (Figure 3b). The cracks presumed to occur near the die surface; where there was a high thermal stress due to a higher temperature gradient. The stress was additionally enhanced by the local stress concentrators, leading to a local accumulation of plastic strain.

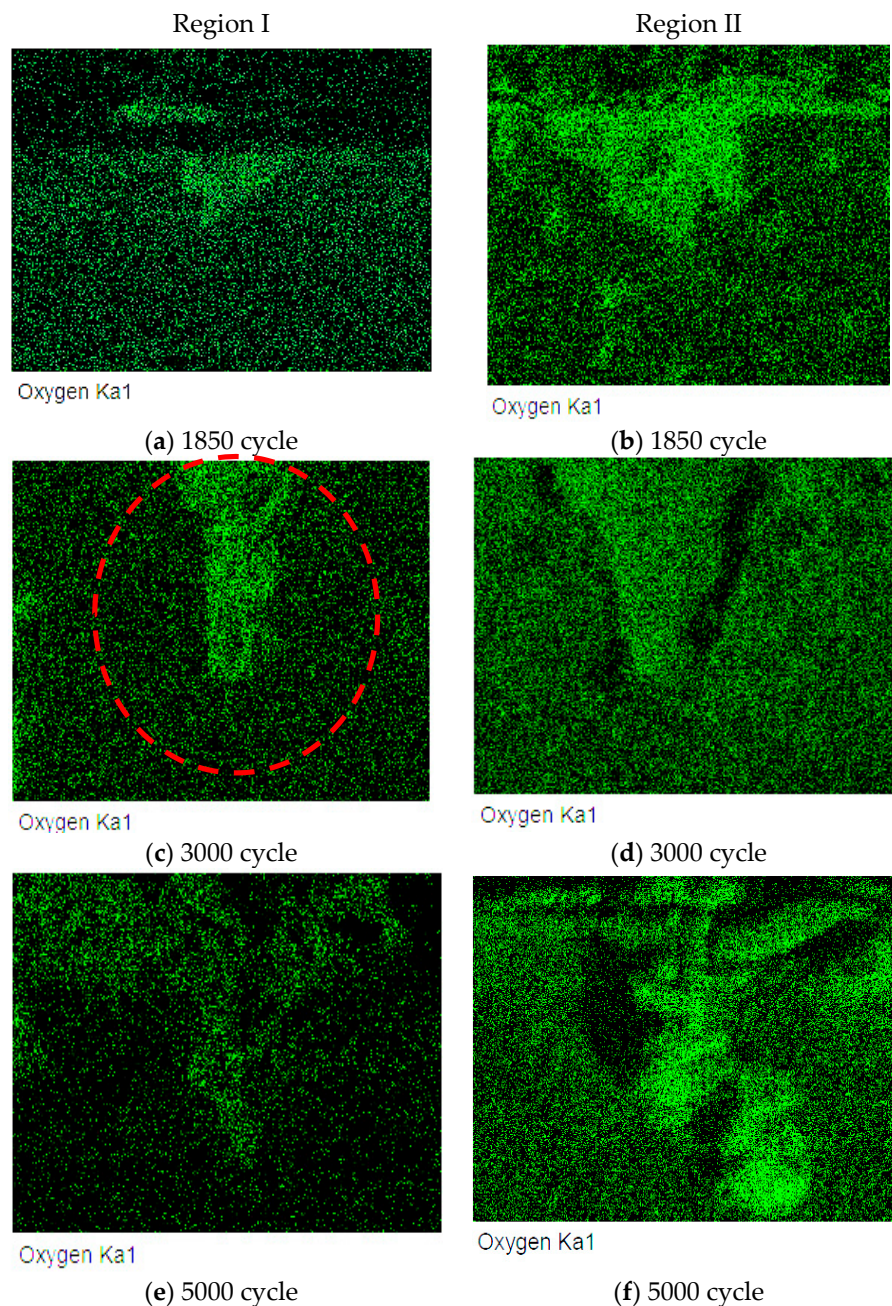
Figure 4. Oxygen distribution within the crack area of Region I and Region II in thermally worn H13 samples at 1850 cycles (a,b); 3000 cycles (c,d); 5000 cycles (e,f), respectively.

There seems to be a homogenous distribution of aluminium and oxygen, though oxygen inter-penetration was continuous. Oxygen penetration after thermal wear process was monitored through EDXs mapping (Figure 4). The molten Al was found to penetrate through the cracking and react with the steel to form Fe-Al intermetallic compound. These compounds lead to the main defect, such as cracks. The micro cracks are the most likely factors causing the penetration of molten aluminium into the crack. Other factors such as the reaction between the H13 and molten aluminium can affect the thermal wear in liquid. The result of the immersion test may be affected by Iron (Fe) atoms from the steel surface layer, which diffuse into the surface and react with oxygen. The Cr, Mo, and Fe levels were low near the crack boundary, because, above 500 °C, substitution diffusion is likely to occur, and alloy carbides can displace the less stable cementite and dissolve into a finer alloy carbide dispersion form [30]. The vacancies on the surface of the steel layer were occupied by the alloying components. The effect of silicon and aluminium can be caused by the short crack within the surface, meaning that they were in contact with the molten aluminium alloy. There was a negative effect of the oxide layer, it was at its lowest thermal expansion and higher volume and fragility.

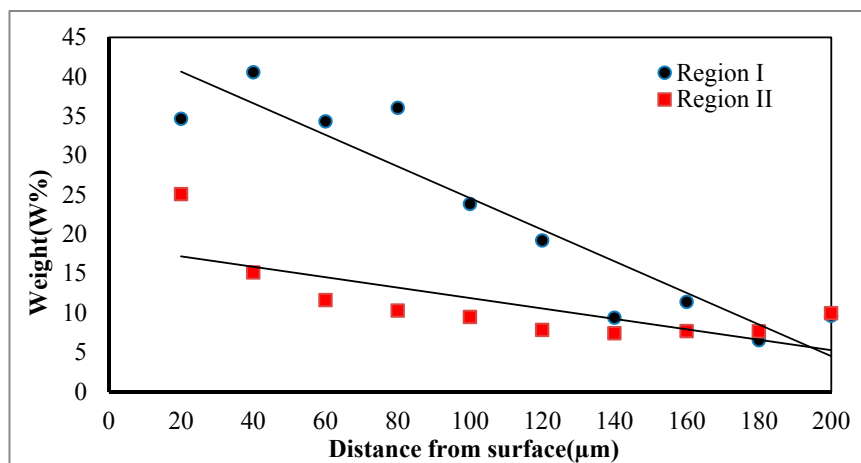
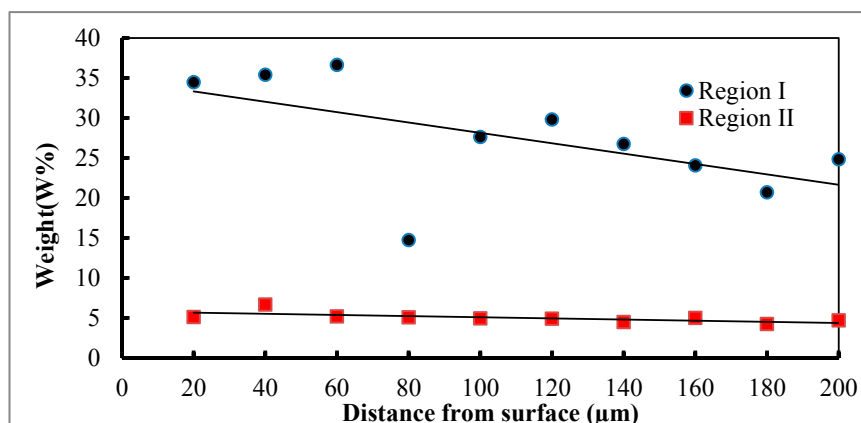
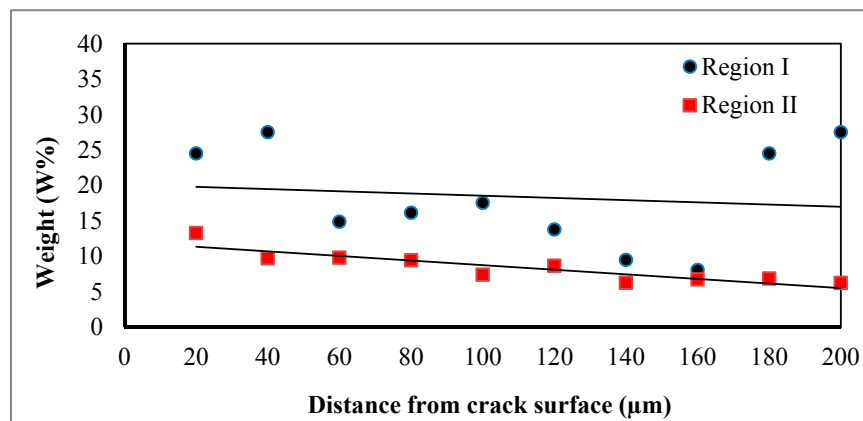
Figure 5. Concentration of oxygen along the surface depth from Region I and II in thermally worn H13 samples at (a) 1850 cycles; (b) 3000 cycles; and, (c) 5000 cycles.

The oxygen concentration in Figure 5 changed significantly in Region I, but after 1850 cycles, the oxygen weight of Region II became less than that of the Region I Figure 5a–c showed the decrease in oxygen weight 33% with an increased number of thermal wear cycle (3000 and 5000 cycles). This is because of the formation of aluminum layer, which, in turn, prevents the interaction of oxygen with air. The surface of the material experienced a significant drop in hardness, while no change was observed at a depth of 160 μm from the materials' surface. These results from surface oxidation and the presence of Mo, V, and Cr in the carbide layers around the cracks.

The solubility of the alloy elements of Region I in molten aluminium metal during specimen immersion is low. A cup-like shape was formed around Region I through a thermal wear cycle. This part can easily slide out of the Region I during the rotating cycle, while a piece of molten aluminium metal adhered at Region II. Therefore, a portion of H13 alloys Region II elements dissolved in the molten metal, resulting in Fe loss (Figure 5).

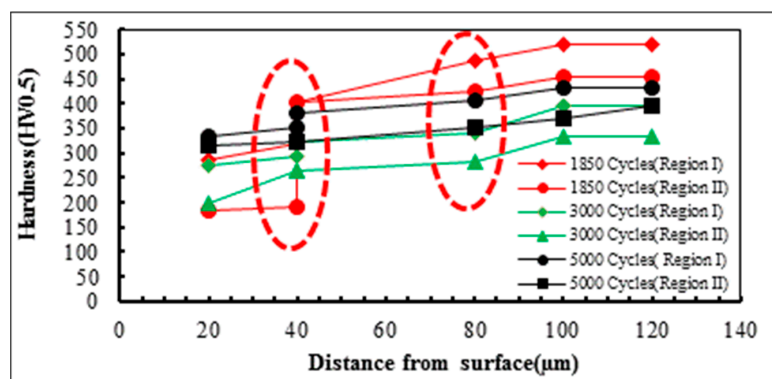
Figure 6. Comparison of Region I and II hardness properties along the surface depth a thermally worn AISI H13 steel sample.

An increasing number of cycles significantly decreased the surface hardness within a depth of 80 μm , while thermal wears of more than 700 $^{\circ}\text{C}$ considerably softened the tool materials. Figure 6 shows some examples of hardness depth profiles after thermal cycling at 700 $^{\circ}\text{C}$. In this figure, it was evident that thermal cycling at 700 $^{\circ}\text{C}$ decreased the hardness of the superficial surface layer, while that of the deeper layer was virtually unaffected. Furthermore, the materials were unaffected at this depth, by contact with the cyclic high-temperature. Ferrite tempering was noticed on the surface of the die, while the microstructure of the central material experienced no changes [34]. The hardness of the material dropped significantly at the surface, while no change was observed at about 120 μm depth from the material's surface. The lowest hardness value of 182 $\text{HV}_{0.5}$ was measured at Region II of the thermally-worn sample surface. After 3000 cycles, a hardness value of 263 $\text{HV}_{0.5}$ was witnessed in Region II, which was lower than the samples what were subjected to 1850 and 5000 cycles. After 3000 cycles at 700 $^{\circ}\text{C}$, there was a reduction in the surface hardness of the specimens from 35% to 40%, but increased with increasing depth from the surface down to the centre.

The lowest hardness value of 351 $\text{HV}_{0.5}$ was measured in Region 1 after 500 cycles in the thermally-worn samples. The lower hardness value in Region I after 5000 cycles was due to the thermal gradient and the increased softening of the sample surface. The surface temperature mainly caused the decrease in hardness values. The areas with crack density and cracks at their highest and deepest values recorded the lowest hardness values [28].
