Mechanical performance of carbon fiber reinforced polymer as repair material for damage wall structure

To cite this article: J Izwan *et al* 2019 *IOP Conf. Ser.: Earth Environ. Sci.* **244** 012026

J Izwan¹, I Md Sayuti¹, I R Noram², O M Md Azree³ and F S Syahrul⁴

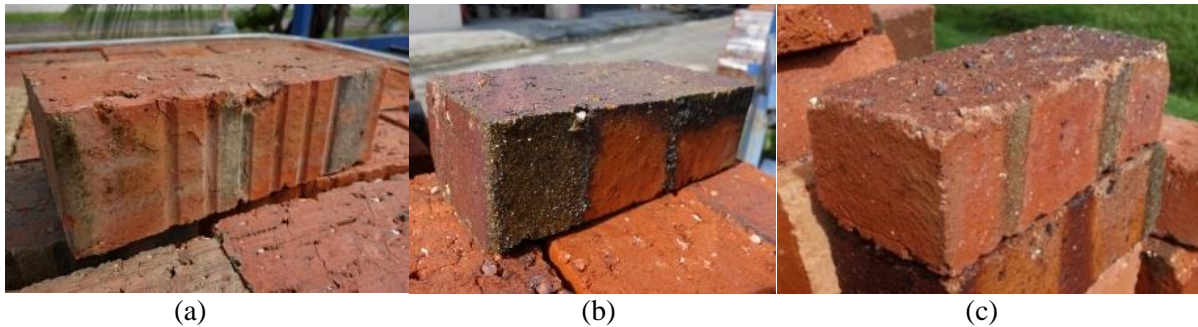
There are three samples of fired clay brick from three different states. They are prepared accordingly to BS3921 for this research. Figure 1 (a), (b) and (c) is an examples of brick unit collected from different state in Malaysia

Figure 1. a) Brick from Beruas Perak, b) Serendah Selangor, c) Sidam Kiri Kedah

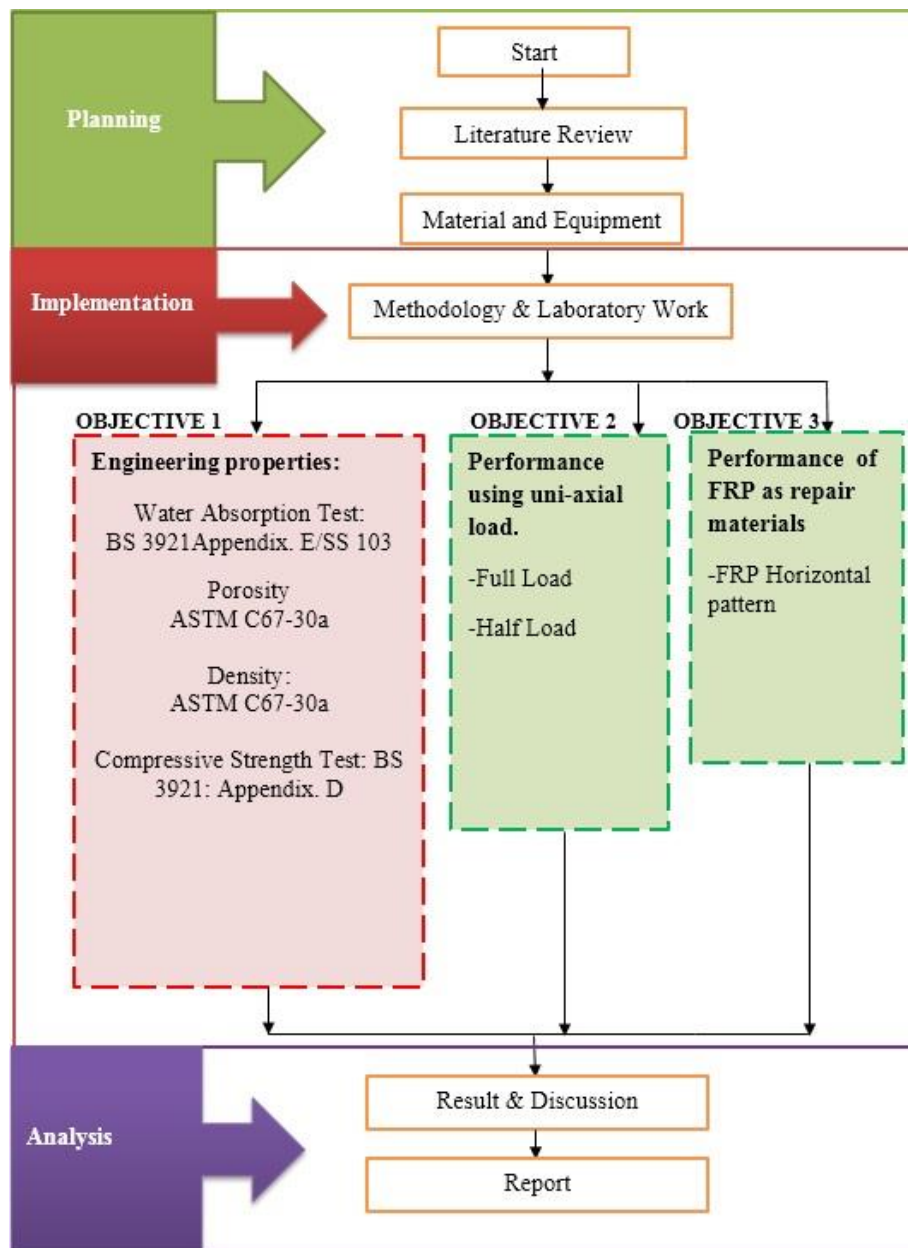
Figure 2 shows the research flowchart to investigate the performance of CFRP as repair material for wall structure.

Figure 2. Flowchart of research work

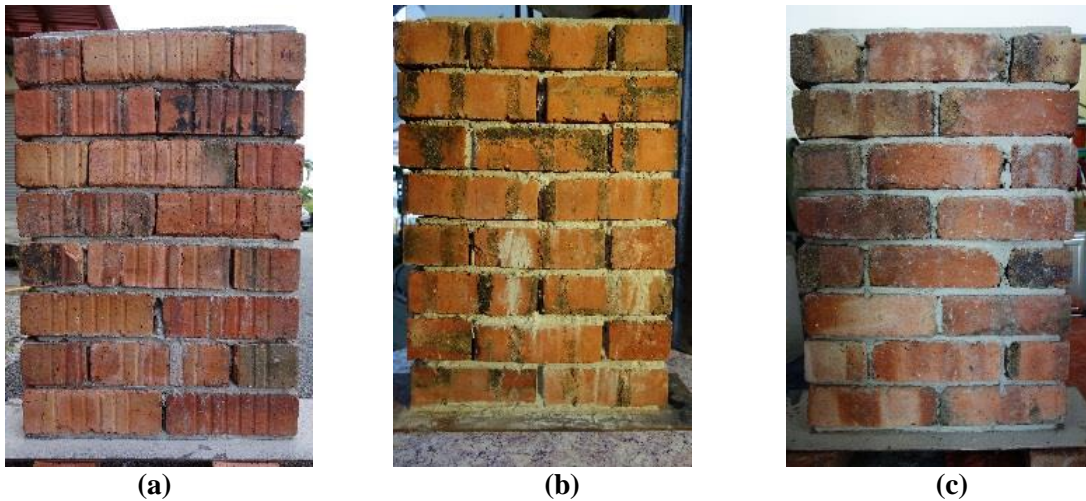
Figure 3 shows the brickwall before loading and repair process. The size of this wall is 430mm (L) X 110mm (W) X 650mm (H). The test for compressive strength and water absorption is accordance to [7] and porosity and density is accordance to [8].

Figure 3. a) Brickwall Beruas Perak, b) Brickwall Serendah Selangor, c) Brickwall Sidam Kiri Kedah

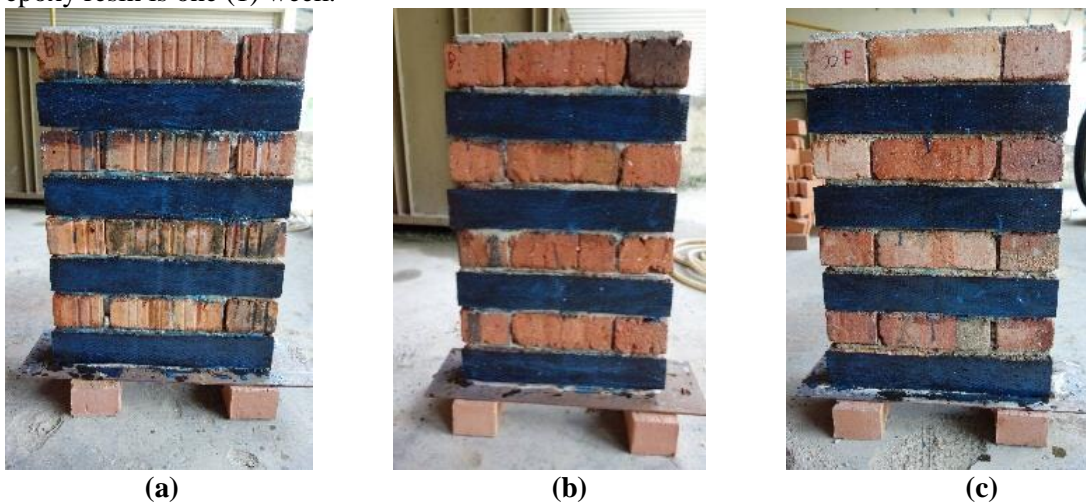
Figure 4 shows the brickwall after being load and repair process. At this stage, the curing time for epoxy resin is one (1) week.

Figure 4. a) Brickwall Beruas Perak, b) Brickwall Serendah Selangor, c) Brickwall Sidam Kiri Kedah

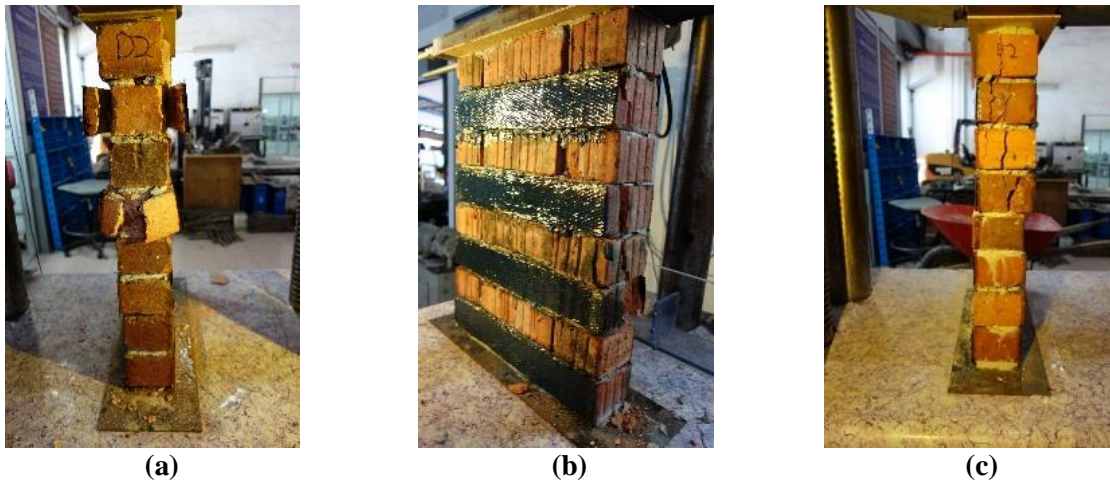
From Table 3, the observation from the tested wall shows the failure was not due to the bonding. It is the brick that failed under compression load. As shown in Figure 5, the CFRP was still stick to the brick even though the wall has failed.

Figure 5. a) Damage brickwall Beruas Perak, b) Damage brickwall Serendah Selangor, c) Damage brickwall Sidam Kiri Kedah
