**A STUDY ON MALAYSIAN ROADSIDE  
SAFETY ADOPTING SAFETY RECOVERY  
ZONE CORRIDOR CONCEPT**

**DOCTOR OF PHILOSOPHY**

**UNIVERSITI MALAYSIA PAHANG**

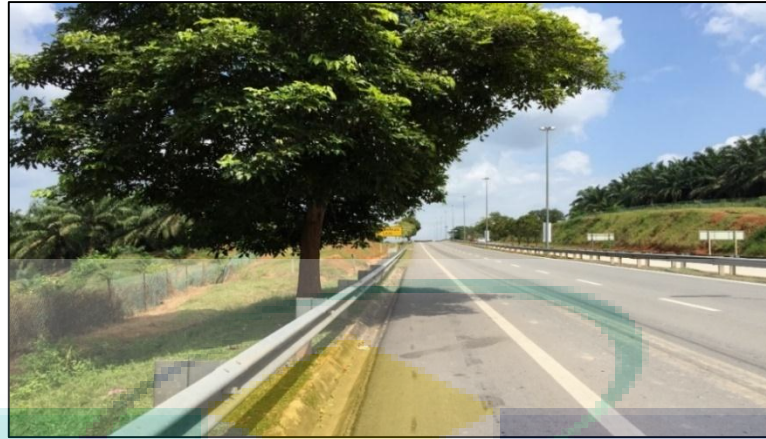
Figure 1.2. Roadside trees protected by guard rail at Lebuhraya Pantai Timur at Chenor Exit, Pahang

Presence of trees within the safety recovery zone corridor is a significant hazard on the roadside. Lesson learned from past accident suggested road authorities place a crash cushion or metal roadside guardrail to a set of trees when their locations are near to the travel lane, as shown in Figure 1.2. The rationale behind the placement of metal guardrail because it offers less impacting force to vehicle compared to a tree. However, the use of metal guardrail itself is a hazard (MnDOT, 2011). This study aims removal of such trees or replanting them at the right place.

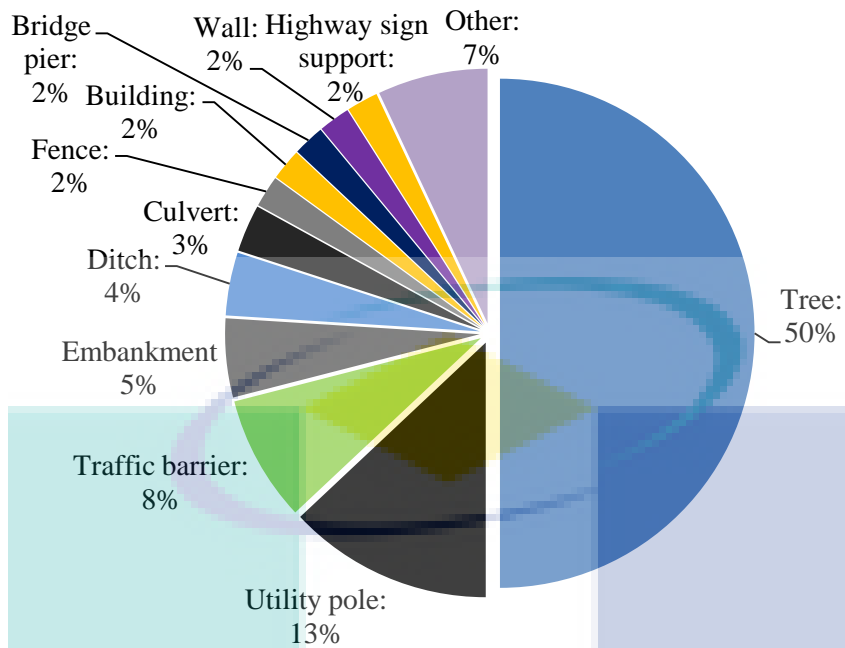
Figure 2.1 Percentage of fixed object crash deaths by object struck, 2013 in US

Figure 2.1 shows the number of deaths and their percentages caused by vehicles crashing into objects fixed on the roadside in the United States in 2013 (Insurance, 2013). A forgiving roadside design may not reduce the number of accidents considerably, but it will minimise the crash severity and fatality substantially (Francesca La Torre et al., 2012).

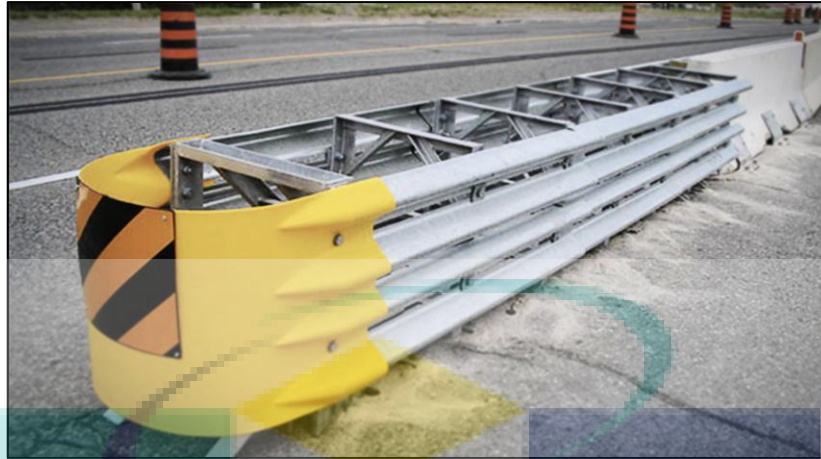
Figure 2.3 Safety barrier with blunt end with crash cushion

European design guide has accepted that safety barriers are forgiving roadside treatments if able to shield hazardous objects or prevent vehicles from skidding away from travel lanes (CEDR, 2012). The design of the safety barrier in Europe has to meet the requirement of EN 1317. Examples of acceptable safety barrier terminations are the blunt end, ramped instead of the flared end, as shown in Figure 2.3. The blunt end terminal is a crash cushion that is fully re-directive and energy-absorbing designed to protect motorists from impacting the end of concrete barriers, toll plazas, bridge piers and other hazards. The barriers are hazardous if their ends are not properly anchored or ramped down into the ground, or when they did not flare away from travel lanes.

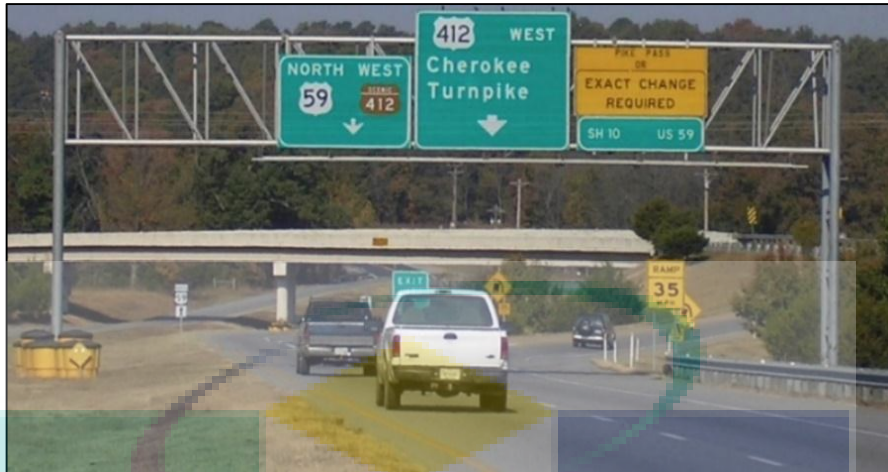
Figure 2.4 Gantry sign poles applying different types of shielding on each sides

The traffic sign poles employed in Figure 2.4 shielded differently on each side. One pole shielded with metal barrier and the other with sandbox. The metal barrier was used due to the high elevation of the pole on steep roadside slope considered secondary hazard. The sandbox barrier surrounding the pole was chosen to benefit gentle roadside slope and no secondary hazard beyond the pole. In this scenario, the first hazard was the pole.

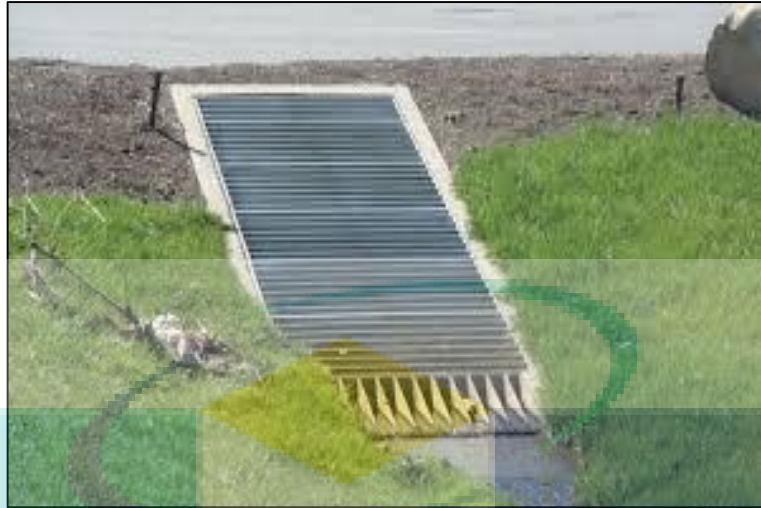
Figure 2.5 Roadside culvert concrete headwall is replaced by metal grating for safety

In America, culverts of varying sizes from 457 mm to 3 m diameter made of concrete, metal and plastic used as cross-drainage structures underneath the roadway and its embankments. Their typical concrete made inlets and outlets headwalls and wing walls for large structures and bevel-end (structure end flushed with roadside slope) sections for smaller culverts. The bevel-end for small culvert inlet and outlet is to reduce projection that is hazardous to traffic. In maintaining a traversable slope, crossing culvert ends can be shortened or lengthen to suit a particular need. An example of shortening a culvert end and built up with steel grating to flush up to maintain a traversable slope is shown in Figure 2.5 (FHWA-SA-09-024, 2009).

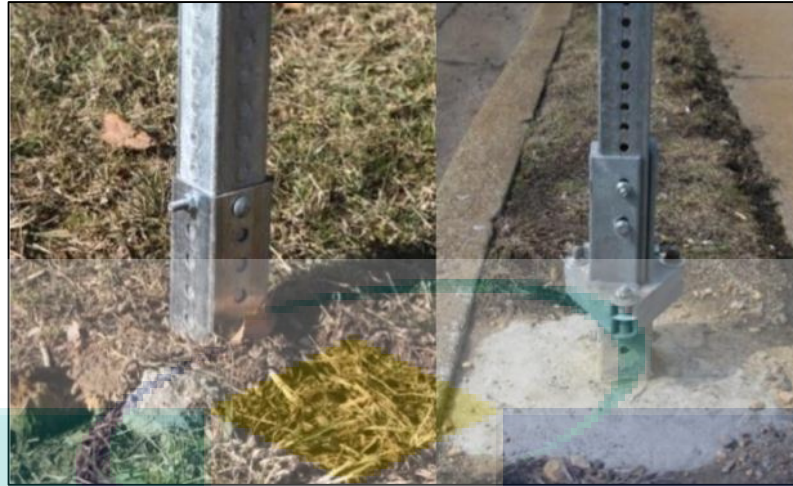
Figure 2.11 U-channel post, sleeve assemblies as the base (left) or slip couplings (right)

Light sign structures may employ U-channel Post, Sleeve Assemblies as The Base (left) or Slip Couplings (right) used in the United States as in Figure 2.11. These devices will increase the safety of a vehicle's passengers as impact pressure is to the signpost.

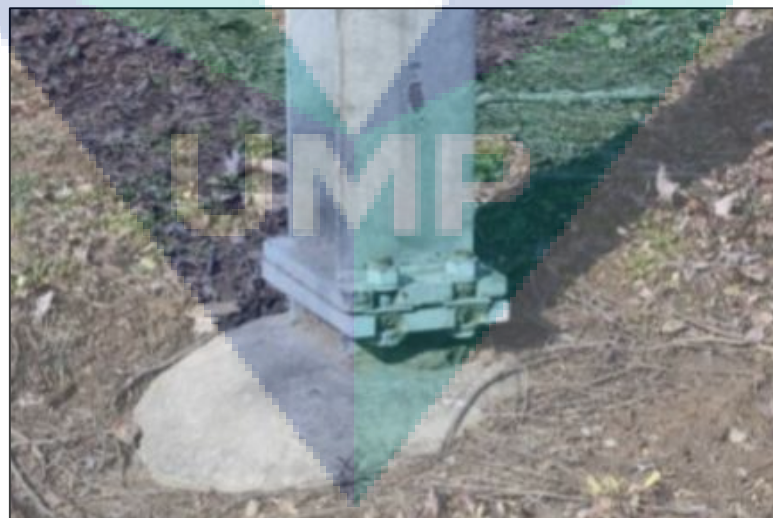
Figure 2.12 Large sign structure using a slip base connecting post to the foundation

Large sign structure installation is by using a slip base connecting post to the foundation, as shown in Figure 2.12. Once struck, the base slipped off from the foundation and rotated around the hinge plate below the sign panel which allows the vehicle to pass through safely. The technician assigned for installation work must fully understand the procedure and ensure correct compliance with its requirements.

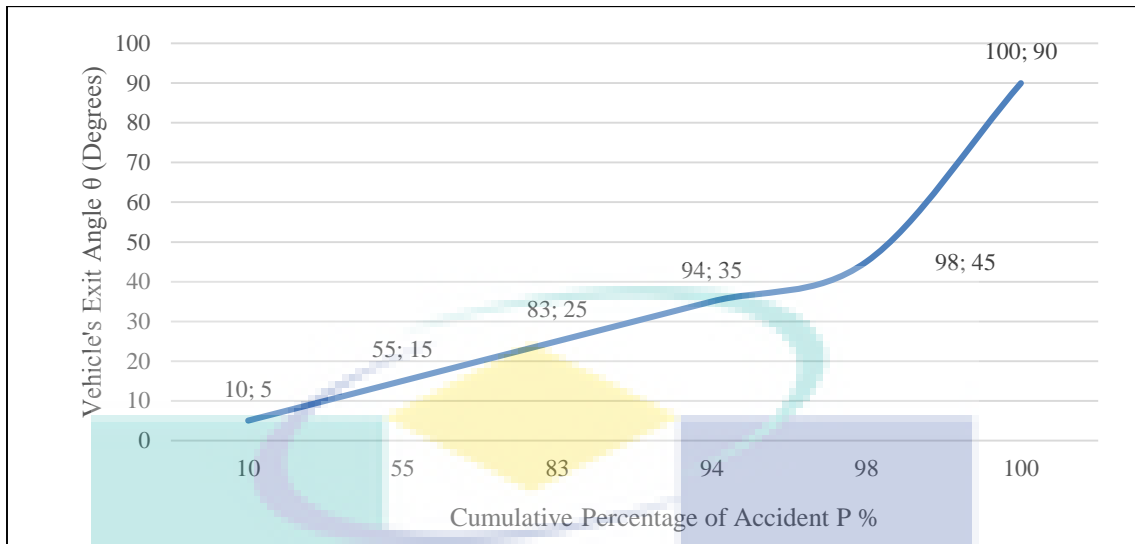
Figure 3.3 Vehicle's exit angle versus cumulative percent of accident

The relationship between the vehicle's exit angle versus the cumulative percentage of accidents is in Table 3.1 (TRL, 2005). Referenced to Figure 3.3 generated from Table 3.1, suggests the vehicle's exit angle that is most probable based on 70% of run-off-road cases is about 20 degrees. The 20 degrees vehicle's angle applied throughout the field road tests, and the outcome represents up to 70% of the cases. It was impossible to skid off from travel lane each time at 20 degrees, but the repetitions of 5 times to each test speeds will compensate the varied results. The 20 degrees lines were painted red and bold to assist drivers' sight.

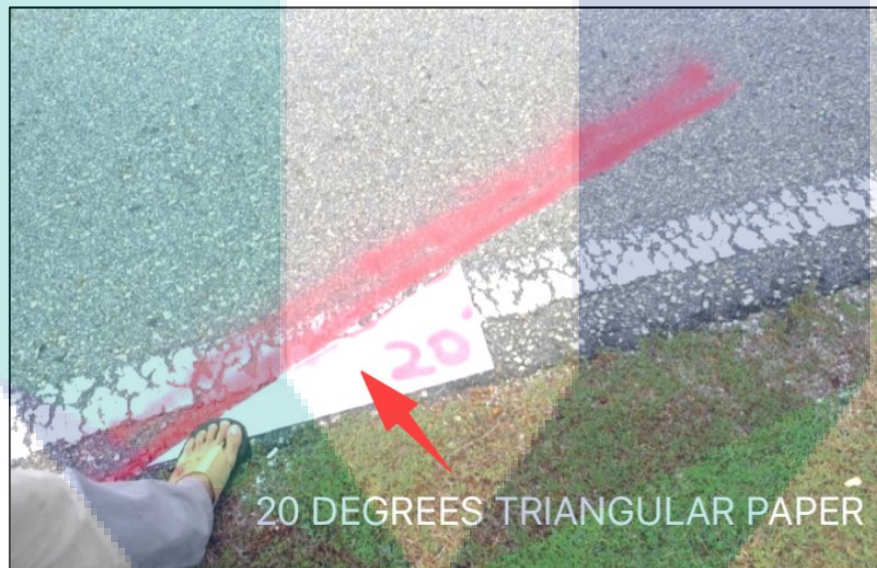
Figure 3.4 Vehicle exit angle of 20 degrees marked with redline on the road

Marking 20 degrees vehicle's exit angle lines measured anti-clockwise from the direction of travelling were carried out by painting edge of the road pavement triangular template as shown in Figure 3.4. A metre length of 100 mm width red painted lines road marking provided excellent visibility to the drivers. Offset to the red line in the roadside corridor; the ground pegged with 300 mm long red-painted wooden sticks laid at 0.5-metre intervals for a total width of 6 metres measured horizontally and perpendicularly to the travel lanes to enable measuring of car trajectory widths as shown in Figure 3.5 and Figure 3.6.

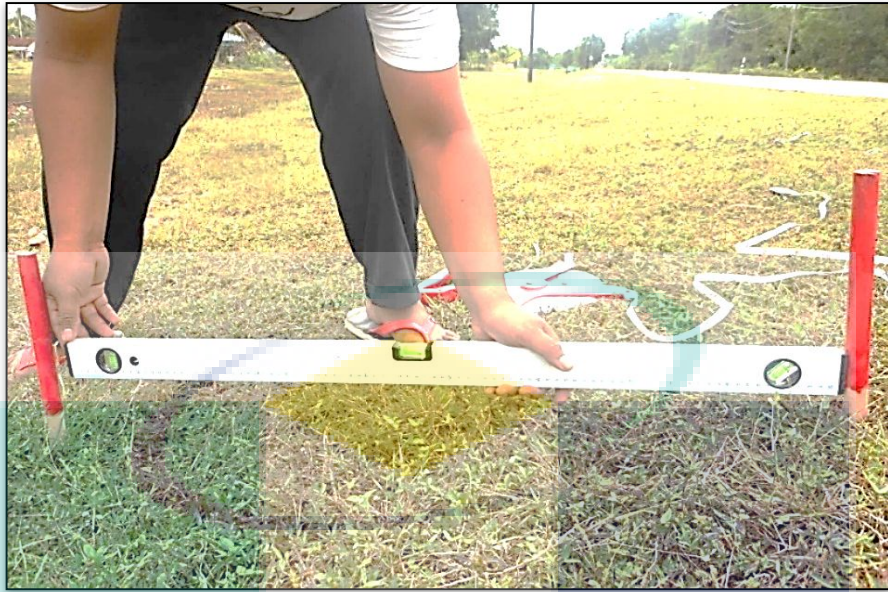
Figure 3.5 Setting offset distances to the marked vehicle exit angle to measure safe zone distances

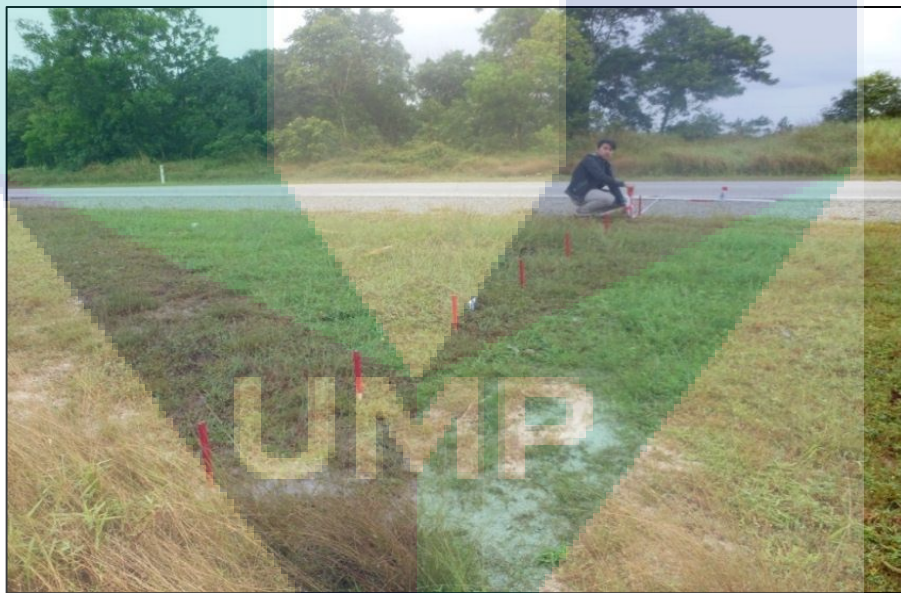
Figure 3.6 Pegging red wooden sticks marking offsets to the vehicle exit angle

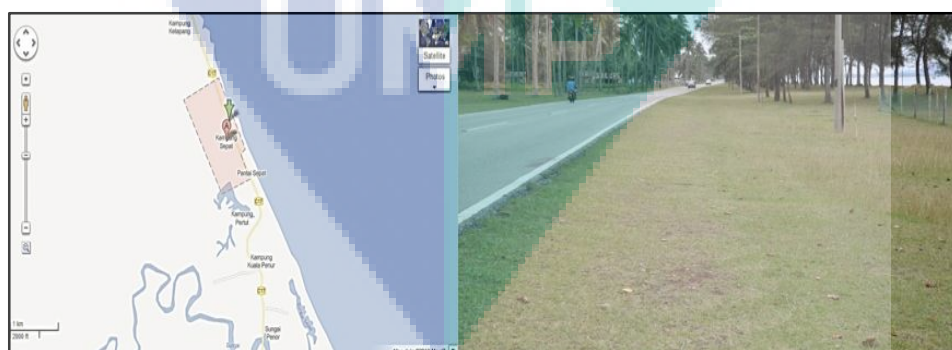
Figure 3.8 Pantai Sepat at KM 35 Kuantan-Pekan, Pahang: (a) Satellite map and (b) Test site photo

substantially. The test location is shown in Figure 3.8. The broad roadside slope with clear open space, excellent ground and non-undulating surface, and having a very low traffic volume made it a chosen ground for the road testing work. Running along the roadside were telephone poles offset at about five metres from the travel lane and spaced at 30 metres centres did not obstruct the testing work. The roadside slope gradient of 1V:7.1H was in the range of selection criteria because gentler than 1V:4H roadside slope gradient for the safe driving test.

The surface of the test area consisted of short to medium-length grass surface on fine sandy clay soil. Some laterites and sands filled the interstices of the grass. The available testing trajectory space was 10 metres wide by 120 metres long. The utility poles offset were about 5 metres away from road edge and distributed at every 30 metres interval. Despite the ground surface has a very gentle slope and generous space, testing at 100 km/h and higher was not possible because of slippery laterite surface due to long weathering process removed the fine particles between coarse laterites made them in loose form. The slippery laterite has caused the driven car to slide sideways at 90 km/h at turning trajectory path. The road elevation against surrounding was shallow compared to other sites because of the non-flooding area contributed by good natural drainage adjacent to the sea. There were no drains beside the road contributed to fewer roadside hazards. The long and straight alignment of the road made the traffic observation during the testing process easy.

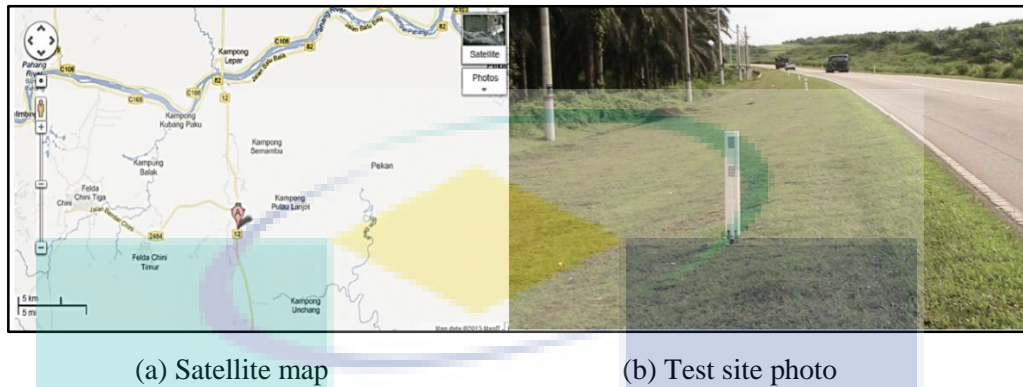
Figure 3.11 KM 71 Muadzam-Kuantan Highway, Pahang: (a) Satellite map and (b) Test site photo

The site is located at KM 71 to Kuantan from Muadzam Shah in the state of Pahang, as shown in Figure 3.11. It has 10 metres wide by 140 metres long obstruction-free roadside space with low traffic volume at more than 20 seconds per vehicle passing. The well-turfed roadside slope surface with the gradient of 1V: 4.8H met the selection criteria limit of good surface condition and gentler than 1V: 4H for safe testing activities.

The surface conditions of the test area were moderate lush medium-length grass surface grown on sandy clay soil. The available driving test trajectory space is 10 metres wide by 140 metres long. The reflector sticks were located 8 metres away from the road edge and spaced at 30 metres interval. The slippery, damp turf surface caused the vehicle to slide further than usual. The field condition was not suitable for test speed at 90 km/h and higher due to steep roadside slope gradient, close utility poles spacing and slippery damp turf conditions.

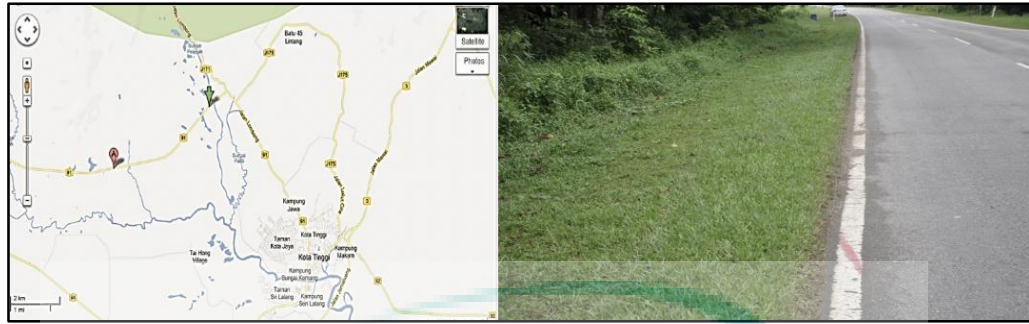
Figure 3.12 KM 3 Bandar Tenggara from Kota Tinggi at Kampung Lukut, Johor: (a) Satellite map and (b) Test site photo

Bandar Tenggara is located in the centre of the Kulai, Kota Tinggi and Kluang in the state of Johor, as shown in Figure 3.12. The roadside open space of about 6 metres wide by 90 metres long was a sufficient car trajectory's path. The ground surface with thick grass has increased the trajectory width due to slippage. The roadside slope gradient of 1V:6.7H gentler than 1V:4H and low traffic volume satisfied both the geometrical and safety requirements.

The surface conditions of the test area were lush medium - length grass surface. The damp grass surface in the morning has caused vehicle sliding when leaving the roadside and encroaching into the carriageway. The thick grass caused drying of morning dew took more extended time than short grass. The available car driving trajectory space was 6 metres wide by 90 metres long. The trees barrier located 6 metres offset from the road and sliding effect of long grass caused driving test at 80 km/h and above was not safe for execution. However, the site was selected to account for a more extensive sampling range

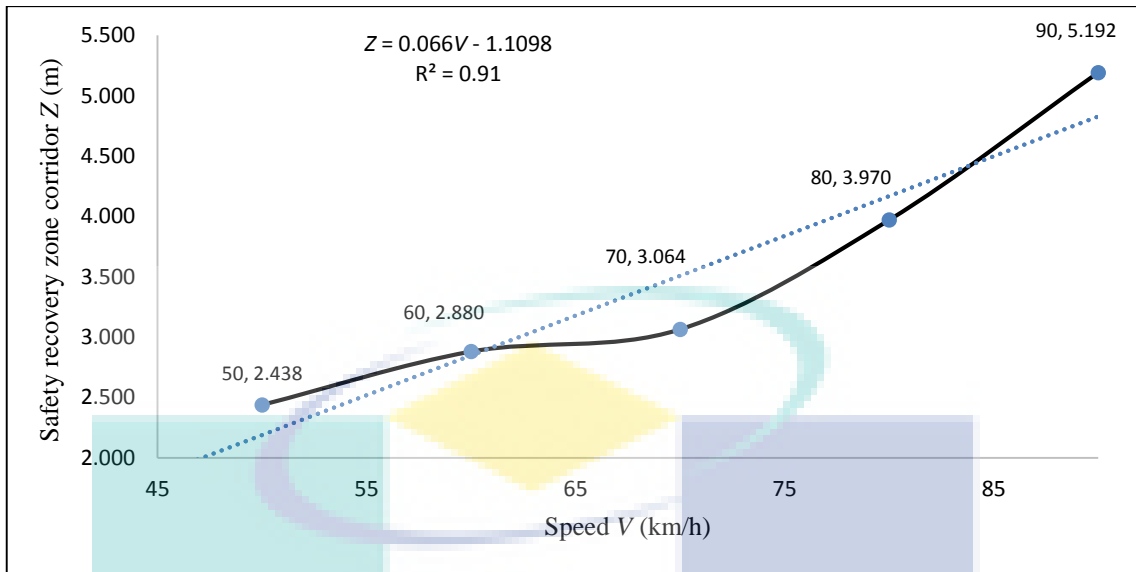
Figure 4.1 Safety recovery zone corridor widths  $Z$  versus vehicle travelling speeds  $V$  for roadside fore-slope gradient 1V:7.1H at Pantai Sepat, Kuantan translated from Table 4.1.

The collected experiment data with computed standard deviation and standard error are shown in Table 4.1. Plotting the measured values of safety recovery zone corridor width  $Z$  versus the vehicle's travelling speeds  $V$ , produced a graph is shown in Figure 4.1. The software generated statistical trendline equation shows the relationship between  $Z$  and  $V$  as  $Z = 0.066V - 1.1098$ . The linear model generated from this data provides the percentage of response variable at the variation of 91%. Deprivation of model fitness appears to be caused by the variation of testing ground condition, which affected the friction and sliding course of the tested car. The model percentage indicates a very confident prediction of  $Z$  values for a car travelling speed between 50 to 90 km/h. Based on the model equation, the predicted values of  $Z$  for the tested vehicle speeds between 50 km/h through 90 km/h and the predicted values of  $Z$  for the untested vehicle speed of 100 km/h and 110 km/h are shown in Table 4.2.

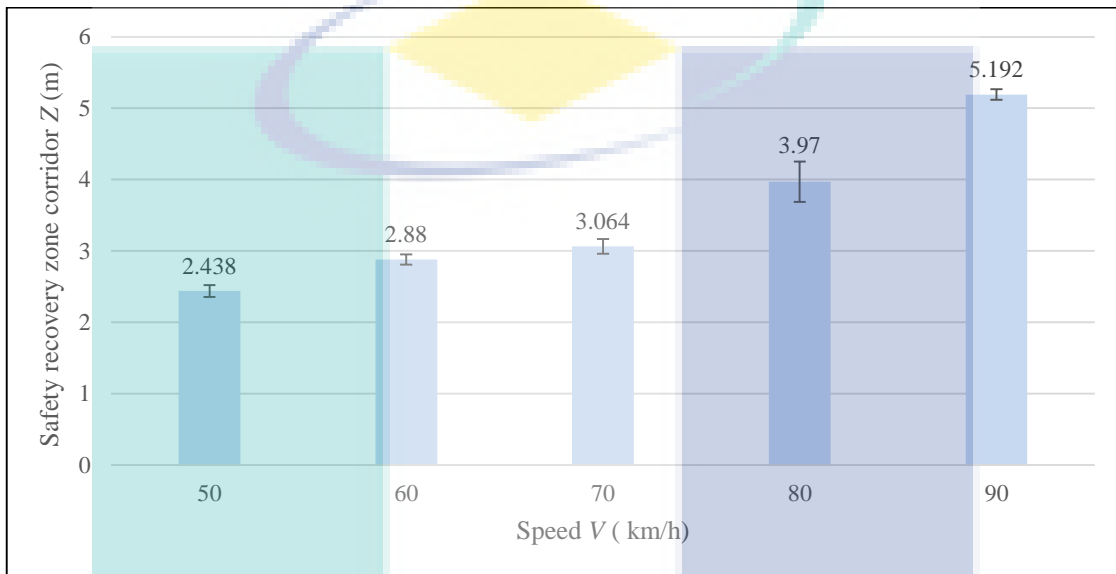
Figure 4.2 Mean of Z versus vehicle travelling speeds V for roadside fore-slope gradient 1V:7.1H at Pantai Sepat, Kuantan translated from Table 4.1.

Plotting the mean values of  $Z$  against travelling speeds  $V$  with standard errors from Table 4.2, a column chart as shown in Figure 4.2 is produced. The figure shows the largest error bar at the car travelling speed of 80 km/h (indicated by depth of error reflector on top of the column) instead of at the highest speed of 90 km/h reporting that the longer turfgrass ground condition at earlier track is slightly more slippery as compared to the later track causing the tyres to slide more on turning on changing direction. In contrast, it can be seen the lowest error of margin is at the speed of 60 km/h instead of at 50 km/h, revealing the longer turf grass on the 60 km/h trajectory path giving more sliding effect on tyres. Based on the horizontal position of error bar caps, at the car travelling speed between 60 to 70 km/h, the variation of  $Z$  does not differ significantly because the condition of the ground at their trajectory paths are quite similar. Other pairs of the error bar at different car travelling speeds can be confidently stated to possess significant difference as the error bar caps are quite separated vertically. The standard errors were not arithmetic in nature, but they were qualitative, reflecting the varying grounds surface conditions producing changing frictional reactions with car tyres.

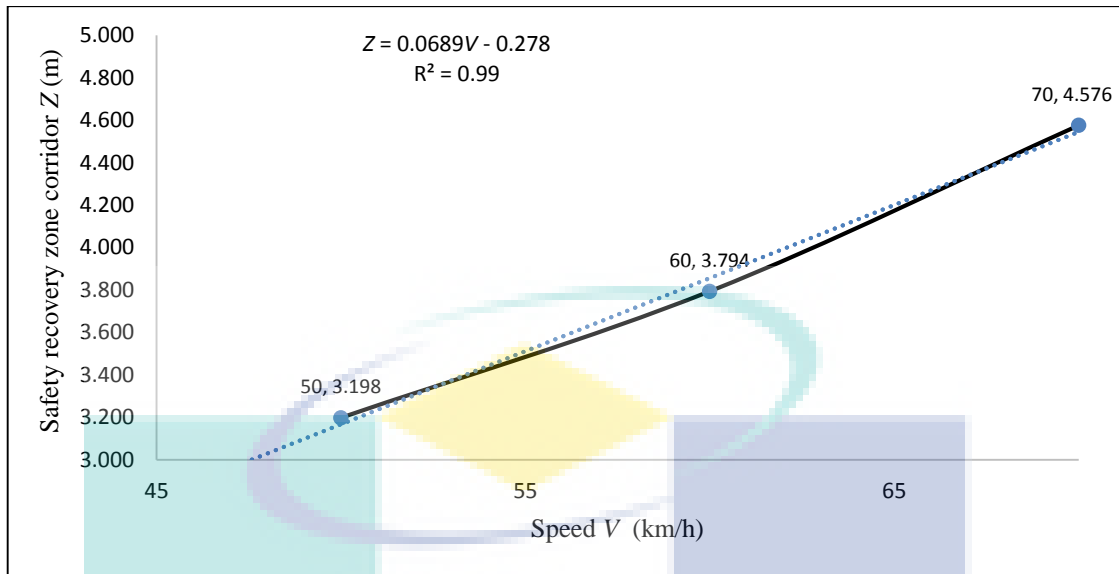
Figure 4.3 Roadside safety recovery zone corridor width  $Z$  versus vehicle speeds  $V$  for roadside fore-slope gradient 1V:5.6H at KM 9 to Bukit Ibam from Muadzam Shah, Pahang

Plotting the values for the vehicle travelling speeds  $V$  versus average safety recovery zone corridor widths  $Z$ , a linear graph, as shown in Figure 4.3 is produced. Generally, the graph shows the safety recovery zone corridor widths  $Z$  increase as the vehicle speeds increase indicates the tests were in good order. The collected data generated statistical trendline equation shows the relationship between  $Z$  and  $V$  as  $Z = 0.0689V - 0.278$ . The linear model generated from this data provides the percentage of response variable variation at 99%. Deprivation of model fitness appears to be caused by the variation of testing ground condition, which affected the friction and sliding course of the tested car. The model percentage indicates a very confident prediction of  $Z$  values for a car travelling speed between 50 to 70 km/h. Based on the linear model, the predicted values of  $Z$  for the tested vehicle speeds between 50 km/h through 70 km/h and the values of  $Z$  for the untested vehicle speed of 80 km/h, 90 km/h, 100 km/h and 110 km/h are shown in Table 4.4.

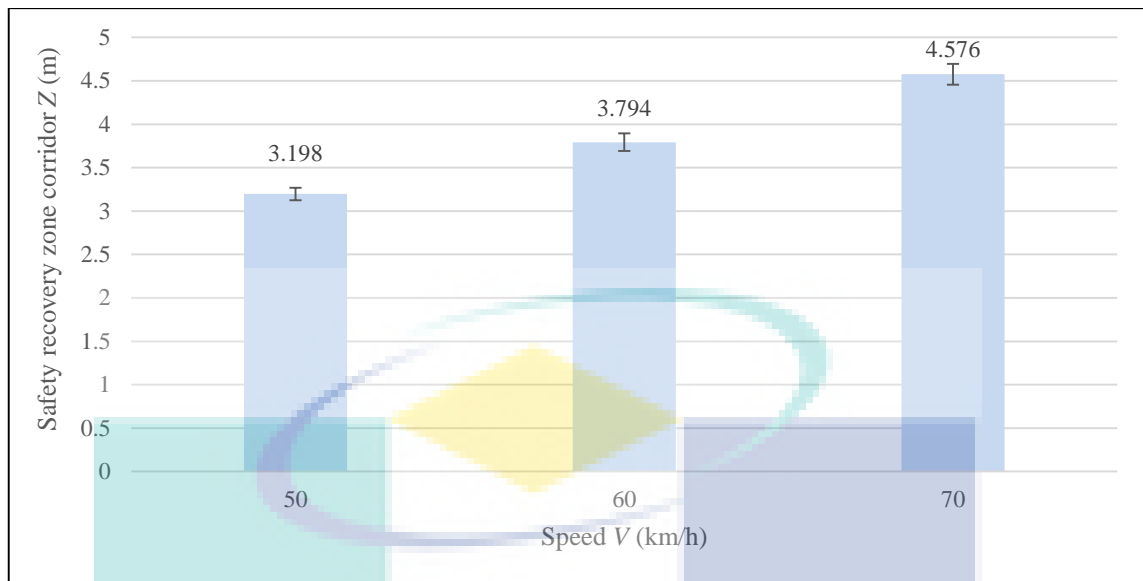
Figure 4.4 Mean of  $Z$  versus vehicle speeds  $V$  for roadside fore-slope gradient 1V:5.6H at KM 9 to Bukit Ibam from Muadzam Shah, Pahang

Plotting the mean values of  $Z$  against travelling speeds  $V$  with standard errors from Table 4.4, a column chart as shown in Figure 4.4 is produced. The figure shows the largest error bar at the car travelling speed of 70 km/h indicating that at the uniform ground condition the error bar margin increases with the increase of car travelling speed giving rise to sliding force as the tyres changed in direction. In contrast, it can be seen that the error of margin is minimum at the lowest speed of 50 km/h, revealing that the driver has better control of the car when driving at low speed. Noticeably, at all the car travelling speed between 50 to 70 km/h, the variation in the safety recovery zone corridor width  $Z$  differed significantly due to the steep slope gradient influenced the car movement trajectory paths with higher downward force.

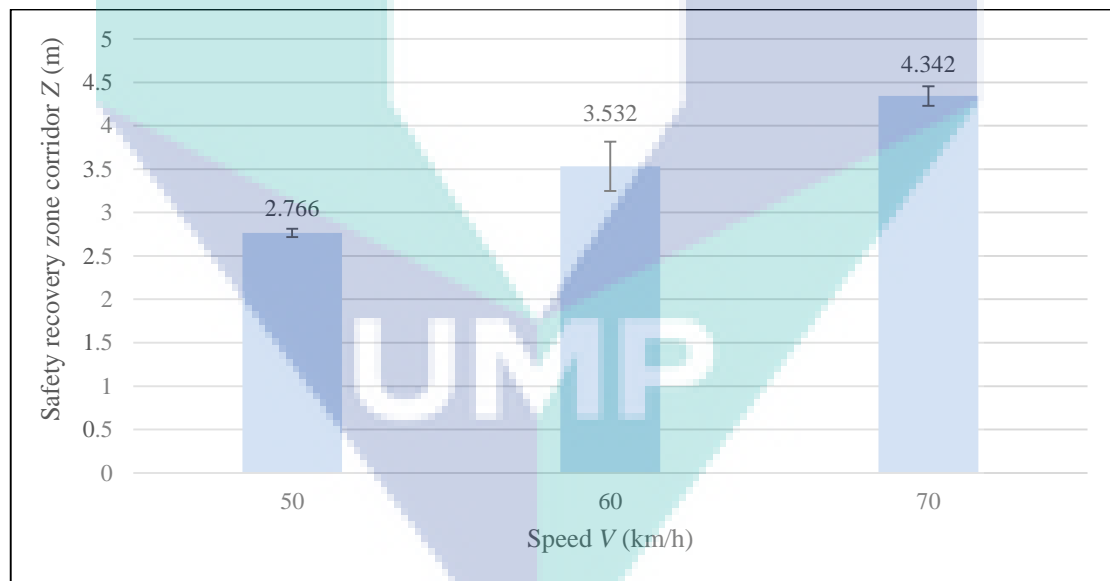
Figure 4.6 Mean of  $Z$  versus vehicle speeds  $V$  for roadside fore-slope gradient 1V:5.8H at 50 metres away from Golden Beach Resort at Pantai Lanjut, Rompin, Pahang

Plotting the mean values of Z against travelling speeds V with standard errors, a column chart as shown in Figure 4.6 is produced. The figure shows that at the car travelling speed of 60 km/h has a larger error bar than the higher travelling speed of 70 km/h. It indicates that the higher density of laterite particles on the ground surface at 60

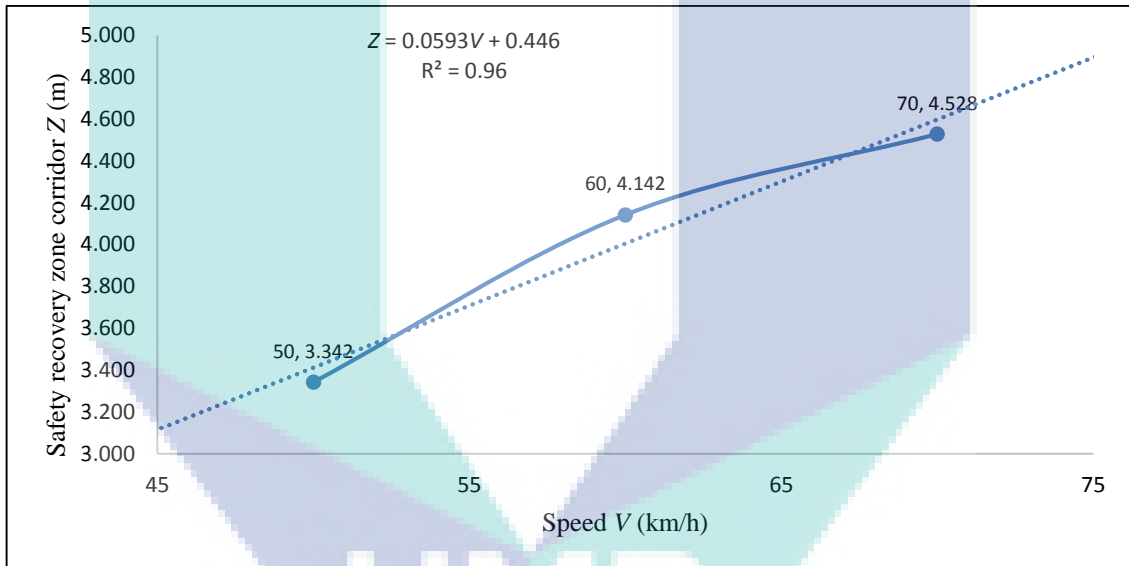
Figure 4.17 Roadside safety recovery zone corridor width *Z* versus vehicle speed *V* for roadside fore-slope 1V:5.3H at KM 5 Simpang Empat to Kuala Kurau, Perak

The collected experiment data with computed standard deviation and standard error is shown in Table 4.17. Plotting the values for vehicle speeds V versus average safety recovery zone corridor widths Z, it produces Figure 4.17. The graph shows the safety recovery zone corridor widths Z increase as the vehicle speeds V increase. The regularly inclined graph indicates that the tests were accomplished. The linear model shows the relationship between V and Z as  $Z = 0.0593V + 0.446$  with  $R^2$  value of 0.96. The model 96% value informs that Z values can safely be predicted from the model equation. Based on the equation, the predicted values of Z for the tested vehicle speeds of 50 km/h, 60 km/h, and 70 km/h, and the values of Z for the untested vehicle speed of 80 km/h, 90 km/h, 100 km/h, and 110 km/h are shown in Table 4.18.

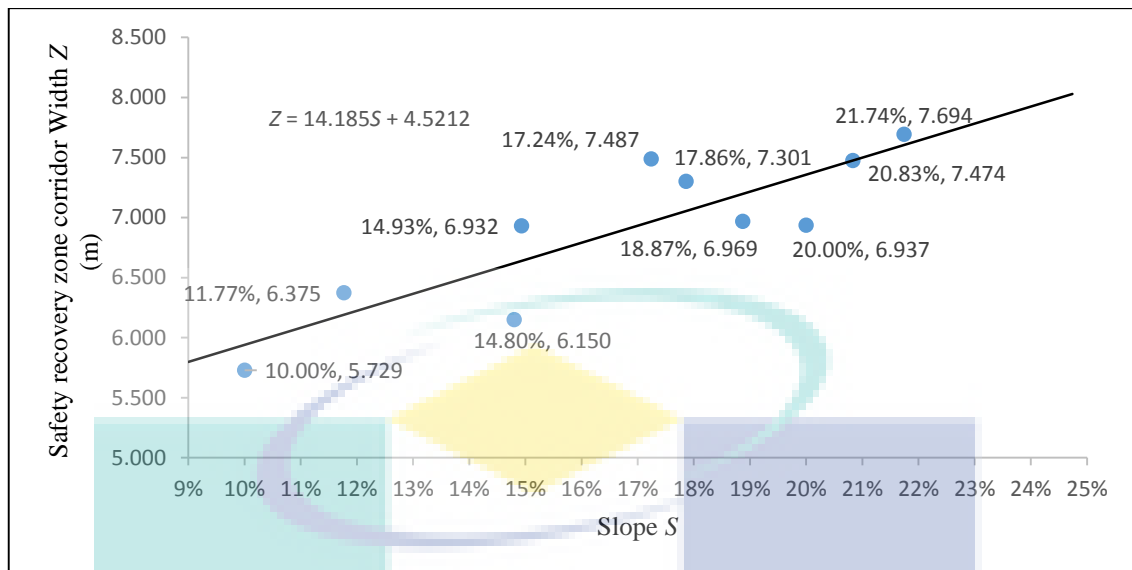
Plotting the values for safety recovery zone corridor widths  $Z$  versus various roadside slope gradients  $S$  at speed  $V$  of 110 km/h from Table 4.21, Figure 4.27 was formed. The generated linear model statistical trend line equation was given by  $Z = 14.185S + 4.5212$ . The computed values of  $Z$  based on the model equation for the slope  $S$  of 1V:4H through 1V:10H, Table 4.28 was produced.

Figure 4.27 Safety recovery zone corridor width  $Z$  versus various roadside fore-slope gradients  $S$  at vehicle speed  $V$  of 110 km/h

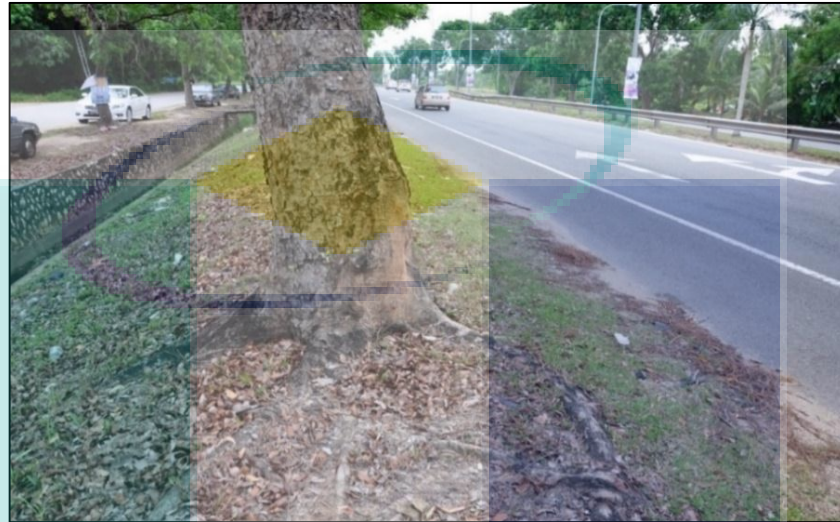
Figure 4.28 shows a tree with a stem diameter of 490 mm at KM 5 Gambang-Kuantan Road, the tree size has grown from the original diameter of less than 100 mm. The tree diameter has multiplied nearly five times of their original size in over 15 years period. Its presence on the roadside has now been classified as a hazard because they are located in the safety recovery zone corridor. When first planted, the size of the tree was less than 100 mm diameter, the size if struck by a car will cause the tree to rupture, unfortunately, as it is now the car will rupture instead.

Figure 4.28 A tree with 490 mm diameter is located 3.8 metres away from the travel lane located at KM 5 Gambang-Kuantan road, Pahang. The tree root spans about 1 metre towards the travel lane

The tree location was about 3.8 metres away from the edge of the travel lane, but the effective distance from the travel lane reduced to 2.8 metres due its root length is nearly a metre was spanning toward the travel lane. It can be concluded that the effective safety recovery zone corridor width available was 2.8 metres encroached into this study safety zone width of 3.79 metres, a dimension suggested by for the speed limit of 80 km/h having roadside slope gradient of less than 1V:10H as shown in Table 4.30. Besides the tree, the root itself was a hazard, as motorbike will lose control running over it. It was evidenced that the skinned off part of the tree was the mark of the previous vehicle struck onto it. Figure 4.29 shows some of the trees along the same abovesaid road have grown up to 800 mm and 600 mm stem diameters, located at behind and in front of the car respectively. They were remains of the trees cut but not uprooted, and became hazards to the roadside. The projected stems 300 mm and 320 mm for the 800 mm and 600 mm diameters trees respectively may cause a colliding vehicle to be airborne and plunge into the nearby drain. All the planted trees spaced at 12 metres interval along the roadside of the main road are hazards to traffics.

Study on cases shown in Figure 4.28 to Figure 4.33 informed that trees along main roads were within the region of safety recovery zone corridors and hazardous to traffic. Therefore, the trees to be removed from the roadsides. The sling road trees in Figure 4.30 were planted as required under National Landscape Policy (National, 1996) for the

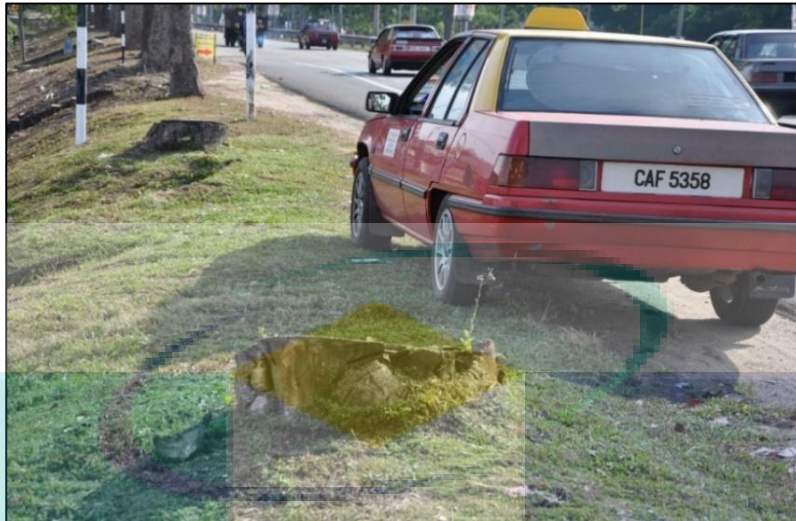
Figure 4.29 The 800 mm with 300 mm projection and 600 mm with 330 mm projection tree stumps behind and in front of the car at KM 4 Jalan Gambang, Kuantan, Pahang

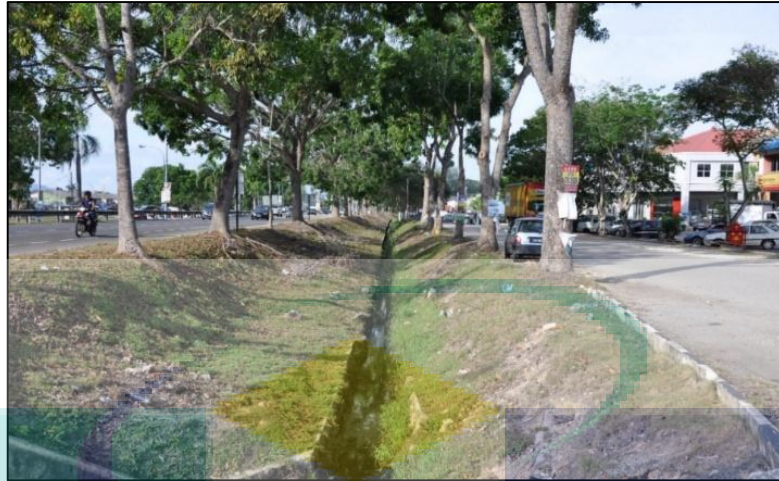
The sling road or collector local street trees shown on the left of Figure 4.30 were hazards as they were planted within the safety recovery zone corridor of 2.36 metres width specified for the road speed limit of 60 km/h and roadside slope gradient less than 1V:10H. They were planted at the edge of the road, which is hardly 0.5 metres away from the travel lane. The initiative was carried out under National Landscape Policy (National, 1996) for the development area with the vision of transforming Malaysia into a beautiful garden nation by the year 2020.

Figure 4.30 The photo taken from KM 5 facing Kuantan city showing left row of tree along the main road and right row of trees along the sling road

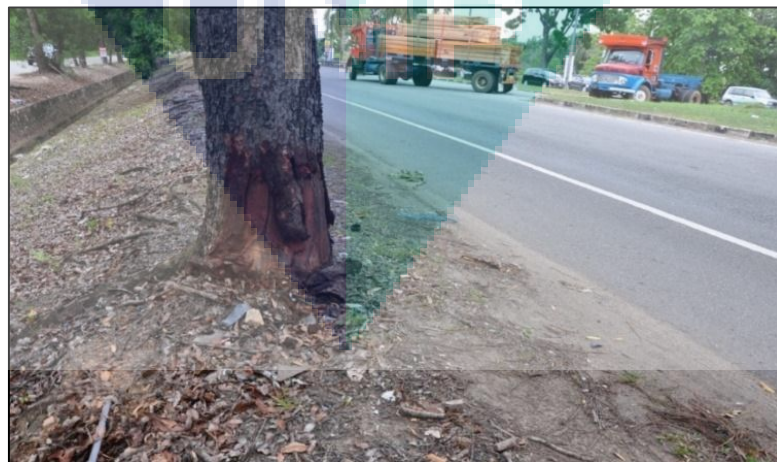
Figure 4.31 shows fresh skin at the bottom part of the tree indicates it was recently struck by a vehicle as evidenced by the broken pieces of vehicle scattered nearby the tree's bottom part. This tree and the earlier in Figure 4.27 were located along the same road of accidents prone area. It is improper for planting trees in the safety recovery zone corridor. Based on the diameter of the tree that was nearly 600 mm, the tree could have been planted when the policy of planting trees along the roadsides introduced. The road speed limit was 80 km/h, upon high impact from crashes it could stand the force and put the colliding car broken into pieces. The road is the main road connecting between Kuantan and Gambang under the jurisdiction of the state road authority. It serves a high volume of traffic throughout the day.

Figure 4.31 The fresh skin at the bottom part of the tree indicates that it was recently struck by a vehicle and the broken pieces of vehicle scattered nearby

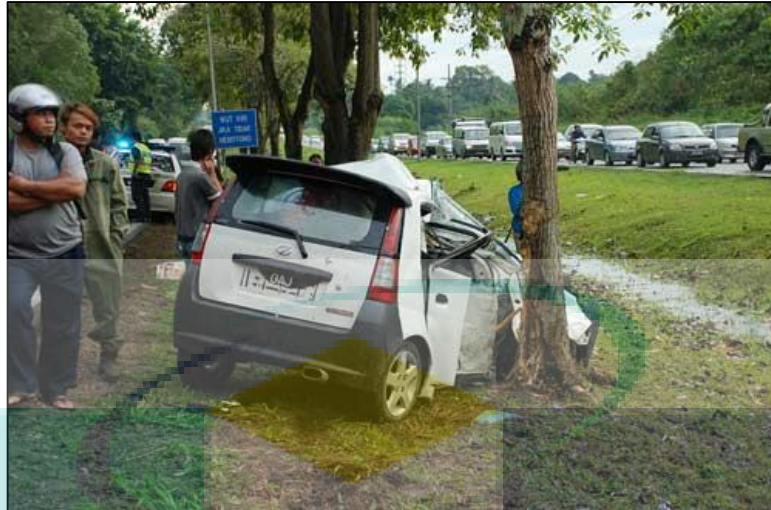
Figure 4.32 A car damaged after it rammed a tree and the driver was killed on the spot at Kidurung, Bintulu, Sarawak in August 2012

The drain between the two opposing lanes in Figure 4.32 is recommended to be converted to swale with sub-surface perforated high-density polyethylene pipe drainage as discussed in Chapter 2 Literature Review. The sub-surface drainage system is usually applied to golf course drainage, which is traversable by cars and very forgiving upon collided with traffic. Once the sub-surface drainage system is introduced, the water ponding is no more visible, and the drainage capacity is increased.

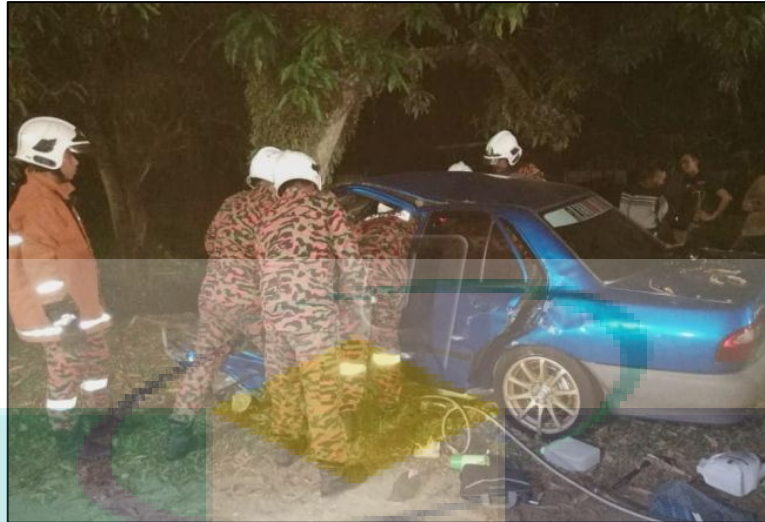
Figure 4.33 shows a car crashed into a tree and killed five in a family at Kampung Pengkalan Atap, Batu Rakit, Terengganu on 9 February 2019 (Utusan, 2019). The tree in the figure has a stem size about 500 mm diameter and was planted within the 3 metres specified clear zone for an urban area in accordance with Malaysia's landscape guideline. At the time of planting, the tree size was less than 100 mm diameter as permitted by the design guide and could be broken by the car on collision after planting. At the time of the car crash, its diameter was about 500 mm, and the car was broken instead. Based on this study, for primary and secondary rural road design standard R4 with the rated speed limit of 90 km/h traversing on the roadside slope of 1V:10H, the recommended roadside safety zone corridor is 4.51 metres. If the tree was planted outside the corridor of 4.51 metres safety zone corridor, the car might escape from the accident.

Figure 4.33 A car crashed into a tree and killed five in a family at Kampung Pengkalan Atap, Batu Rakit, Terengganu on 9 February 2019

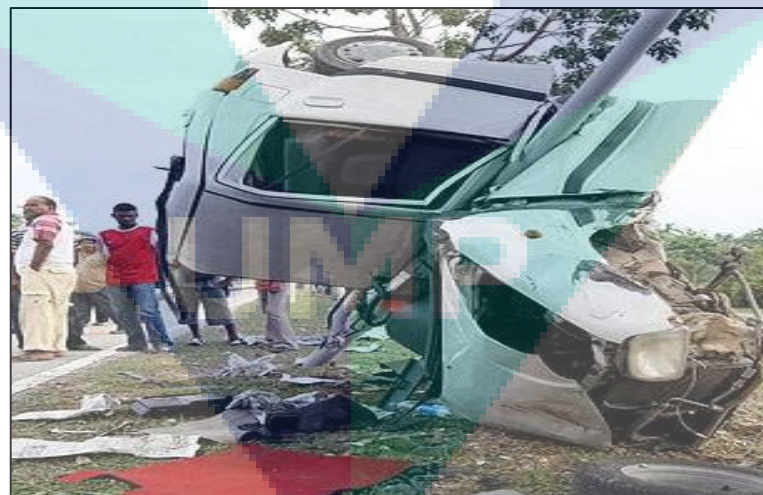
The car in Figure 4.35 rammed into a lighting pole, splitting the car into two at Dengkil/Cyberjaya Exit (Cinta, 2010). The pole was positioned into the ground at 3 metres away from the travel lane. The driver was killed as the extent of impact was very forceful.

Figure 4.35 A car rammed into lighting pole splitting the car into two killing the driver at Dengkil/Cyberjaya Exit

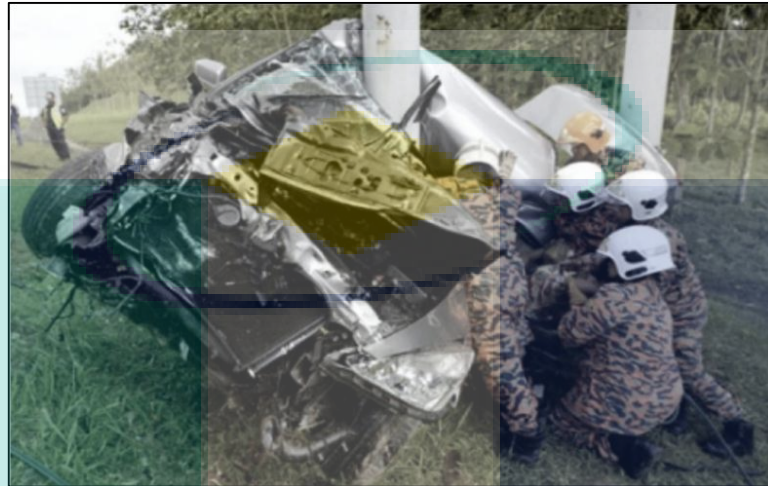
obstructions to skidding vehicle. Figure 4.36 shows a car crashed into a signboard pillar, causing five in a family killed on 02 May 2013 at North-South Expressway, Kulai Jaya, Johor (Dailyimage, 2013).

Figure 4.36 A car crashed into a road signboard pillar causing five in a family killed on 2 May 2013 at North-South Expressway, Kulai Jaya, Johor

The signboard pillar shown in Figure 4.36 shall be kept away from the travel lane as far as the width of safety recovery zone corridor. Based on the study outcome, for rural expressway travelling speed of 110 km/h and roadside slope of 1V:4H, the required free of obstruction corridor width is 8.07 metres compared to the signboard post position of about 6 meters away from the travel way. The recommended solution is to redesign with cantilevered structure with pillar shifted by 2.07 metres further away from the travel lane. The car might escape from the accident if the signboard was located outside the 807 metres safety recovery zone corridor recommended in the study.

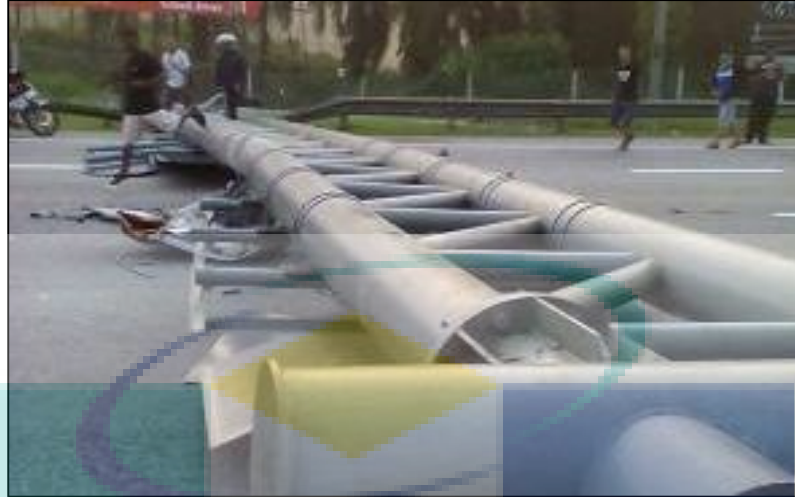
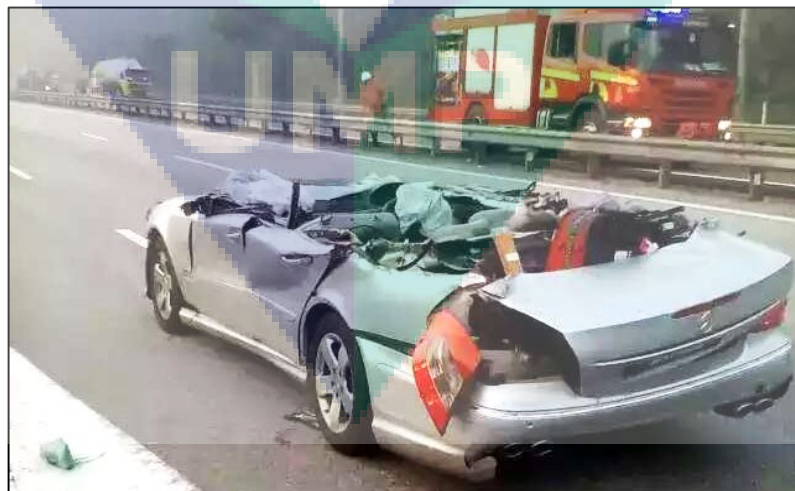
Figure 4.37 and Figure 4.38 show a metal signboard girder collapsed onto a passing car after a trailer crashed into its post on 10 October 2015 at km 399.8 Tanjung Malim/Behrang, North-South Highway (Astro, 2015). The accident caused three in the family died. Typically, the signboard girder was supported on metal pipe column and positioned at about 5 meters away from the edge of a travel lane. The position of the girder columns was too close to the travel lane contributed to the accident. Numerous similar structures are found in Malaysian streets and require their layouts to be evaluated and corrected as necessary.

Figure 4.37 A signboard girder collapsed onto a passing car after a trailer crashed into its post caused 3 in the family died on 10 October 2015 at KM 399.8 Tanjung Malim/Behrang, North-South Highway

Figure 4.38 A passing by car that carried the 3 deceased vehicle occupants

Case study to problem in Figure 4.37 and Figure 4.38 on signboard metal girder collapsed informed that the signboard nearest column 5 metres away from the edge of travel lane was located inside safety zone corridor. Based on the outcome of this study in Table 4.30 the width of safety recovery zone corridor for the region was 6.89 metres, the value for rural design standard R6 expressway with speed limit 110 km/h and having roadside slope of 1V:6H. Could the girder signboard pillar was built outside the safety zone, the lorry may had escaped from hitting the steel column and avoided the signboard collapsed and saved the three passengers life. Design of the girder pillar can be improved by providing deeper stump to provide counter moment from impact and bottom part of the pillar be shielded with crash cushion made of boxed-sand or metal barrier.
