**A STUDY ON MALAYSIAN ROADSIDE  
SAFETY ADOPTING SAFETY RECOVERY  
ZONE CORRIDOR CONCEPT**

**DOCTOR OF PHILOSOPHY**

**UNIVERSITI MALAYSIA PAHANG**

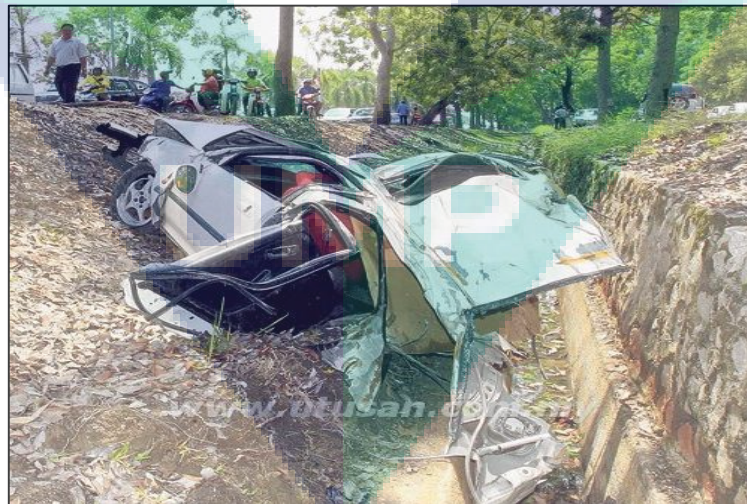
A roadside drain is among significant hazards for Malaysian road. Figure 4.39 shows skidding car where the driver could not control the car due to steep roadside slope of 1V:1H i.e. the gradient is steeper than 1V:4H a non-traversable slope, and hitting the hard surface drain's rubble pitching wall and bounced back causing three passengers died and one severely injured at KM 5 Kuantan-Gambang, Kuantan, Pahang Highway (Kosmo, 2015).

Figure 4.39 Roadside drain is a hazard to road users. Kuantan, 19 August 2014 – 3 passengers died and 1 severely injured at KM 5, Jalan Gambang-Kuantan.

Referring to a case study shown in Figure 4.39, should the one-sided rubble line wall be with turfed earth and 1V:1H inside slope in place of the nearly vertical embankment, the accident may probably not be fatal but with injuries. If the approaching slope (the drain slope closest to the road) having a slope of 1V:1H was built with the study recommended minimum slope of 1V:4H, there was a possibility the skidding car may traverse back into the driving lane, and the passengers may have survived from death. If the roadside tree and the drain were positioned outside the study recommended safety recovery zone corridor, there was a very high chance that the passengers may survive both deaths and injuries. The tragedy was evident that the drain design was not forgiving and needed to be redesigned and reconstructed with a forgiving design concept. The solution to Figure 4.44 is to ensure the drain is constructed outside safety recovery zone corridor or reform to forgiving design type as discussed in the following section.

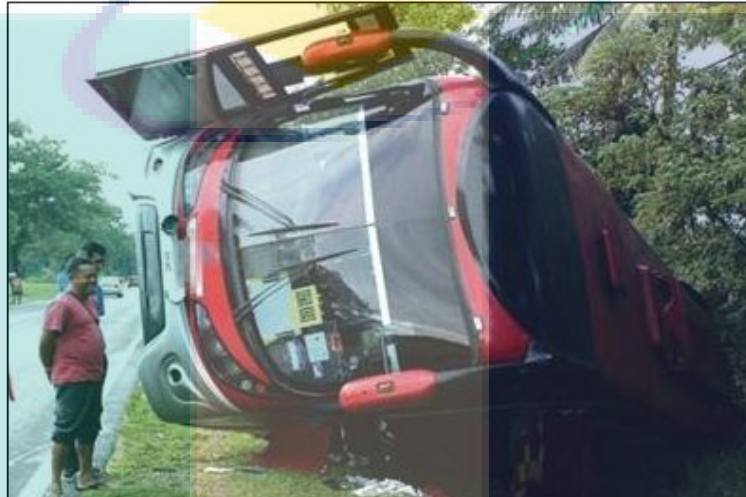
Figure 4.40 shows a bus skidded into a roadside drain located at less than 2 metres away from the travel lane (Ammboi, 2013). The bus was avoiding collision with the oncoming car encroaching into its lane, but unfortunately, the roadside drain was too near to travel lane causing the bus got into the drain. The roadside emergency lane was undersized, and the drain was constructed within the safety zone corridor, causing an impossible situation for the bus to stop or traverse back into the carriageway.

Figure 4.40 Roadside drain is a hazard to road users. Avoiding a car coming to its lane, the bus got into roadside drain at Kampung Gerai, Jertih, Terengganu  
Source: Ammboi (2013)

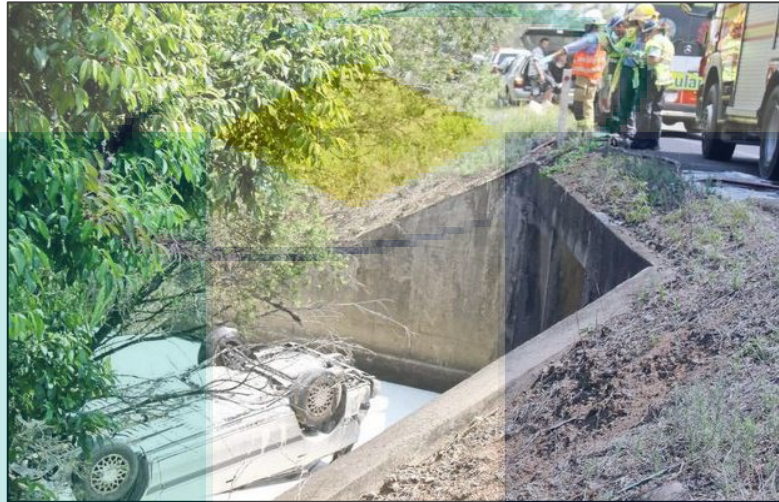
It is typical for a road crossing culvert design to comprise of the tubing section and headwalls complete with wings at both ends. The headwall and wings are introduced for backing earth behind them. Figure 4.41 shows a car plunged into headwall culvert opening at the south of Gympie, Queensland, Australia (Gympie, 2012). Most of the culverts in Malaysia are having openings that are not closed with a metal grating as shown in Figure 4.42 in view to no statutory requirement to do so. The projection of the concrete

Figure 4.41 A car plunged into culvert opening at South of Gympie, Queensland, Australia on 17 November 2012

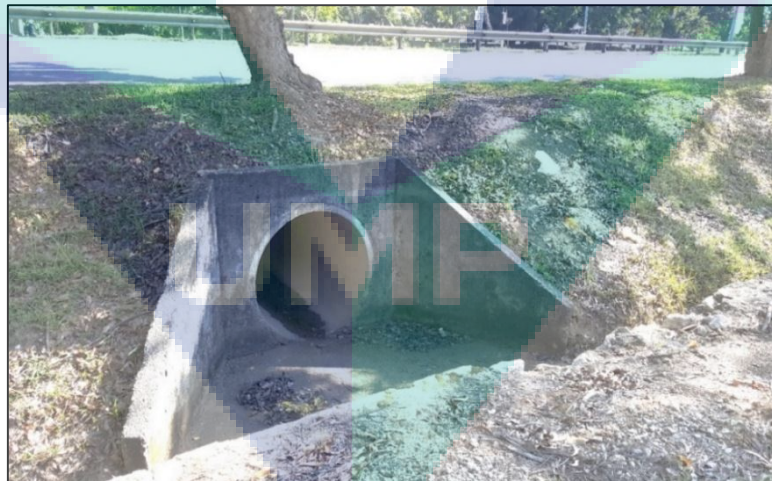
Figure 4.42 Concrete culvert at KM 5 Gambang-Kuantan Highway, Kuantan, Pahang

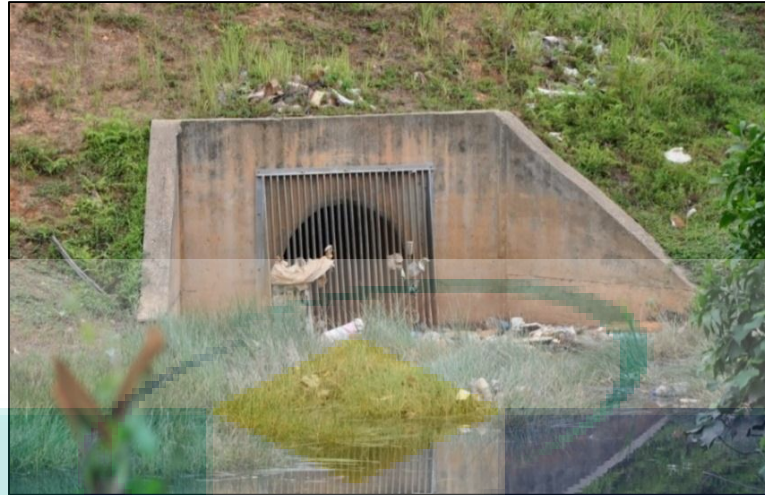
Figure 4.43 The culvert discharging to the stream is provided with steel screen to trap rubbish at the side of KM 5 Gambang-Kuantan, Kuantan, Pahang

head and wing walls above ground surface worsen the condition as the vehicle can be airborne upon striking them. Some culverts discharging into the flood-prone area has got their inlet closed with steel grating as in Figure 4.43 to prevent rubbish built-up, mainly serves as a flood mitigation measure.

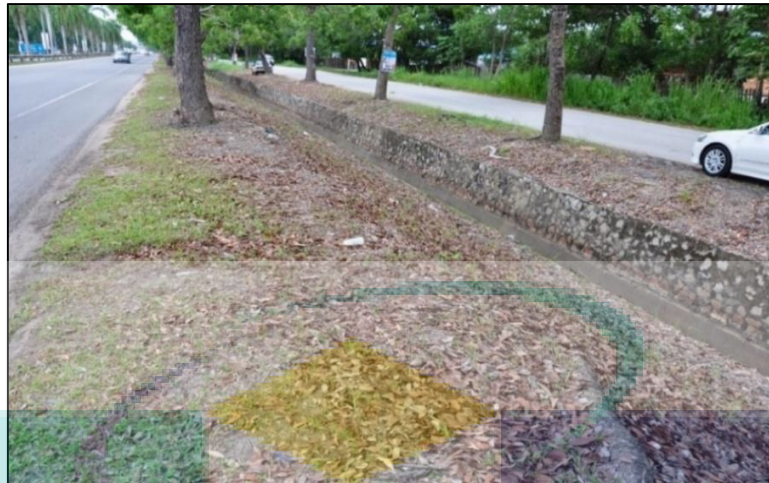
Figure 4.44 shows Kuantan-Gambang highway on the left of the viewer and the right of the viewer was sling road. The drain served stormwater discharge from the main road and the sling road. It can be observed that the installed rubble pitched drain was not forgiving to traffic and contributed to a fatal accident. It is recommended that the drain be reconstructed with new traffic friendly design.

Figure 4.44 Overall elevation showing the site for accident shown in Figure 4.39 took place

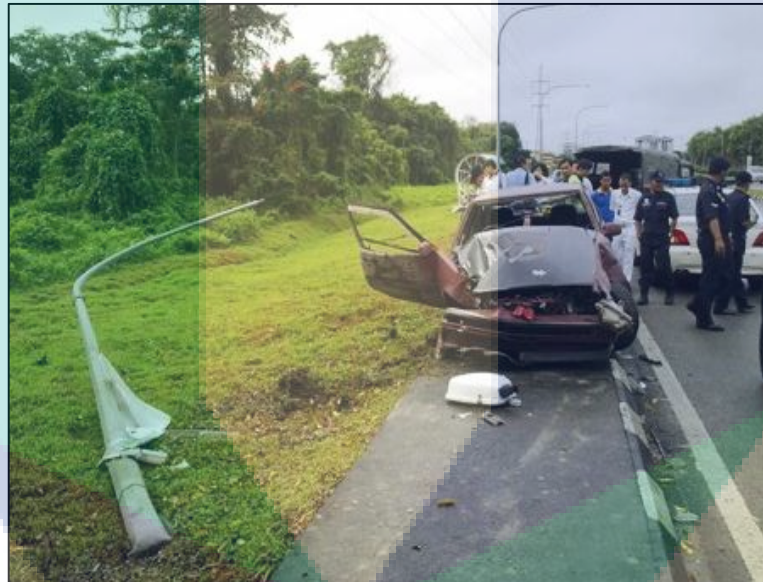
Kerb, though appear to be small in size but the force of impact may cause fatal accident as in the case shown in Figure 4.48 where the car hit the kerb, airborne and hit the light pole and landed on the pedestrian path causing the driver died on 20 February 2011 at Jalan Tun Jugah, Kuching, Sarawak (Kemalangan, 2011). There were practices installing kerbs with substantial projection to facilitate future repaving without having to dismantle and replace the kerbs, a practice proven to be wrong.

Figure 4.48 The car hit kerb, then light pole and landed on pedestrian path causing the driver died on 20 February 2011 at Jalan Tun Jugah, Sarawak

Could the kerbs in Figure 4.48 and Figure 4.49 installed with the type shown in Figure 4.50 or Figure 4.51, the driver could have drove-up the kerb instead of airborne and then manage the car steering to land the car safely. Poor engineering roadside design will not compromise motorist mistake, and sound engineering design may forgive motorist mistake. The problem discussed is typical nationwide.

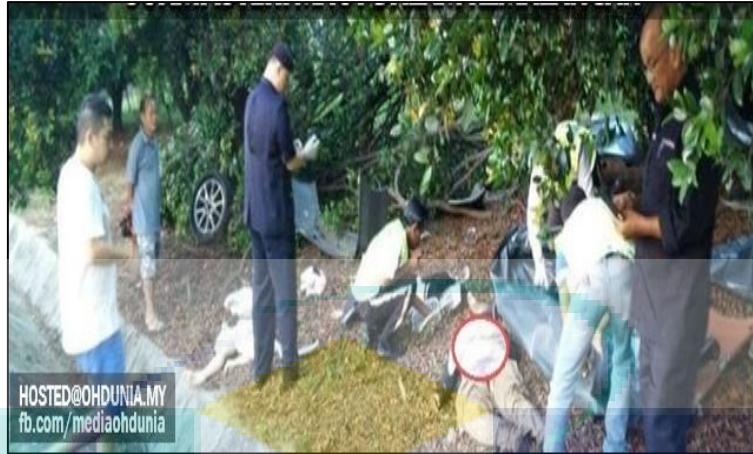
Likewise, in the case shown in Figure 4.49, the car hit the kerb, then airborne killed four at kilometre 9.9 Elite highway Subang Jaya (Ohdunia, 2015). The kerb on the roadside was very high in elevation and having a steep vertical face for car safe climbing was unlikely to be performed. Many Malaysian streets installed with a high elevation and steep face kerbs need replacement.

Figure 4.49 An accident killed 4 at KM 9.9 Elite Highway Subang Jaya  
Source: Ohdunia (2015)

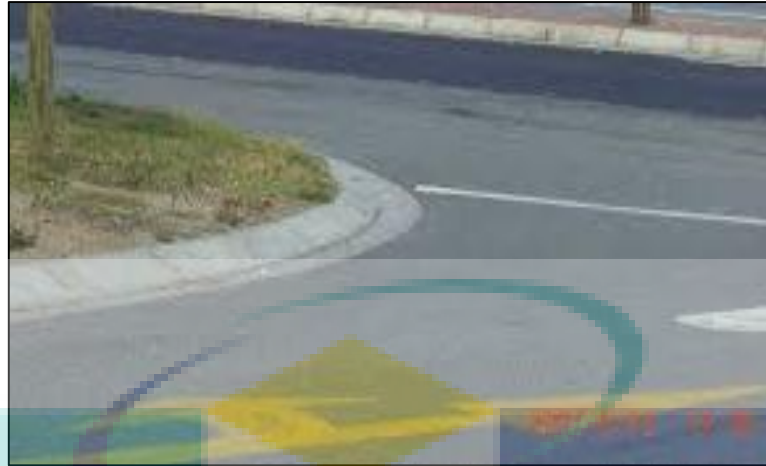
Figure 4.50 Kerb is more forgiving with low drop level, tapered with the provision of slight depression for drainage at Port Elizabeth, South Africa

Poorly designed kerbs cause damages to tyre sidewalls, wheel alignment sometimes burst and may lead to fatal accidents on prolonged usage (Septua, 2015). A sample of favourable and forgiving design kerb is shown in Figure 5.32 at Port Elizabeth, South Africa has about 25 mm drop, tapered slope to the berm. The African kerb is lined with concrete slab edging the paved road and perfectly formed a smooth channel. Similar kerb adopted to some places in Putrajaya is shown in Figure 4.51, but the kerb was not lined with a concrete slab edging the paved road that made it sub-standard as compared to the African version. Straying off from travel lane, wheel contact with kerbs could cause a vehicle to be airborne and overturn (AASHTO, 2011).

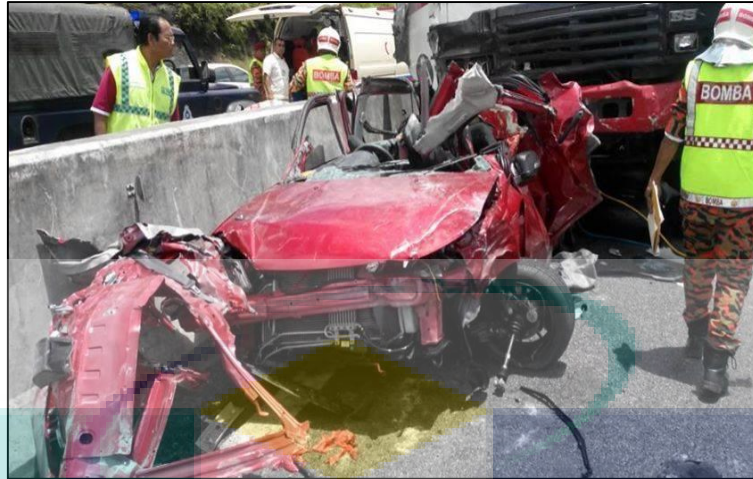
Figure 4.52 shows a car crashed into a concrete barrier and caused two died from 5 in the family at km 256 PLUS highway on 4 October 2014 (Melvister, 2014). The concrete barrier was of the rigid type barrier, and it redirected the vehicle upon collision where dissipated energy absorbed by the vehicle and causing the car metal body to deform, and lead to the fatal accident.

Figure 4.52 A car crashed into concrete wall and caused 2 died from 5 in the family at KM 256 PLUS Highway on 4 October 2014

The case in the Figure 4.52, there was no shielding provided to reduce degree of crash impact. Installation of crash cushion cylindrical high-density polyethylene barrier as shown in Figure 2.2 in such accident-prone area may have saved the passengers life. Generally, concrete barrier is applied as divider for separation of opposing lanes in order to prevent opposing car from crossing to the other side.

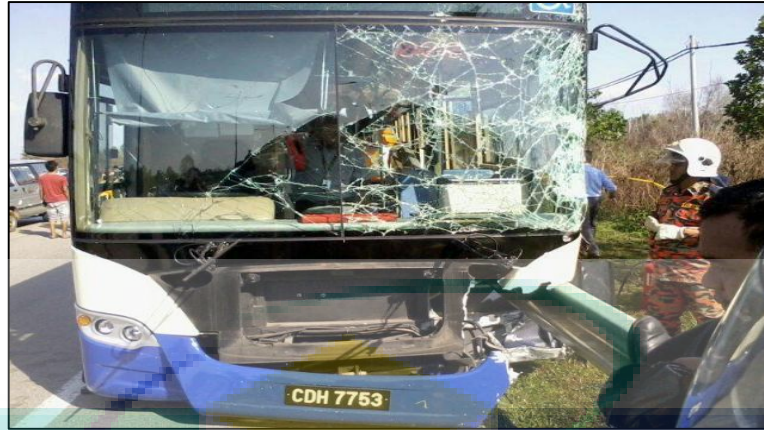
Figure 4.53 A metal beam punctured through the rapid Kuantan bus at KM 13 Kuantan-Pekan, Pahang

The roadside metal beam guardrail itself can be a hazard as shown in Figure 4.53 and Figure 4.54. It was an accident at KM 13 Jalan Kuantan-Pekan, where the bus front left tyre exploded, and the bus then crashed into roadside longitudinal safety barrier and caused the metal beam punctured through the bus (Sinar, 2014). One passenger leg was broken, and two passengers were with minor injuries. The safety barrier installed was to shield a row of trees planted 3 metres from the road edge marginal line. Should the safety recovery zone corridor of 5.39 metres width for R5 type for the rural road as recommended in this study under Table 4.30 was enforced, the barrier was not required to be installed. It was because the planting of trees in the region was not permissible, and such an accident could have been avoided. Could the colliding vehicle was a car in place of the bus, the accident could be fatal. The accident was not fatal to bus passengers because the bus floor level was very much higher than the usual car's floor level. However, the tragedy has been very scary to the public till now. The road authorities must have kept all similar installation under road safety auditors check list.

The cases in Figure 4.53 and Figure 4.54, the application of metal beam as roadside barrier to shield trees was not permissible in practice because they were hazards and not necessary. The Malaysian “Guidelines on Design and Selection of Longitudinal Traffic Safety Barrier” recommends engineers to consider removal or relocation, prior to application of safety barrier as a shield on the roadside (REAM-GL-9, 2006). It was very clear that the intent of the guide was not to keep trees nearby to roads and use metal beams as shield.

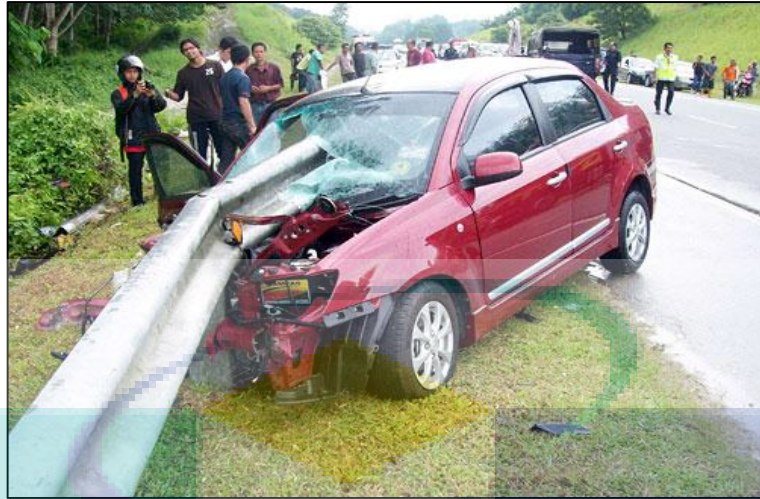
Figure 4.55 A metal barrier penetrated into skidding car causing 4 died at KM 73 Kuala Kangsar Road, Gerik, Perak

Figure 4.55 shows an errant car crushed into the guardrail causing 4 died at KM 73 Kuala Kangsar road, Gerik, Perak (Langkah, 2011). The tragedy implied that responsible Malaysian authority has great task to evaluate all existing infrastructures and if necessary, to redesign many of the existing roadside barrier system. The Guidelines on Design and Selection of Longitudinal Traffic Safety Barrier has no recommendation for providing roadside barrier to road having low lying area beside the site table (REAM-GL-9, 2006). However, it is believed that the engineer felt the need of the metal beam barrier in preventing the skidding vehicle from encroaching into the low-lying area.

The case in the Figure 4.55, the metal beam barrier was installed to prevent traffic from encroaching into low lying area. The metal beam barrier was not installed according to safe engineering practice where blunt end to be provided in order to avoid beam puncturing into approaching vehicle. Application of soft and displaceable barrier is more

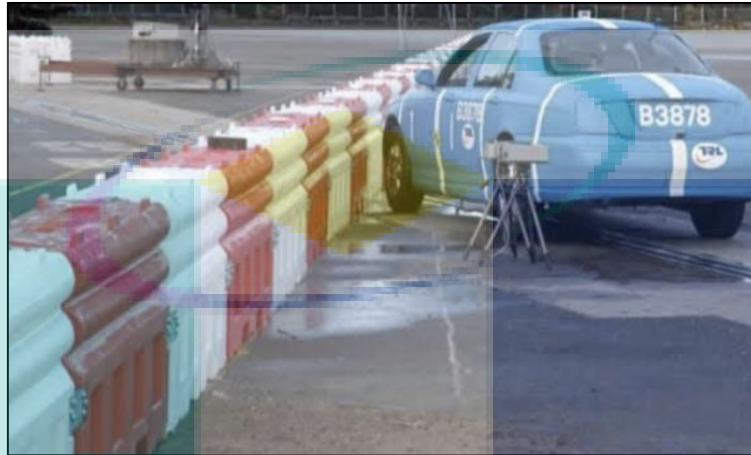
Figure 4.56 Boxed-sand for roadside safety traffic barrier

impact tolerable than hard and semi-rigid barrier. Installing boxed-sand safety traffic barrier as shown in Figure 4.56 is cheaper and safer than the metal barrier, and giving high chance of survival for the 4 died vehicle passengers.
