To cite this article: A M A Budiea et al 2020 IOP Conf. Ser.: Mater. Sci. Eng. 849 012023

Corrosion study of pipeline material for seabed sediment in tropical climate

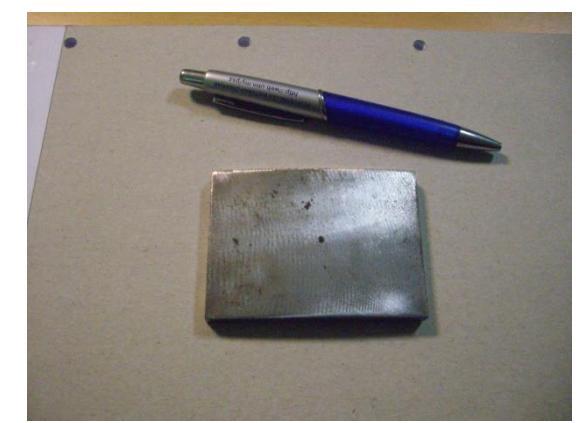
Figure 1: Sample of coupon ready for experimental work

Then, all the specimens subjected to milling process using the milling machine to remove the Fusion bonded epoxy (FBE) coating and corrosion product in order to produce uniform surface as shown in Figure 1. After that, hand grinder is used for grinding the coupons to further smoothen the surface of specimens. Towards the end of the preparation process, the specimens were cleaned, dried and stored in desiccators to prevent them from being exposed to corrosion.

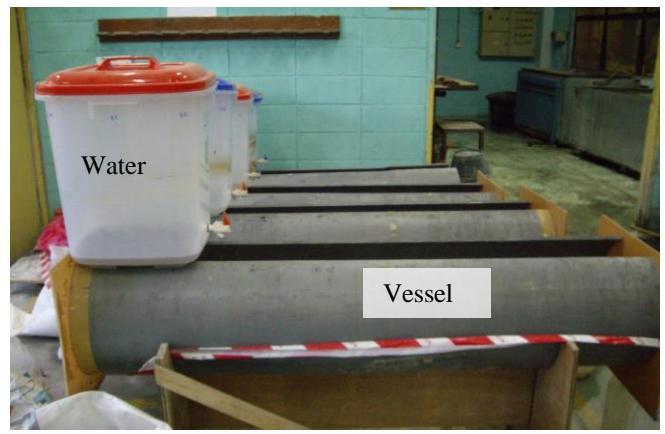
Figure 2: Vessels used to place different sediments

The corrosion test vessel is plastic container with a siphon and a control valve. The container that used to store sea water has been fixed at higher level than testing vessel, to enable sea water to flow into the vessels replacing the used water with fresh water. The tank has seabed sediment to a certain height covered with sea water to simulate the closest possible real site condition. The seawater storage container designed to be a rigid and inactive container with outlet and valve, and connected to the tank, similar method that has been used by [12]. He used this method to simulate sea environment zones including atmosphere zone, submerged zone, tidal zone, splash zone and seabed sediment zone. The

method used intensively to study the seabed sediment alone. The corrosion testing vessels used in this study is illustrated in **Figure 2**.

The four vessels have been used into each of them placed different sediments with different condition. Sea water was filled and covered the soil up to 200 mm above the soil surface to simulate the actual environment, the sea water was changed periodically and the temperature and other parameters in the tank have been measured simultaneously.

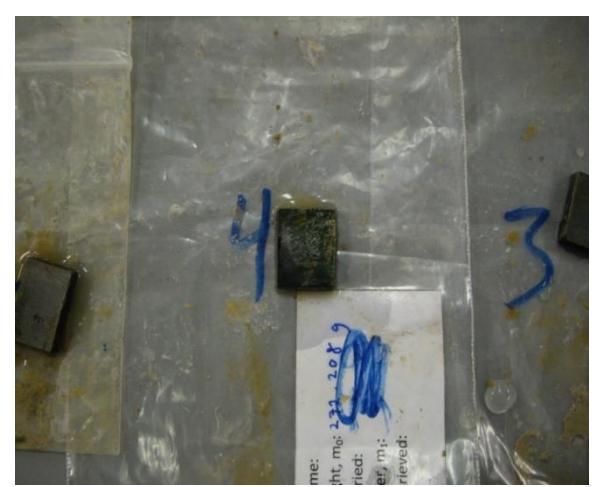
Figure 3: Coupon after retrieved from sediment

Weight loss method was used to calculate the corrosion rate and the progress of metal loss experienced by the coupons as a function of time. After the retrieval of coupons which have been subjected to sediment environment, coupons undergone of cleaning process, Figure 3 shows coupons after normal cleaning. This process of cleaning was applied for all steel specimens. The retrieved coupons were rinsed and gently scrubbed under distilled water to remove adherent soil. Then, the chemical cleaning procedure as described in [14] was used to remove the remaining impurities leaving the bare coupon in Figure 4. Coupons were weighed repeatedly until it reaches its constant weight.

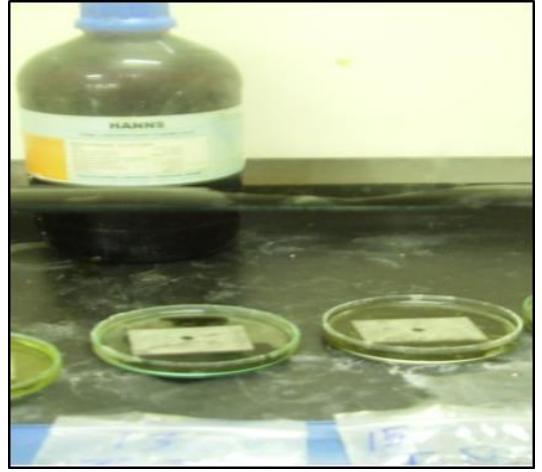
Figure 4: Chemical cleaning of coupons

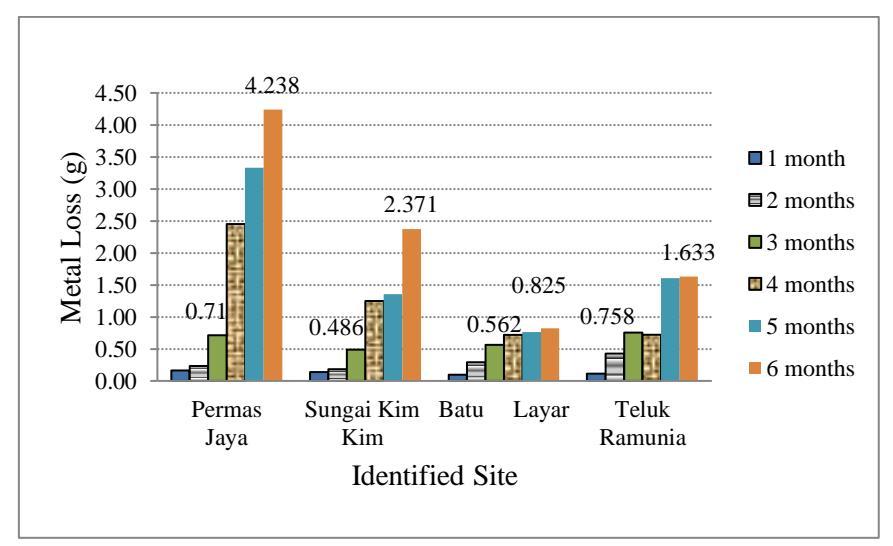
Figure 5 Metal loss of coupons tested at laboratory in sediment samples collected from four sites.

In this experimental work, near shore environment was simulated to represent similar condition to the site, specifically focusing on metal loss behaviour of steel specimens due to exposure to near shore sediment. Herein, the sediments which have been collected from different sites with dissimilar properties are used in the laboratory to study the metal loss behaviour. The purpose of this simulation is to find a way to study and monitor the specimens more closely and to enrich the data besides the data collected from the site. **Figure 5** shows a graph of metal loss (in gram) for four different sites; Permas Jaya, Sungai Kim Kim, Batu Layar and Teluk Ramunia, representing the behaviour of steel corrosion in near shore simulated conditions. It can be seen from the graph that all sites show lower metal loss in the first month that are 0.160 g in Permas Jaya, 0.136 g in Sungai Kim Kim, 0.094 g in Batu Layar and 0.113 g in Teluk Ramunia. The result shows the metal loss increases gradually from time to time and at the end of six months. As presented in **Figure 5**, the metal losses are 4.238 g, 2.371 g, 0.825 g and 1.633 g in that order at the respective locations. The results presented in **Figures** 6 to 9 show the behaviour of metal loss of each type of sediment in greater details. Monthly retrieval of steel specimens was considered for a period of six months to cover the early stage of metal loss for each condition.

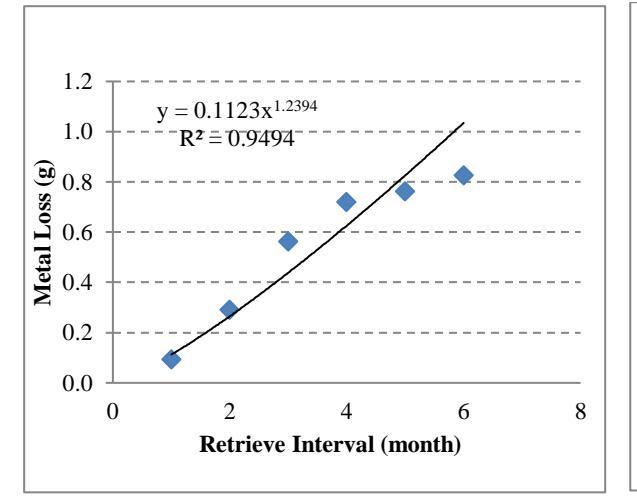
Figure 8: Metal loss for Batu Layar sediment

The results of this study show that the behaviour of metal loss is increasing with the time of exposure although the results are different from one site to another in terms of the average metal loss values. As it can be seen in **Figures 6 to 9**, the laboratory studies were limited to six months. However, the results are still reasonable to certain extent. For example, the results obtained at three months show that the metal loss is 0.486 g metal loss at the laboratory. The highest metal loss was obtained at Permas Jaya sediment for laboratory after six months exposure. This finding enhances the possibility to simulate the real environment at laboratory. It should be highlighted that the limitation of recent study to simulate exactly every aspect of the site in terms of daily changes of weather conditions e.g. temperature or humidity. Nevertheless, the simulation at the laboratory will indicate generally the behaviour of corrosion rate. The specimens were retrieved more frequent as compared with in-situ retrieves which normally takes longer intervals for each retrieve. Shorter retrieval time enables closer monitoring to the specimens and provides clearer ideas of exposure condition.

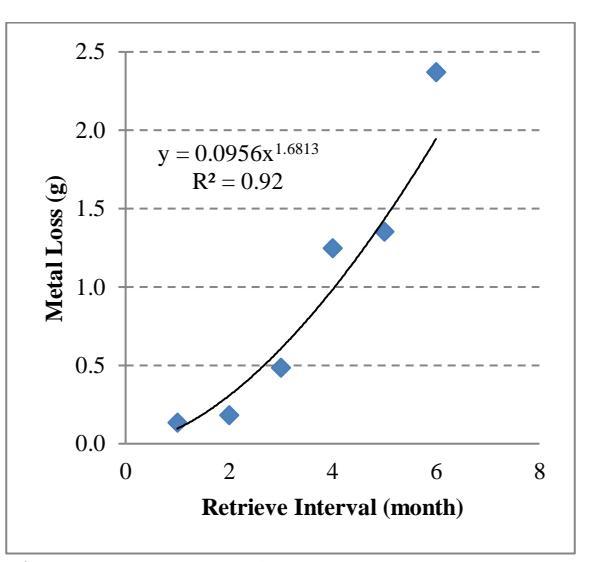
Figure 7: Metal loss for Sungai KimKim sediment

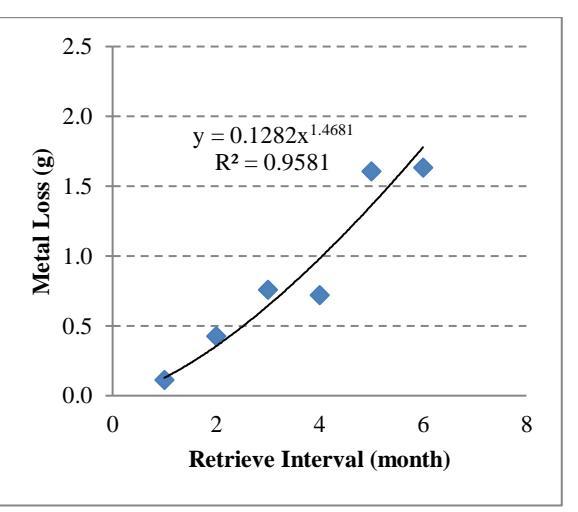
Figure 9: Metal loss for Teluk Ramunia sediment
